Characterization of Tannic Acid-Coated AZ31 Mg Alloy for Biomedical Application and Comparison with AZ91

Article

Abstract: Magnesium alloys are promising materials for bioresorbable implants that will improve patient life and reduce healthcare costs. However, their clinical use is prevented by the rapid degradation and corrosion of magnesium, which leads to a fast loss of mechanical strength and the formation of by-products that can trigger tissue inflammation. Here, a tannic acid coating is proposed to control the degradation of AZ31 and AZ91 alloys, starting from a previous study by the authors on AZ91. The coatings on the two materials were characterized both by the chemical (EDS, FTIR, XPS) and the morphological (SEM, confocal profilometry) point of view. Static degradation tests in PBS and electrochemical measurements in different solutions showed that the protective performances of the tannic acid coatings are strongly affected by the presence of cracks. The presence of fractures in the protective layer generates galvanic couples between the coating scales and the metal, worsening the corrosion resistance. Although degradation control was not achieved, useful insights on th

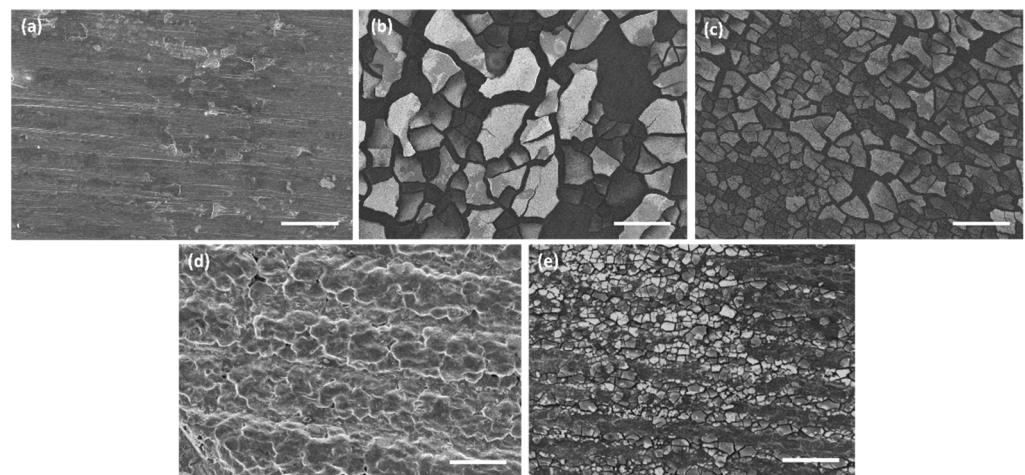
Figure 1. SEM images (100 \times) of (a) AZ91 uncoated, (b) AZ91TA_5, (c) AZ31 uncoated, (d) AZ31TA_5, (e) AZ31TA_20. Markers are 200 μ m each.

The AZ91 bare sample (Figure 1a) presents a rough surface that resembles the layered topology of the 3D-printed polymer pattern replicated by investment casting (Figure S1 in Supplementary Material). After tannic acid coating (Figure 1b) the main topography is maintained but plenty of micro-scales completely cover the surface, confirming surface reaction and coating, as reported in [20].

The surface of the bare AZ31 sample (Figure 1c) appears as a typical rolled metal with some scratches and scales, attributable to surface deformation and oxidation during working. After tannic acid coating in a 5 mg/mL solution for 3 h (Figure 1d), analogously to AZ91 substrates, a lot of big (hundreds of microns) scales cover the surface. When coating is performed in a 20 mg/mL TA solution for 30 min (Figure 1e), scales have smaller dimensions (not so far from the ones obtained on AZ91 samples) and cover the surface in a more homogeneous way (less detachment). The presence of the phenolic coating is also confirmed by EDS analyses (Table S1 in Supplementary Material), where an increase in the C content was detected after the treatments on both AZ31TA_5 and AZ3TA_20. No differences in the two coatings were observed in terms of the chemical composition.

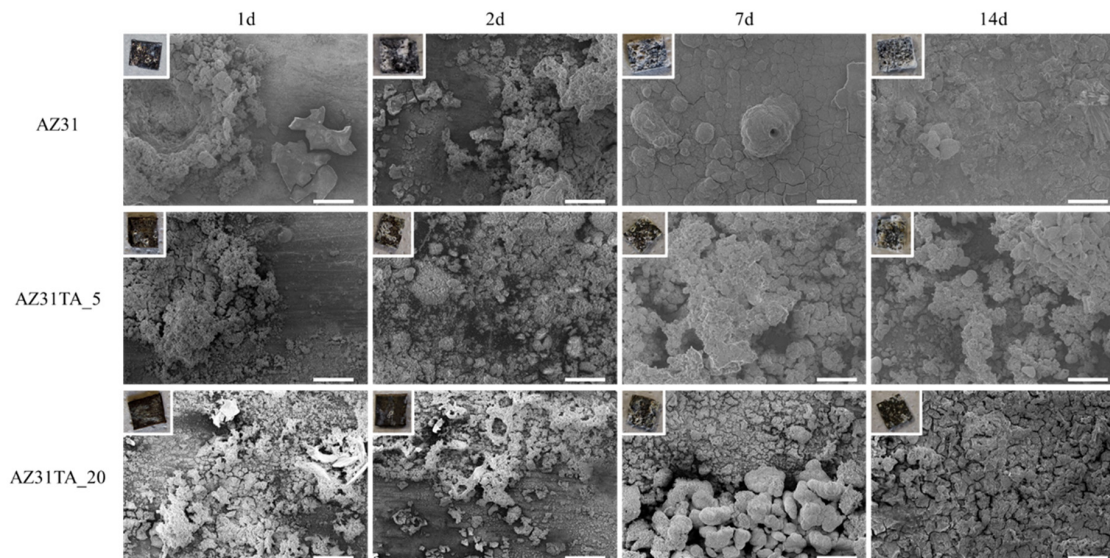
Figure 3. SEM images of AZ31, AZ31TA_5, and AZ31TA_20 samples after degradation in PBS at different time points, namely 1, 2, 7, and 14 days. Markers are 200 μm each. Optical pictures of the samples are shown in the insets of the images.

As possible to see by SEM micrographs (Figure 3), degradation products are promptly formed on the surface of both uncoated and coated AZ31 samples, as early as after 1 day of soaking in PBS. EDS chemical analysis (Table S2 in Supplementary Material) showed that the corroded layer is mainly formed by magnesium oxides and phosphate species [30]. The degradation products grew constantly with increased soaking time, covering all the surfaces with white oxide flakes, and were observed at a macroscopic scale (Figure 3 insets).

From the optical and SEM observation of the samples, it seems that a thicker and more compact oxide layer is formed on the surface of the bare AZ31 alloy, compared to the coated surfaces, and that the coating on AZ31TA_20 is more effective than the one on AZ31TA_5 to slow the corrosion of magnesium.

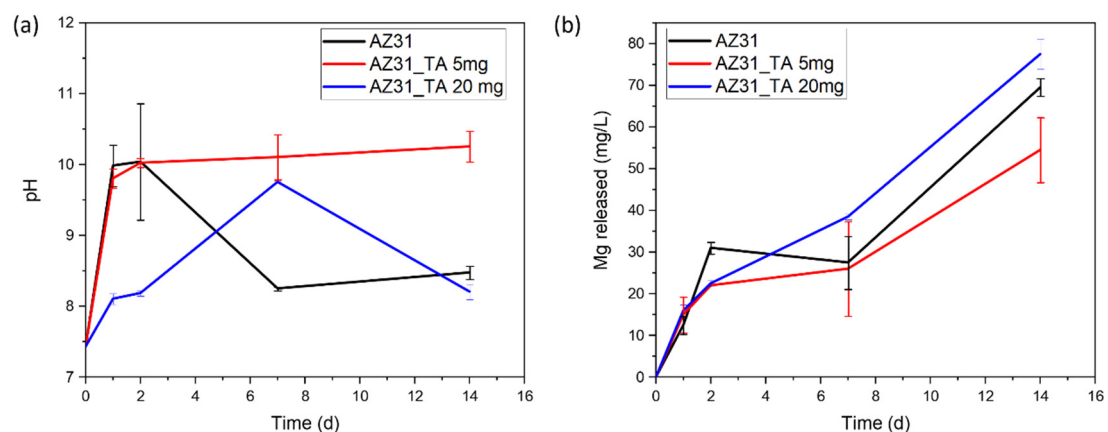
Figure 4. Degradation test in PBS, (a) pH trend versus soaking time, (b) Mg release vs. soaking time.

Figure 4 reports pH and magnesium ions release in PBS during sample soaking for up to 14 days. A rapid pH increase, up to 10, can be observed after 1 d for both AZ31 and AZ31TA_5, while AZ31TA_20 can maintain solution pH close to 8 up to 2 d. A pH decrease of around 8 after 7 or 14 days can be recorded for AZ31 and AZ31TA_20, respectively, while AZ31TA_5 induces persistent basification up to 14 d. The differences, mainly visible at 7 days of soaking, can be correlated with the dissolution and deposition of degradation products. No significant differences can be denoted among samples considering Mg release.

Looking at these results, AZ31TA_20 seems more promising than AZ31TA_5. Degradation behavior is in accordance with SEM observations; in fact, AZ31_TA 20 mg presents smaller scales and cracks, suggesting better coverage and protection. However, it seems that the ability of the tannic acid coating to protect Mg substrates from degradation in PBS is higher on AZ91 substrates [20] than on AZ31. This behavior can be attributed both to a lower reactivity of AZ91 substrates, as reported in [19], and to a better coverage (fewer cracks) of the obtained TA coating.

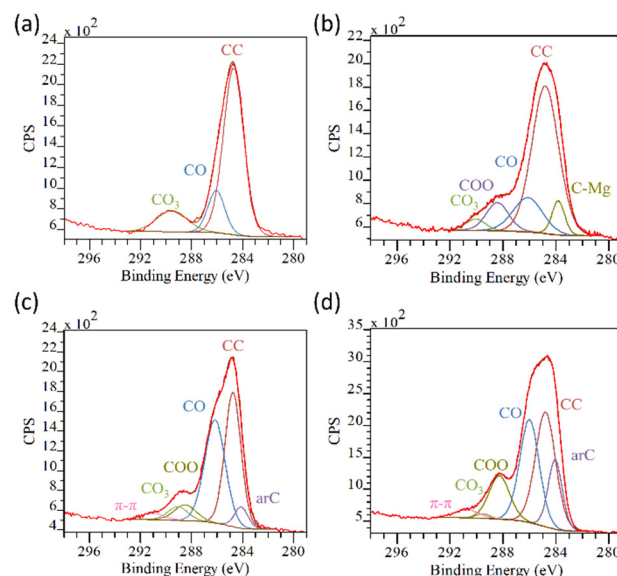
Figure 6. C1s peak deconvolution of: (a) AZ31; (b) AZ91; (c) AZ31TA_20; and (d) AZ91TA. In each image: red line: experimental spectrum; brown line: fitted spectrum; light brown line: baseline.

Further information on the surface chemistry can be drawn by analyzing the high-resolution peaks. Before coating, the C1s of both AZ31 and AZ91 (Figure 6a,b) are composed of signals arising mainly from carbonates (CO_3 , BE \approx 289–290 eV) and carbonaceous contaminations (CO, BE \approx 286 eV; COO, BE \approx 288 eV) [24]. A contribution by C-Mg bonds (BE \approx 284 eV) [35] is observed in the AZ91 pristine sample, probably due to some reaction occurring when the molten metal is cast into a ceramic mold with residues after burning a 3D polymeric pattern. The deposition of a TA-containing coating, following the surface modification, can be observed by the increase in the CO and COO components of the C1s peak (Figure 6c,d; Table S3 in Supplementary Material) and the appearance of the peaks related to aromatic C (arC, BE \approx 284 eV) [36] and the delocalized electron of the π - π aromatic bonds (BE \approx 291 eV) [37]. These chemical groups and bonds are very typical of the TA, as possible to see by its chemical formula (Figure S2 in Supplementary Material). The lower intensity of the TA peaks on coated AZ31 with respect to the coated AZ91 can be related to the presence of larger cracks in the coatings on the former surface, which therefore exposes uncoated parts, in agreement with the compositional results (Table 2).
