# Characterization of Tannic Acid-Coated AZ31 Mg Alloy for Biomedical Application and Comparison with AZ91

**Abstract:** Magnesium alloys are promising materials for bioresorbable implants that will improve patient life and reduce healthcare costs. However, their clinical use is prevented by the rapid degradation and corrosion of magnesium, which leads to a fast loss of mechanical strength and the formation of by-products that can trigger tissue inflammation. Here, a tannic acid coating is proposed to control the degradation of AZ31 and AZ91 alloys, starting from a previous study by the authors on AZ91. The coatings on the two materials were characterized both by the chemical (EDS, FTIR, XPS) and the morphological (SEM, confocal profilometry) point of view. Static degradation tests in PBS and electrochemical measurements in different solutions showed that the protective performances of the tannic acid coatings are strongly affected by the presence of cracks. The presence of fractures in the protective layer generates galvanic couples between the coating scales and the metal, worsening the corrosion resistance. Although degradation control was not achieved, useful insights on the d

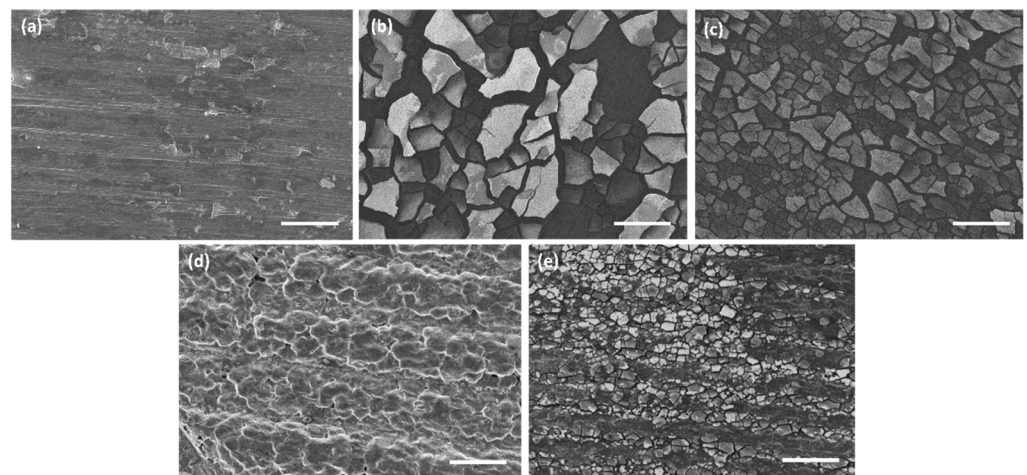
**Figure 1.** SEM images (100 $\times$ ) of (a) AZ91 uncoated, (b) AZ91TA\_5, (c) AZ31 uncoated, (d) AZ31TA\_5, (e) AZ31TA\_20. Markers are 200  $\mu$ m each.

The AZ91 bare sample (Figure 1a) presents a rough surface that resembles the layered topology of the 3D-printed polymer pattern replicated by investment casting (Figure S1 in Supplementary Material). After tannic acid coating (Figure 1b) the main topography is maintained but plenty of micro-scales completely cover the surface, confirming surface reaction and coating, as reported in [20].

The surface of the bare AZ31 sample (Figure 1c) appears as a typical rolled metal with some scratches and scales, attributable to surface deformation and oxidation during working. After tannic acid coating in a 5 mg/mL solution for 3 h (Figure 1d), analogously to AZ91 substrates, a lot of big (hundreds of microns) scales cover the surface. When coating is performed in a 20 mg/mL TA solution for 30 min (Figure 1e), scales have smaller dimensions (not so far from the ones obtained on AZ91 samples) and cover the surface in a more homogeneous way (less detachment). The presence of the phenolic coating is also confirmed by EDS analyses (Table S1 in Supplementary Material), where an increase in the C content was detected after the treatments on both AZ31TA\_5 and AZ3TA\_20. No differences in the two coatings were observed in terms of the chemical composition.

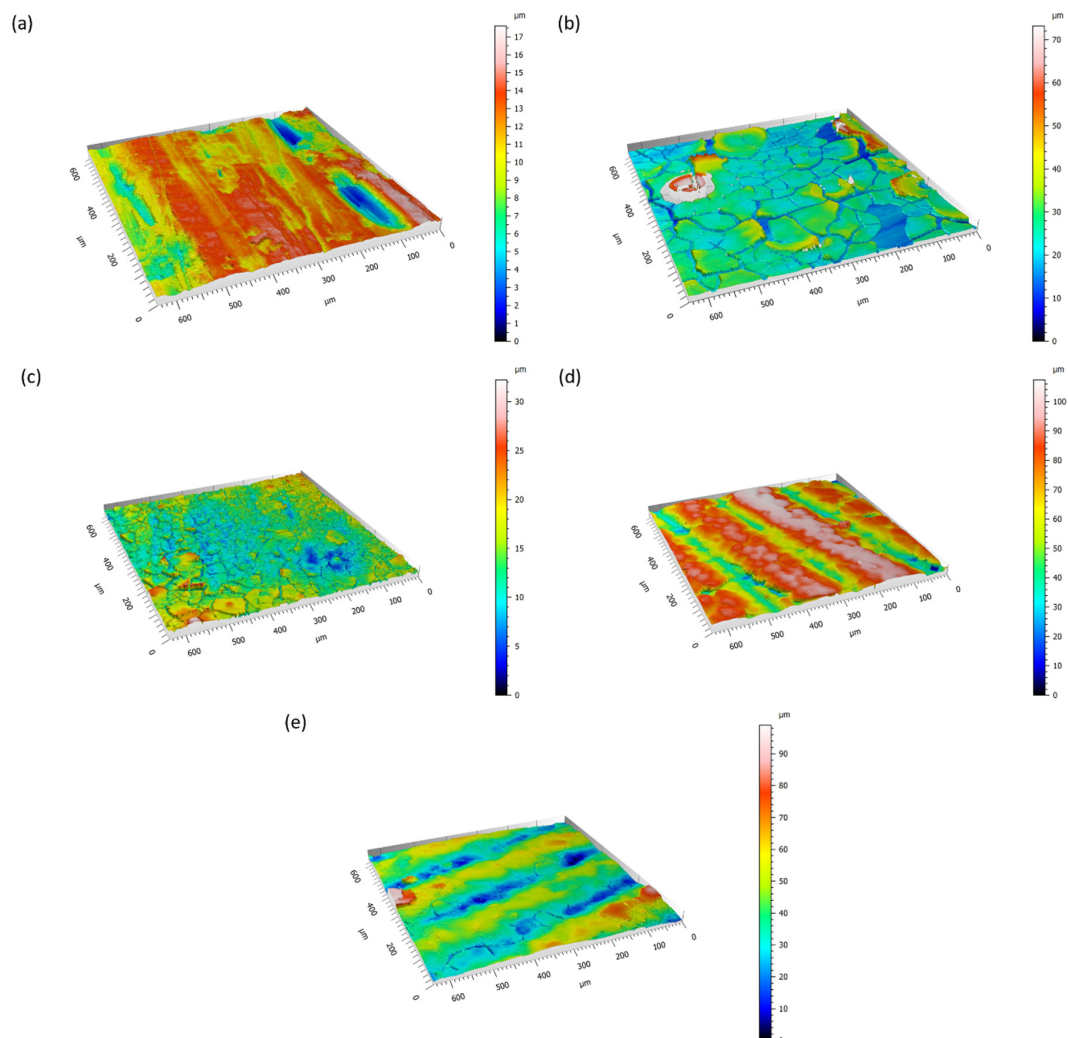
**Figure 2.** Three-dimensional reconstruction of (a) AZ31, (b) AZ31TA\_5, (c) AZ31TA\_20, (d) AZ91, (e) AZ91TA obtained by optical profilometry.

The formation of scales of different dimensions on AZ31 samples and the flattening effect of the TA coating of AZ91 are well visible in the 3D reconstruction of the surfaces obtained by optical profilometry (Figure 2).

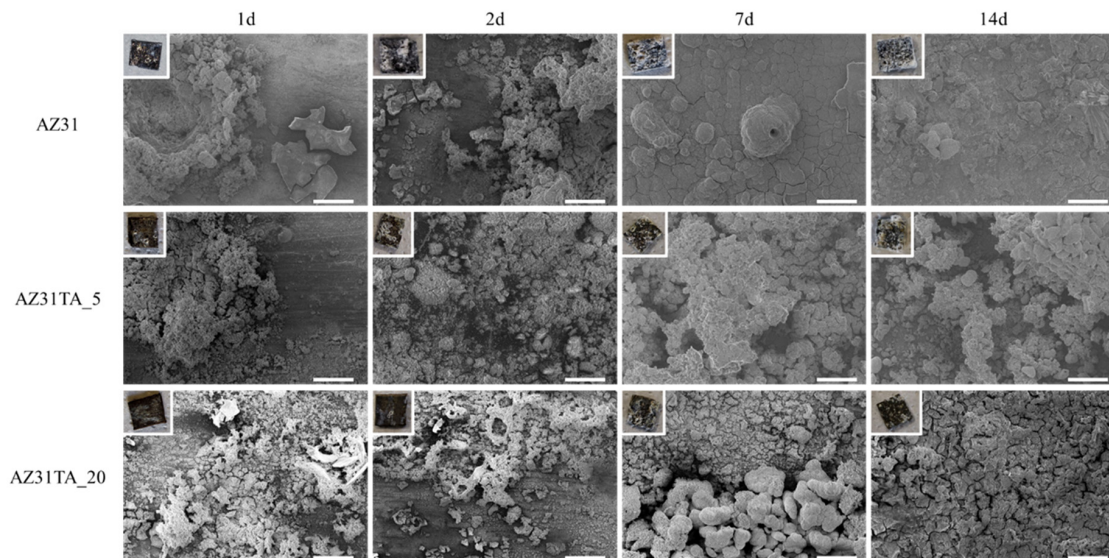
**Figure 3.** SEM images of AZ31, AZ31TA\_5, and AZ31TA\_20 samples after degradation in PBS at different time points, namely 1, 2, 7, and 14 days. Markers are 200  $\mu\text{m}$  each. Optical pictures of the samples are shown in the insets of the images.

As possible to see by SEM micrographs (Figure 3), degradation products are promptly formed on the surface of both uncoated and coated AZ31 samples, as early as after 1 day of soaking in PBS. EDS chemical analysis (Table S2 in Supplementary Material) showed that the corroded layer is mainly formed by magnesium oxides and phosphate species [30]. The degradation products grew constantly with increased soaking time, covering all the surfaces with white oxide flakes, and were observed at a macroscopic scale (Figure 3 insets).

From the optical and SEM observation of the samples, it seems that a thicker and more compact oxide layer is formed on the surface of the bare AZ31 alloy, compared to the coated surfaces, and that the coating on AZ31TA\_20 is more effective than the one on AZ31TA\_5 to slow the corrosion of magnesium.

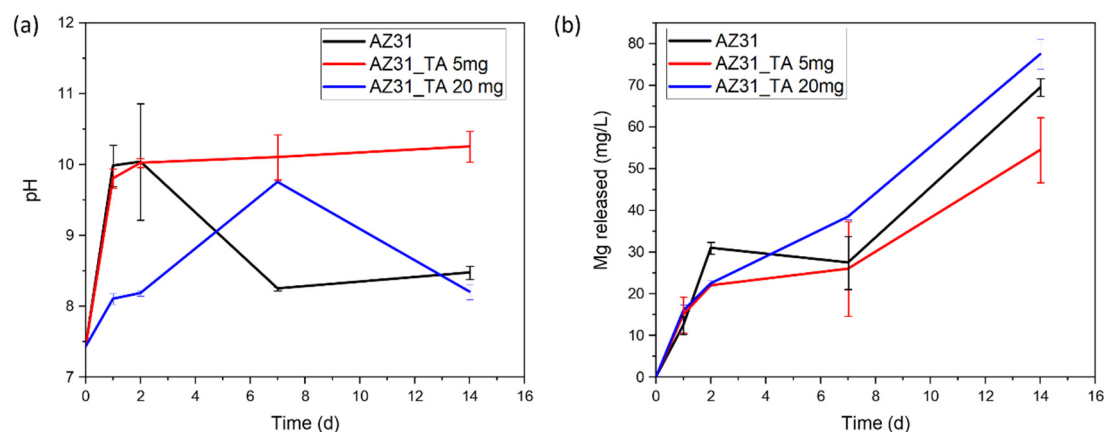
**Figure 4.** Degradation test in PBS, (a) pH trend versus soaking time, (b) Mg release vs. soaking time.

Figure 4 reports pH and magnesium ions release in PBS during sample soaking for up to 14 days. A rapid pH increase, up to 10, can be observed after 1 d for both AZ31 and AZ31TA\_5, while AZ31TA\_20 can maintain solution pH close to 8 up to 2 d. A pH decrease of around 8 after 7 or 14 days can be recorded for AZ31 and AZ31TA\_20, respectively, while AZ31TA\_5 induces persistent basification up to 14 d. The differences, mainly visible at 7 days of soaking, can be correlated with the dissolution and deposition of degradation products. No significant differences can be denoted among samples considering Mg release.

Looking at these results, AZ31TA\_20 seems more promising than AZ31TA\_5. Degradation behavior is in accordance with SEM observations; in fact, AZ31\_TA 20 mg presents smaller scales and cracks, suggesting better coverage and protection. However, it seems that the ability of the tannic acid coating to protect Mg substrates from degradation in PBS is higher on AZ91 substrates [20] than on AZ31. This behavior can be attributed both to a lower reactivity of AZ91 substrates, as reported in [19], and to a better coverage (fewer cracks) of the obtained TA coating.

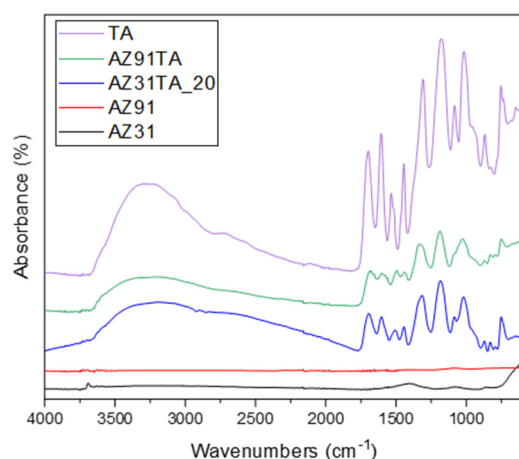
**Figure 5.** FTIR spectra of bare AZ31 and AZ91, of Mg samples after coating with tannic acid (AZ31\_TA 20 mg/mL and AZ91\_TA), and of tannic acid (TA).

The FTIR spectra are reported in Figure 5. As expected, the untreated metal surfaces have almost no absorption in the IR region, but a weak band around  $1400\text{ cm}^{-1}$  was detected on AZ31, which can be related to some carbonates on the surface of the alloy [31]. After the coating formation, the typical fingerprint of tannic acid can be observed in the spectra, with the bands rising from the vibrational mode of phenolic OH (the halo at  $3300\text{ cm}^{-1}$ ), C=O (at  $1700\text{ cm}^{-1}$ ), aromatic rings ( $1700\text{--}1400\text{ cm}^{-1}$ ), COOH ( $1400\text{--}1200\text{ cm}^{-1}$ ), and C-O ( $1200\text{--}1000\text{ cm}^{-1}$ ) [32–34]. The higher intensity of the organic peaks on the AZ31TA\_20 with respect to the AZ91TA is related to more intimate contact between the sample and the ATR crystal, due to the lower roughness of the AZ31 samples, which results in better signal detection. FTIR spectra are a further confirmation of the successful integration of tannic acid within the coating on the different alloys.

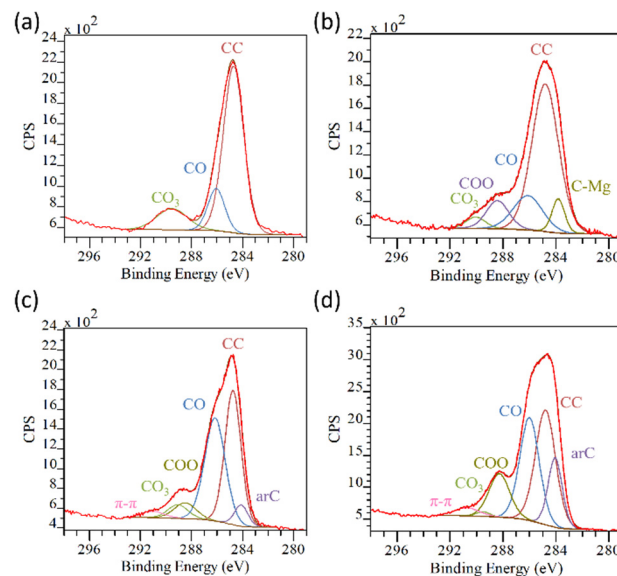
**Figure 6.** C1s peak deconvolution of: (a) AZ31; (b) AZ91; (c) AZ31TA\_20; and (d) AZ91TA. In each image: red line: experimental spectrum; brown line: fitted spectrum; light brown line: baseline.

Further information on the surface chemistry can be drawn by analyzing the high-resolution peaks. Before coating, the C1s of both AZ31 and AZ91 (Figure 6a,b) are composed of signals arising mainly from carbonates ( $\text{CO}_3$ , BE  $\approx$  289–290 eV) and carbonaceous contaminations (CO, BE  $\approx$  286 eV; COO, BE  $\approx$  288 eV) [24]. A contribution by C-Mg bonds (BE  $\approx$  284 eV) [35] is observed in the AZ91 pristine sample, probably due to some reaction occurring when the molten metal is cast into a ceramic mold with residues after burning a 3D polymeric pattern. The deposition of a TA-containing coating, following the surface modification, can be observed by the increase in the CO and COO components of the C1s peak (Figure 6c,d; Table S3 in Supplementary Material) and the appearance of the peaks related to aromatic C (arC, BE  $\approx$  284 eV) [36] and the delocalized electron of the  $\pi$ - $\pi$  aromatic bonds (BE  $\approx$  291 eV) [37]. These chemical groups and bonds are very typical of the TA, as possible to see by its chemical formula (Figure S2 in Supplementary Material). The lower intensity of the TA peaks on coated AZ31 with respect to the coated AZ91 can be related to the presence of larger cracks in the coatings on the former surface, which therefore exposes uncoated parts, in agreement with the compositional results (Table 2).

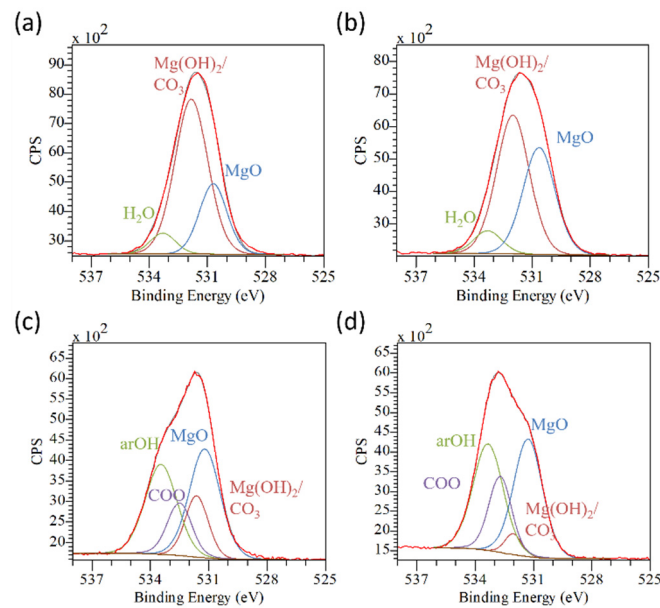
**Figure 7.** O1s peak deconvolution of: (a) AZ31; (b) AZ91; (c) AZ31TA\_20; and (d) AZ91TA. In each image: red line: experimental spectrum; brown line: fitted spectrum; light brown line: baseline.

Similar results were found observing the O1s peaks. The pristine alloys (Figure 7a,b) show the expected components of the magnesium native oxide layer, a mixture of oxide  $\text{MgO}$  (BE  $\approx$  530.5 eV) and hydroxide  $\text{Mg}(\text{OH})_2$  (BE  $\approx$  531.6) [13,24,38]. Adsorbed water was also found (BE  $\approx$  533.5) [24]. On the other hand, the coated surfaces have very strong contributions by the aromatic hydroxyl groups (BE  $\approx$  533.5) and a smaller one by COO groups (BE  $\approx$  531.5) [36] of the tannic acid. Again, the higher contribution of the organic molecules in the coating was observed for the AZ91TA surface, sustaining the hypothesis of a more continuous layer. The fact that the amount of magnesium hydroxide is much higher than the one of magnesium oxide in the coating (Table S4 in Supplementary Material)

suggests that a reaction occurs during the soaking in the TA solution, with the formation of mainly MgO instead of Mg(OH)<sub>2</sub> and the formation of a mixed layer TA-Mg oxide.

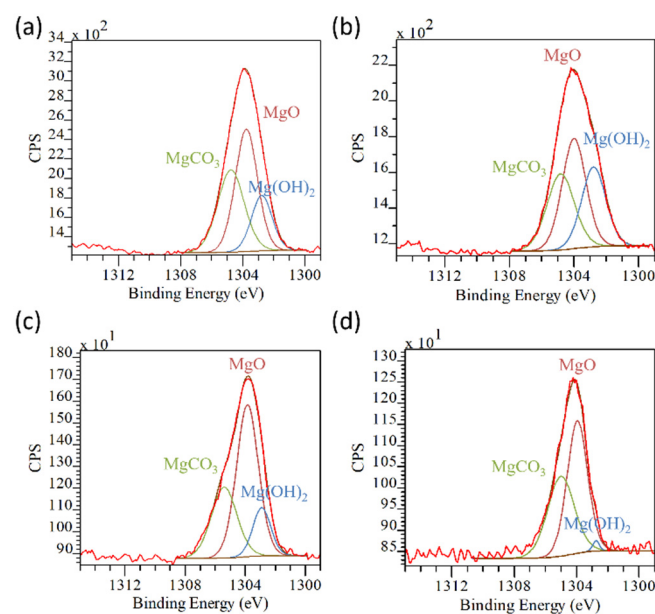
**Figure 8.** Mg1s peak deconvolution of: (a) AZ31; (b) AZ91; (c) AZ31TA\_20; and (d) AZ91TA. In each image: red line: experimental spectrum; brown line: fitted spectrum; light brown line: baseline.

The hypothesis on the evolution of the oxide layer based on the oxygen spectra is confirmed by the deconvolution of the Mg1s peaks. Concerning the untreated alloys, the surface is composed of a mixture of mainly magnesium oxide (BE  $\approx$  1303.7), along with hydroxide (BE  $\approx$  1302.5) and carbonates (BE  $\approx$  1304.6) (Figure 8a,b; Table S5 in Supplementary Material) [15,18]. When the coating is formed on the alloys, a reduction of the components related to the magnesium hydroxide and carbonates was observed, while the MgO increased on both treated AZ31 and AZ91 (Figure 8c,d; Table S5 in Supplementary Material). These results strengthened the suggestion of the formation of MgO instead of Mg(OH)<sub>2</sub> during the reaction with the TA solution.

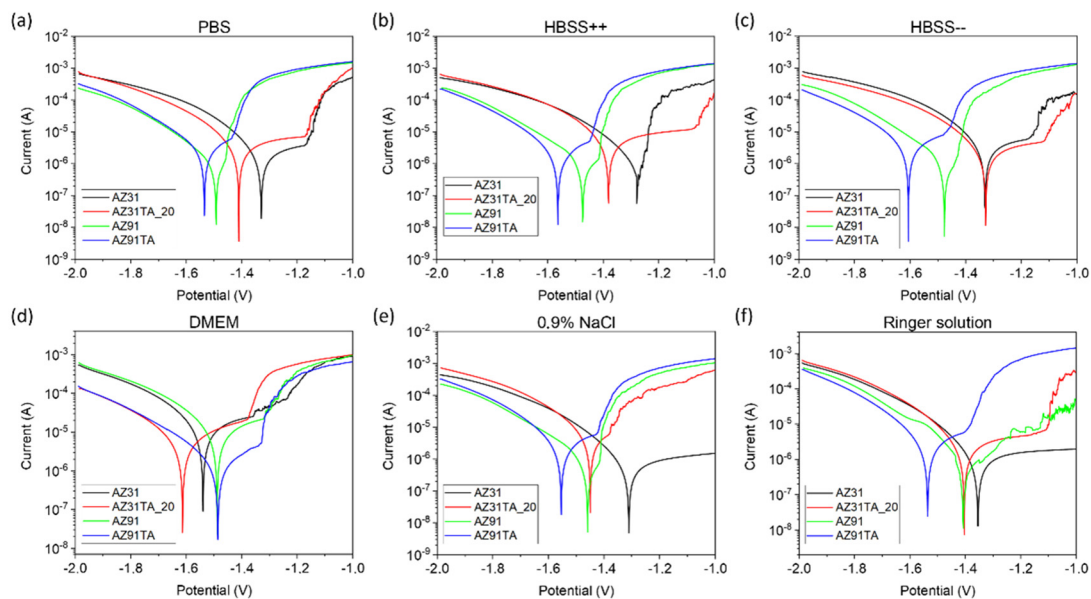
**Figure 9.** Tafel plots of all samples in the different test fluids: (a) PBS; (b) HBSS, (c) HBSS w/o Ca Mg; (d) DMEM; (e) 0.9% NaCl; and (f) Ringer solutions.

Figure 9 shows the Tafel plots obtained by potentiodynamic polarization measurements. The shifting of corrosion current potential was observed to a more negative side after coating for both AZ31 and AZ91 in the PBS, HBSS, 0.9% NaCl, and Ringer solutions. This indicates the weakening of the barrier for corrosion [25,39]. However, no such shift was observed for AZ91TA in DMEM. Similarly, AZ31TA\_20 also showed no shifting in corrosion potential ( $E_{corr}$ ) in HBSS (without  $Ca^{2+}$  and  $Mg^{2+}$  ions). This randomness in the shifting of the  $E_{corr}$  might be because of the random scales and cracks present on the coated samples and the site of the sample surface exposed to the fluid and it is difficult to predict the real mechanism behind it. Coatings with fewer or no cracks can reduce this uncertainty.
