Characterization of Tannic Acid-Coated AZ31 Mg Alloy for Biomedical Application and Comparison with AZ91

Abstract: Magnesium alloys are promising materials for bioresorbable implants that will improve patient life and reduce healthcare costs. However, their clinical use is prevented by the rapid degradation and corrosion of magnesium, which leads to a fast loss of mechanical strength and the formation of by-products that can trigger tissue inflammation. Here, a tannic acid coating is proposed to control the degradation of AZ31 and AZ91 alloys, starting from a previous study by the authors on AZ91. The coatings on the two materials were characterized both by the chemical (EDS, FTIR, XPS) and the morphological (SEM, confocal profilometry) point of view. Static degradation tests in PBS and electrochemical measurements in different solutions showed that the protective performances of the tannic acid coatings are strongly affected by the presence of cracks. The presence of fractures in the protective layer generates galvanic couples between the coating scales and the metal, worsening the corrosion resistance. Although degradation control was not achieved, useful insights on the degrada

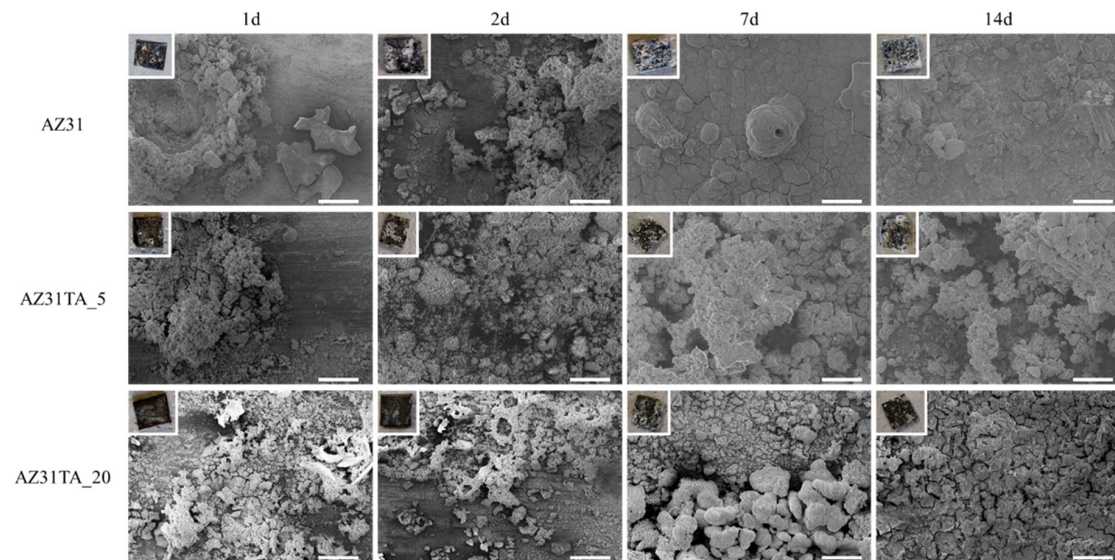
Figure 3. SEM images of AZ31, AZ31TA_5, and AZ31TA_20 samples after degradation in PBS at different time points, namely 1, 2, 7, and 14 days. Markers are 200 μm each. Optical pictures of the samples are shown in the insets of the images.

As possible to see by SEM micrographs (Figure 3), degradation products are promptly formed on the surface of both uncoated and coated AZ31 samples, as early as after 1 day of soaking in PBS. EDS chemical analysis (Table S2 in Supplementary Material) showed that the corroded layer is mainly formed by magnesium oxides and phosphate species [30]. The degradation products grew constantly with increased soaking time, covering all the surfaces with white oxide flakes, and were observed at a macroscopic scale (Figure 3 insets).

From the optical and SEM observation of the samples, it seems that a thicker and more compact oxide layer is formed on the surface of the bare AZ31 alloy, compared to the coated surfaces, and that the coating on AZ31TA_20 is more effective than the one on AZ31TA_5 to slow the corrosion of magnesium.
