Characterization of Tannic Acid-Coated AZ31 Mg Alloy for Biomedical Application and Comparison with AZ91

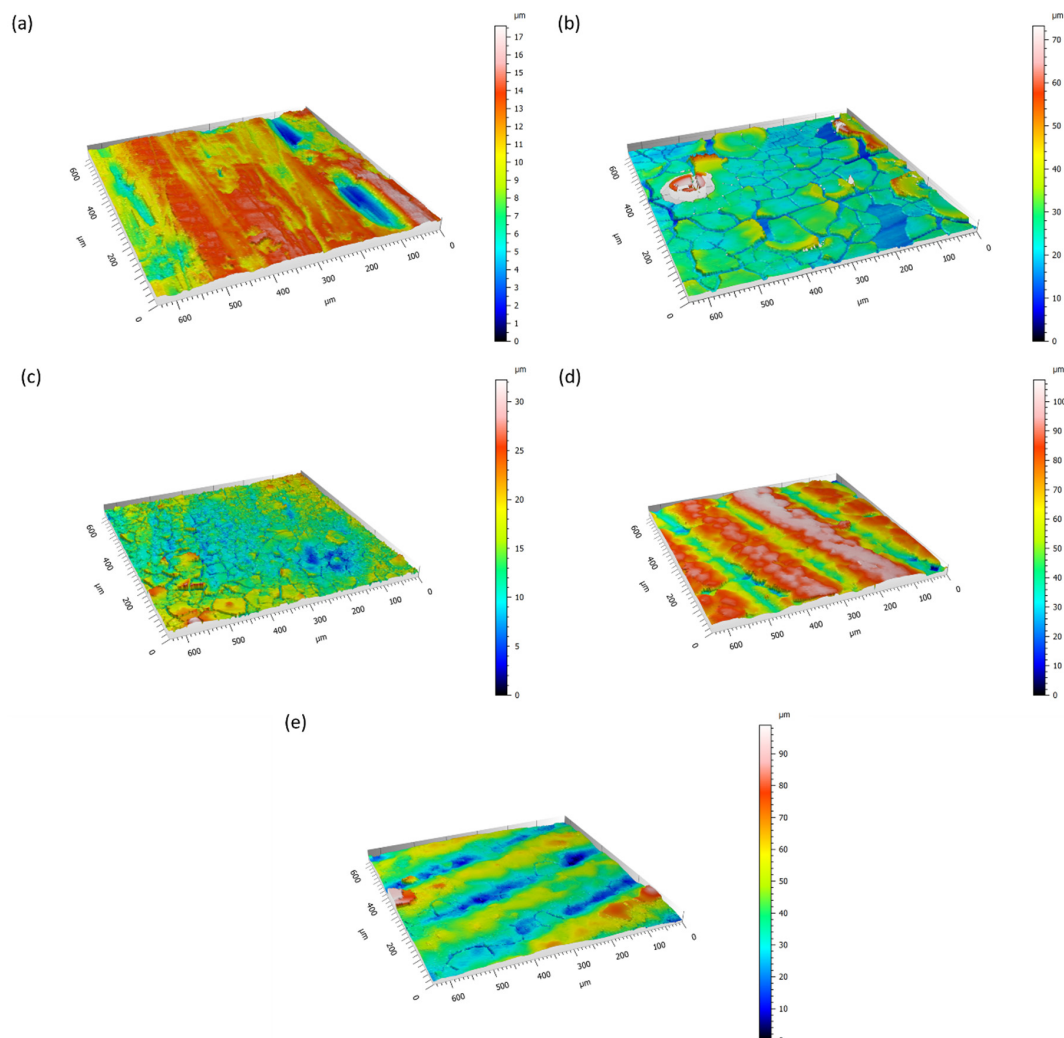
Figure 2. Three-dimensional reconstruction of (a) AZ31, (b) AZ31TA_5, (c) AZ31TA_20, (d) AZ91, (e) AZ91TA obtained by optical profilometry.

The formation of scales of different dimensions on AZ31 samples and the flattening effect of the TA coating of AZ91 are well visible in the 3D reconstruction of the surfaces obtained by optical profilometry (Figure 2).

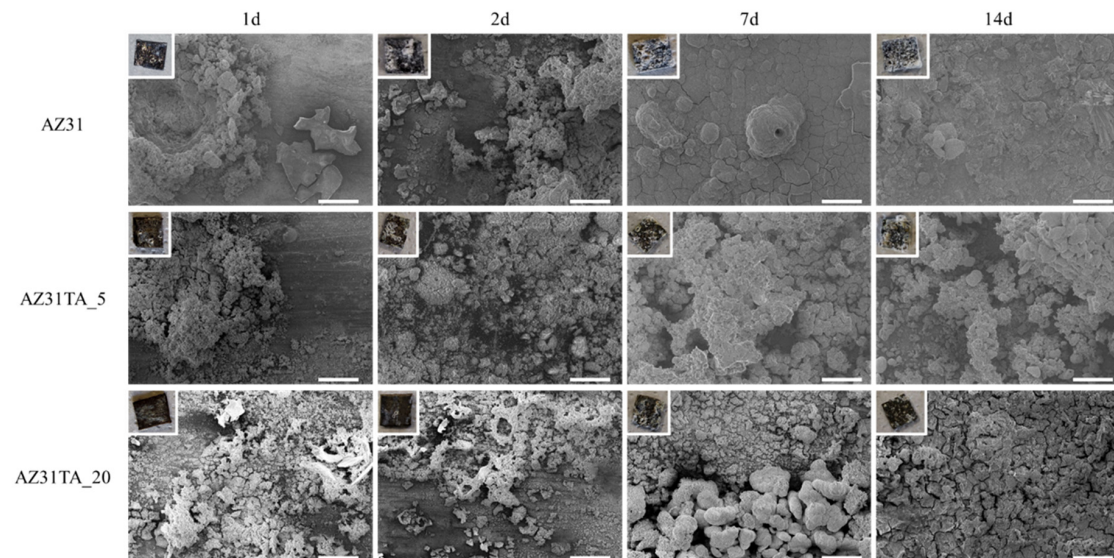
Figure 3. SEM images of AZ31, AZ31TA_5, and AZ31TA_20 samples after degradation in PBS at different time points, namely 1, 2, 7, and 14 days. Markers are 200 μm each. Optical pictures of the samples are shown in the insets of the images.

As possible to see by SEM micrographs (Figure 3), degradation products are promptly formed on the surface of both uncoated and coated AZ31 samples, as early as after 1 day of soaking in PBS. EDS chemical analysis (Table S2 in Supplementary Material) showed that the corroded layer is mainly formed by magnesium oxides and phosphate species [30]. The degradation products grew constantly with increased soaking time, covering all the surfaces with white oxide flakes, and were observed at a macroscopic scale (Figure 3 insets).

From the optical and SEM observation of the samples, it seems that a thicker and more compact oxide layer is formed on the surface of the bare AZ31 alloy, compared to the coated surfaces, and that the coating on AZ31TA_20 is more effective than the one on AZ31TA_5 to slower the corrosion of magnesium.

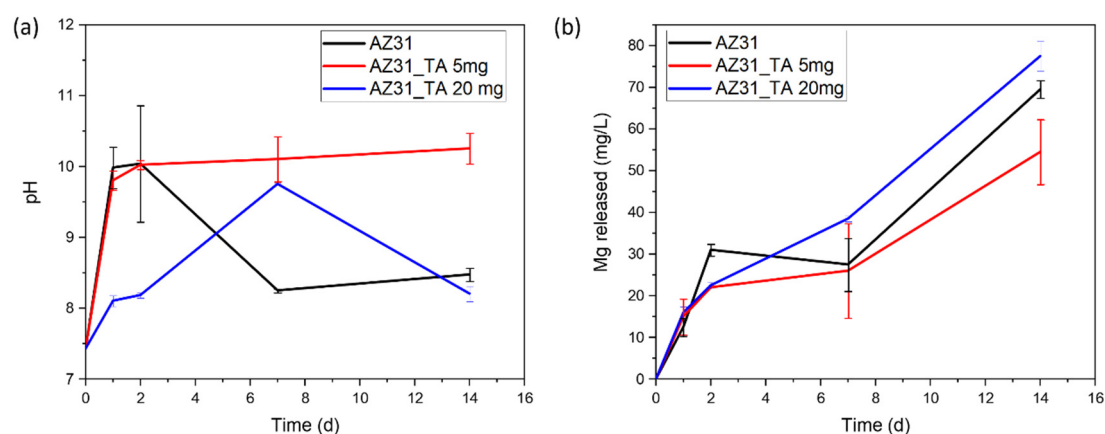
Figure 4. Degradation test in PBS, (a) pH trend versus soaking time, (b) Mg release vs. soaking time.

Figure 4 reports pH and magnesium ions release in PBS during sample soaking for up to 14 days. A rapid pH increase, up to 10, can be observed after 1 d for both AZ31 and AZ31TA_5, while AZ31TA_20 can maintain solution pH close to 8 up to 2 d. A pH decrease of around 8 after 7 or 14 days can be recorded for AZ31 and AZ31TA_20, respectively, while AZ31TA_5 induces persistent basification up to 14 d. The differences, mainly visible at 7 days of soaking, can be correlated with the dissolution and deposition of degradation products. No significant differences can be denoted among samples considering Mg release.

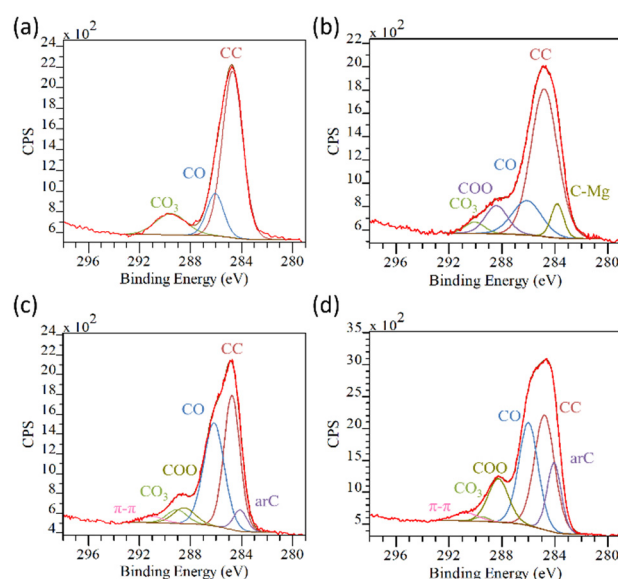
Figure 6. C1s peak deconvolution of: (a) AZ31; (b) AZ91; (c) AZ31TA_20; and (d) AZ91TA. In each image: red line: experimental spectrum; brown line: fitted spectrum; light brown line: baseline.

Further information on the surface chemistry can be drawn by analyzing the high-resolution peaks. Before coating, the C1s of both AZ31 and AZ91 (Figure 6a,b) are composed of signals arising mainly from carbonates (CO_3 , BE \approx 289–290 eV) and carbonaceous contaminations (CO, BE \approx 286 eV; COO, BE \approx 288 eV) [24]. A contribution by C-Mg bonds (BE \approx 284 eV) [35] is observed in the AZ91 pristine sample, probably due to some reaction occurring when the molten metal is cast into a ceramic mold with residues after burning a 3D polymeric pattern. The deposition of a TA-containing coating, following the surface modification, can be observed by the increase in the CO and COO components of the C1s peak (Figure 6c,d; Table S3 in Supplementary Material) and the appearance of the peaks related to aromatic C (arC, BE \approx 284 eV) [36] and the delocalized electron of the π - π aromatic bonds (BE \approx 291 eV) [37]. These chemical groups and bonds are very typical of the TA, as possible to see by its chemical formula (Figure S2 in Supplementary Material). The lower intensity of the TA peaks on coated AZ31 with respect to the coated AZ91 can be related to the presence of larger cracks in the coatings on the former surface, which therefore exposes uncoated parts, in agreement with the compositional results (Table 2).

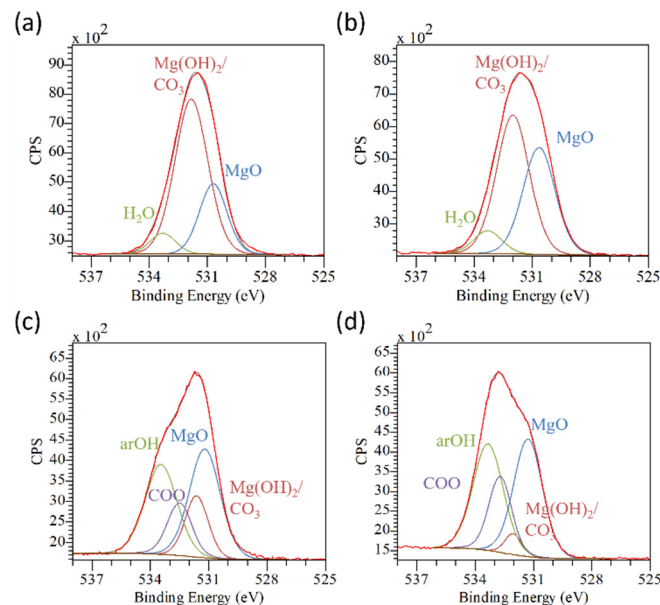
Figure 7. O1s peak deconvolution of: (a) AZ31; (b) AZ91; (c) AZ31TA_20; and (d) AZ91TA. In each image: red line: experimental spectrum; brown line: fitted spectrum; light brown line: baseline.

Similar results were found observing the O1s peaks. The pristine alloys (Figure 7a,b) show the expected components of the magnesium native oxide layer, a mixture of oxide MgO (BE \approx 530.5 eV) and hydroxide $\text{Mg}(\text{OH})_2$ (BE \approx 531.6) [13,24,38]. Adsorbed water was also found (BE \approx 533.5) [24]. On the other hand, the coated surfaces have very strong contributions by the aromatic hydroxyl groups (BE \approx 533.5) and a smaller one by COO groups (BE \approx 531.5) [36] of the tannic acid. Again, the higher contribution of the organic molecules in the coating was observed for the AZ91TA surface, sustaining the hypothesis of a more continuous layer. The fact that the amount of magnesium hydroxide is much higher than the one of magnesium oxide in the coating (Table S4 in Supplementary Material)

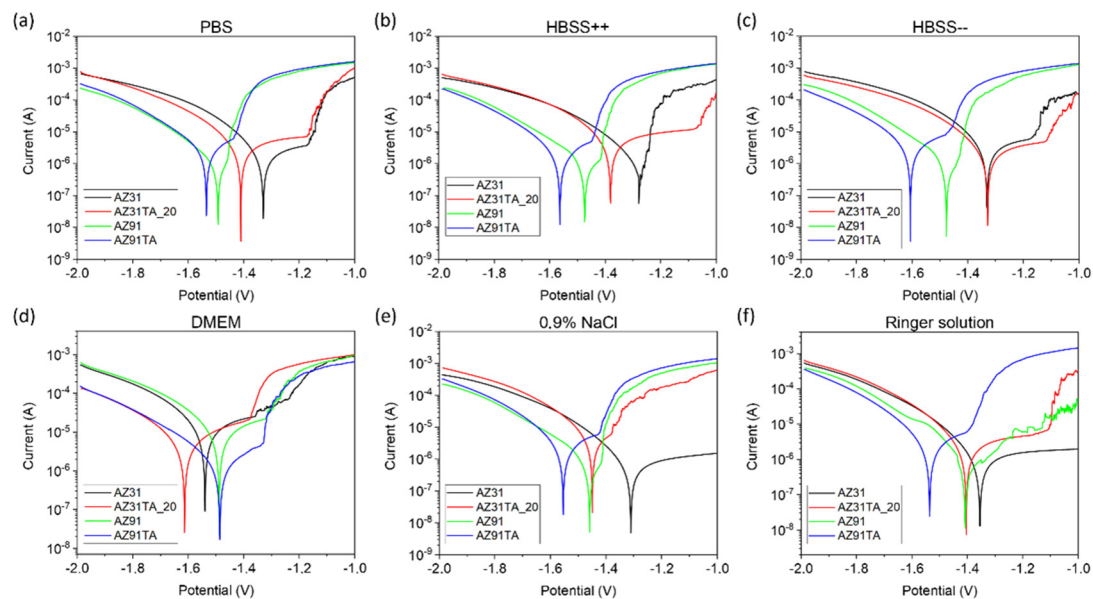
Figure 9. Tafel plots of all samples in the different test fluids: (a) PBS; (b) HBSS, (c) HBSS w/o Ca Mg; (d) DMEM; (e) 0.9% NaCl; and (f) Ringer solutions.

Figure 9 shows the Tafel plots obtained by potentiodynamic polarization measurements. The shifting of corrosion current potential was observed to a more negative side after coating for both AZ31 and AZ91 in the PBS, HBSS, 0.9% NaCl, and Ringer solutions. This indicates the weakening of the barrier for corrosion [25,39]. However, no such shift was observed for AZ91TA in DMEM. Similarly, AZ31TA_20 also showed no shifting in corrosion potential (E_{corr}) in HBSS (without Ca^{2+} and Mg^{2+} ions). This randomness in the shifting of the E_{corr} might be because of the random scales and cracks present on the coated samples and the site of the sample surface exposed to the fluid and it is difficult to predict the real mechanism behind it. Coatings with fewer or no cracks can reduce this uncertainty.
