Multidisciplinary analyses on the 11th-12th century bronze doors of San Marco, Venice

Multidisciplinary analyses on the 11th-12th century bronze doors of San Marco, Venice / Modlinger, M.; Bernabei, M.; Bontadi, J.; Fellin, M.; Fera, M.; Ghiara, G.; Negri, M.; Utz, J.. - In: PLOS ONE. - ISSN 1932-6203. - 18:7(2023).
[10.1371/journal.pone.0288094]

Two 11th- and 12th-century entrance doors from the Basilica di San Marco in Venice, made of different copper alloys and woods, were non-invasively examined in situ. The chemical composition of the metals, the way in which different metal parts were joined together, the tree species used to construct the supporting structures and the age of the wood are determined. A portable ED-XRF instrument and optical microscopes were used. The doors were also photographed to produce high-resolution orthophotos and 3D models. The metal parts of the doors were made of leaded tin-bronze and quaternary Cu-Sn-Zn-Pb alloys and were mounted on a wooden multi-layer structure of larch and silver fir; the dendrochronological dates of some of the larch boards are 1965, *terminus post quem*.

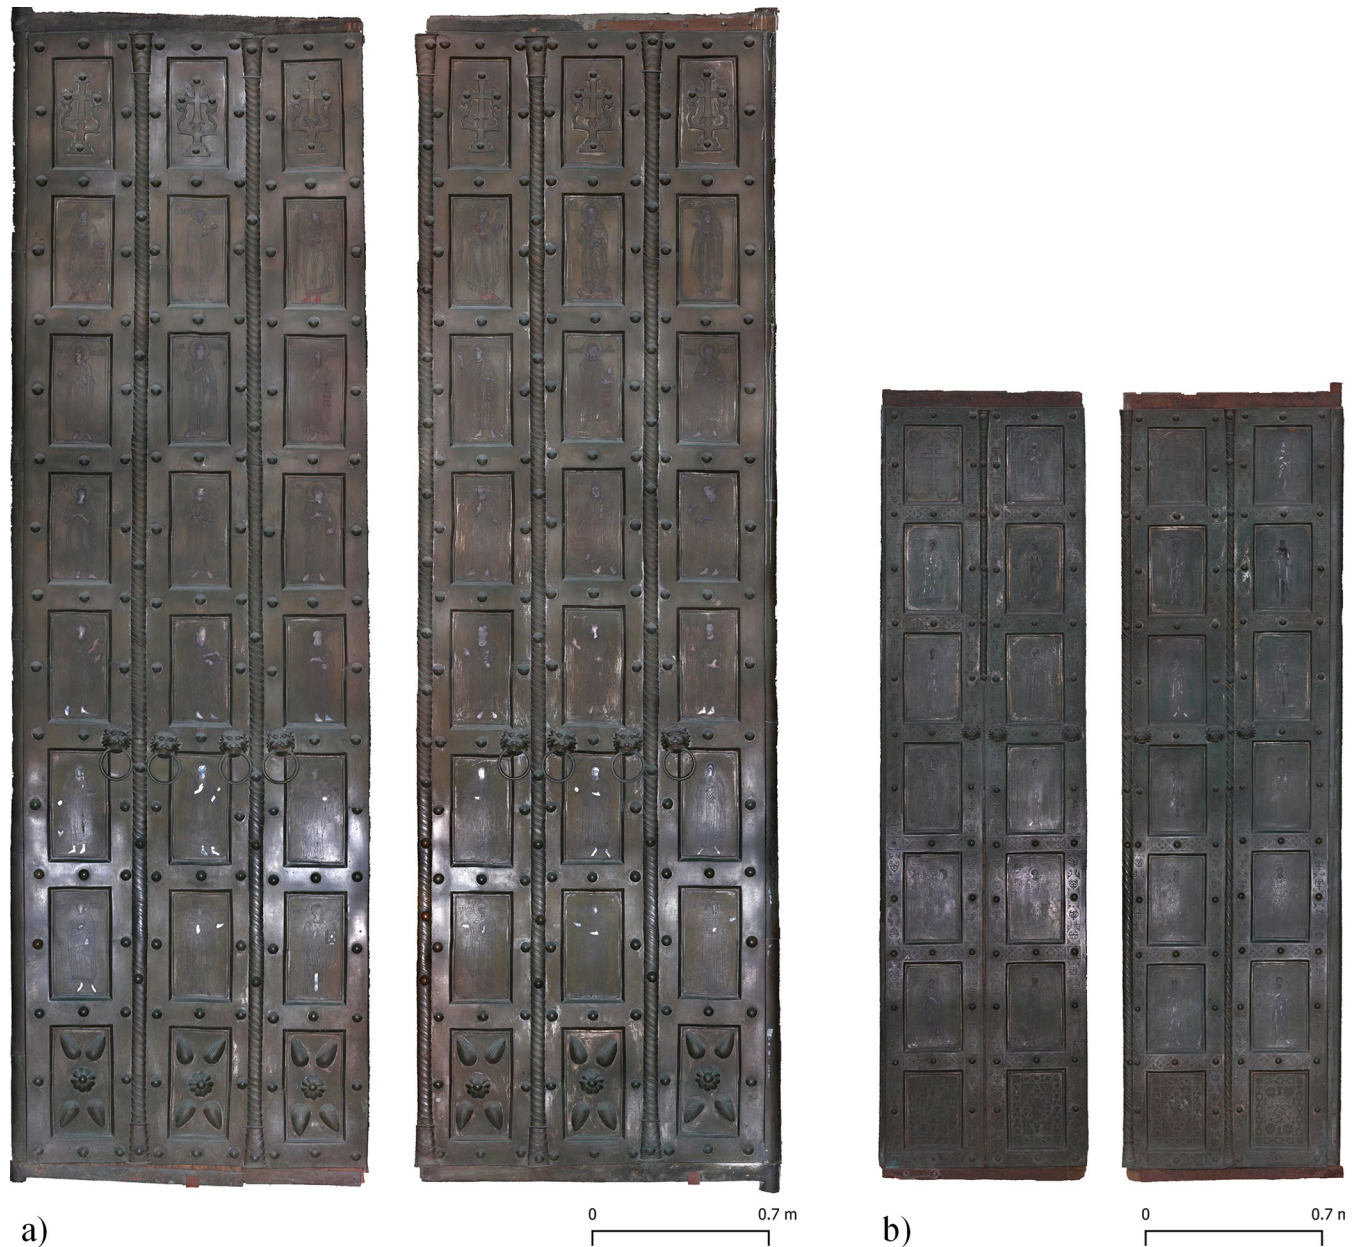
Fig 1. Basilica di San Marco, Venice, Italy. Orthophotos of the two 11th–12th century bronze doors studied. Left: main door; right: door San Clemente. The shiny areas in the lower part of the doors are those where people touch the doors most.

Like other bronze doors, the two doors from the Basilica di San Marco in Venice (Figs 1 and 2), which are the focus of this paper, have inlays of various materials that allow for multi-coloured depictions on flat plates of copper alloy. Only the upper and lower registers show ornamental motifs in bronze relief. The pictorial programme of both doors consists of standing figures of Christ, Mary, the Apostles, the Evangelists, the Fathers of the Church and proto-martyrs (in the case of the main door, prophets and archangels are also added). Both doors belong to the so-called "Byzantine Doors", a group of eight doors in Italy that were probably made (partially or completely) in Byzantium (today's Istanbul, Turkey) in the second half of 11th century and the first half of the 12th century.

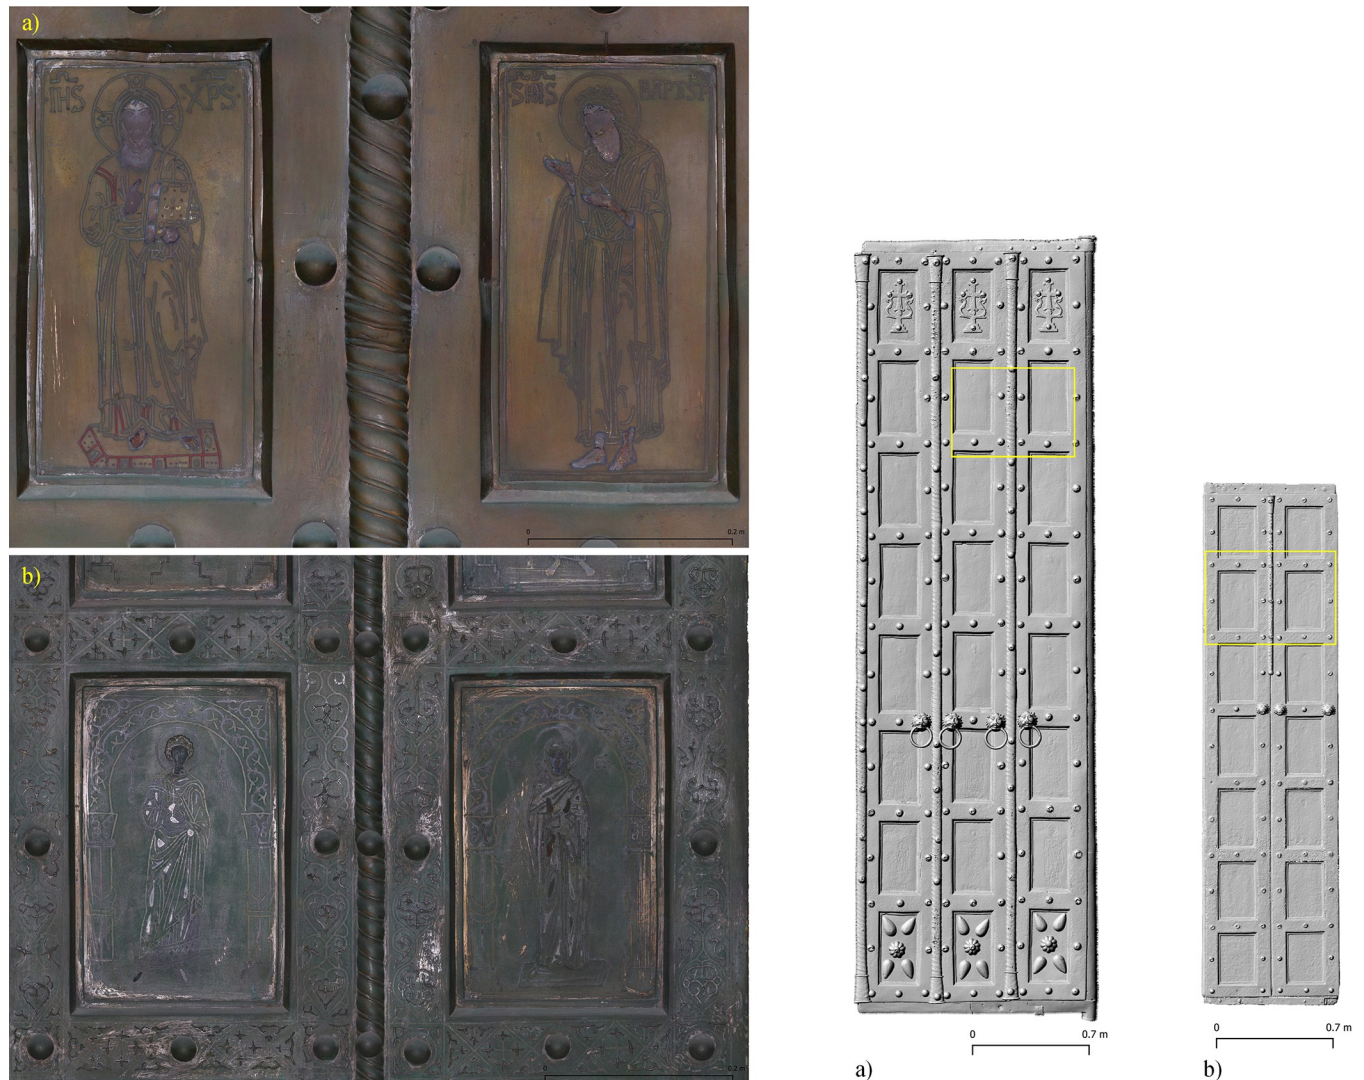
Fig 3. Basilica di San Marco, Venice, Italy. Orthophoto detail, shaded Digital Surface Model. a) Main door, right leaf, plates E2 (left) and F2 (right). b) Door San Clemente, left leaf, plates A2 and B2.

As an example, the right leaf of the main door (max. extent 4.7x1.45 m, coverage area 6.63 m²) was covered by 444 images at an average perpendicular distance of 1 m. The overlap is over 60% and most parts are covered by at least 6 images. The resulting Digital Surface Model (DSM) has an object resolution of 0.141 mm/pixel. On this basis a T ru e O rthophoto was generated as an orthomosaic with a resolution of 0.2 mm/pixel using an orthographic projection normal to the surface plane (Fig 3).

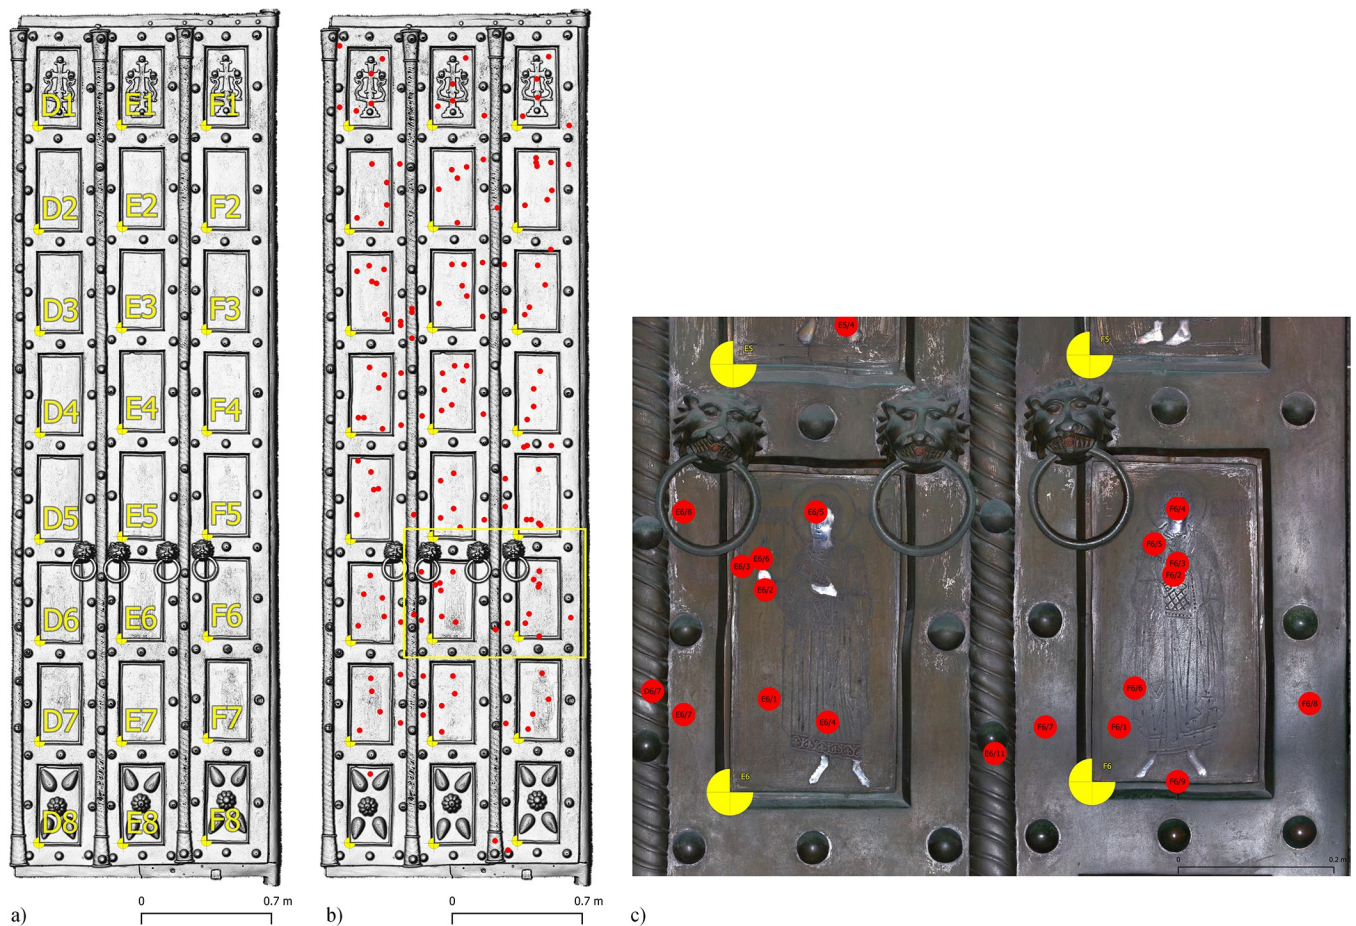
Fig 4. Basilica di San Marco, Venice, Italy. Digital Surface Model visualisation and detail of the orthophoto. **a)** Main door, right leaf, plates mapping. **b)** main door, right leaf, mapping of ED-XRF measurement points. **c)** Main door, right leaf, mapping of ED-XRF measurement points mapped on orthophoto (plates E6 and F6), as indicated in b).

On each plate of both doors, between 4 and 10 analyses were taken on the metal part ([Fig 4](#)). The mean of each piece was used for data processing. Additional analyses were carried out on the frames, columns, hinges and lion heads. Inlays were also analysed on both doors; however, as the inlay is usually thinner and smaller than the measurement area, quantitative results could not be obtained as the background composition of the plate was always measured

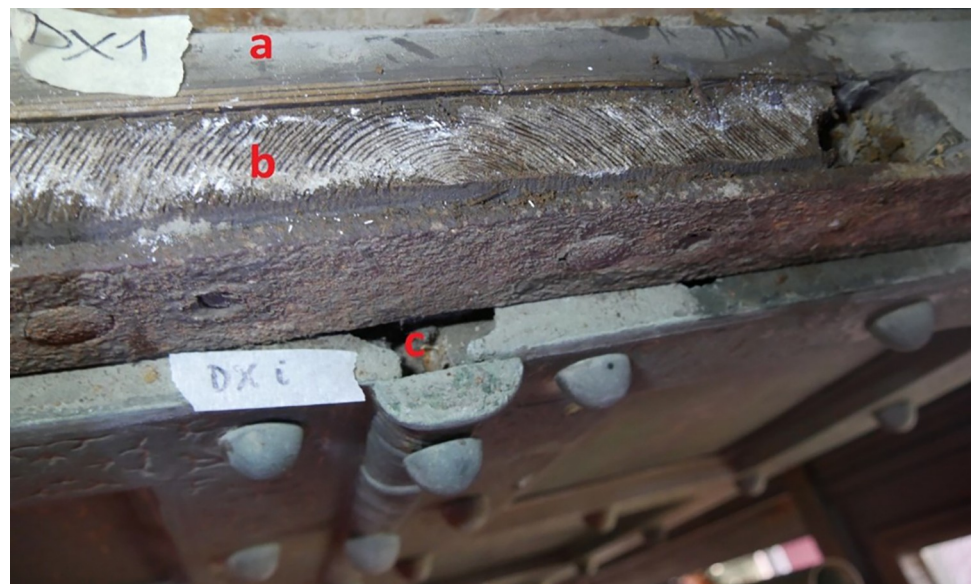
Fig 5. The upper side of the right leaf of the San Clemente door. a) The first layer of horizontal planks. b) The second layer of planks placed vertically: the annual rings on the cross section are highlighted with chalk powder. c) The gap through which a third layer of wood could be glimpsed.

Investigations on the upper sides of the San Clemente door revealed a third layer of wood seen through the gaps in the metal cover (Fig 5). This layer appears to be in direct contact with the bronze plates and, as far as can be determined by examining it through thin gaps, it would appear to be older than the other two layers of boards. Using tweezers and a scalpel, small samples were taken from both doors to verify the tree species, while, on San Clemente door, photographs were taken on the cross sections of the vertical planks for wood dating. Cross sections are the most useful surface for accurately measuring the annual ring widths used in dendrochronological dating.

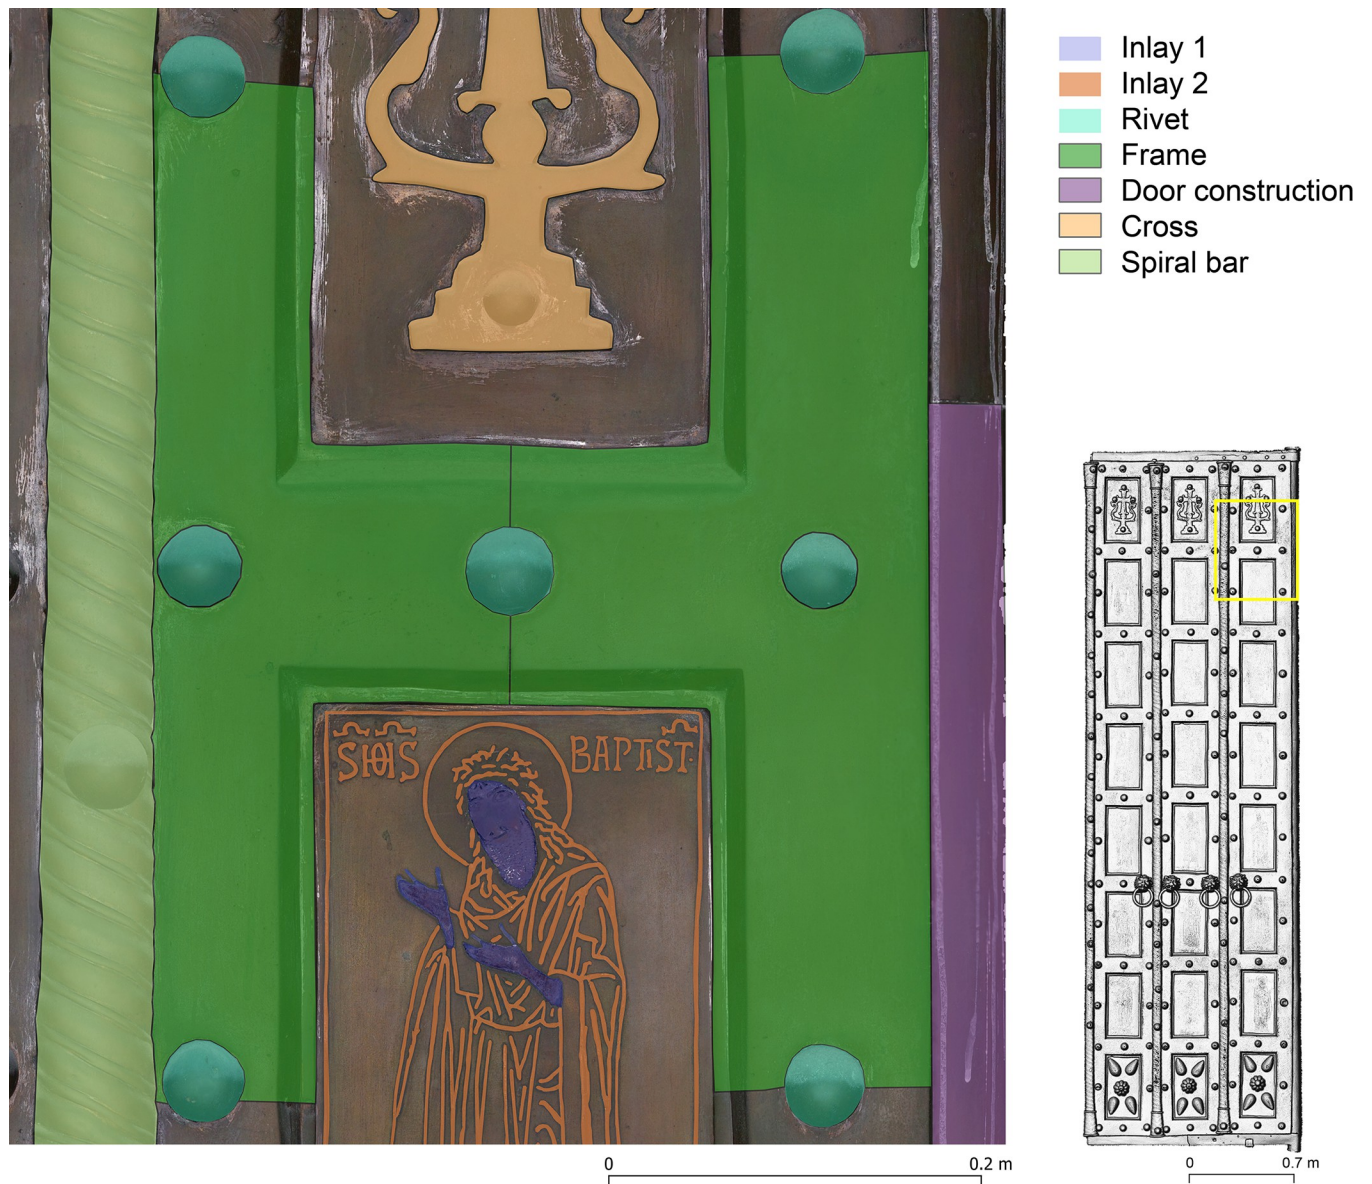
Fig 6. Basilica di San Marco, Venice, Italy. Main door, right leaf, plates F1 (top) and F2 (bottom). Background Orthophoto/DSM, construction elements and chemically analysed entities.

The use of image-based modelling within the project has proved to be of great benefit on many levels. It supports the spatial documentation of the chemical analyses, but also helps in the interpretation of the construction and shows the current conservation status of the investigated objects. The collected data was accumulated in a desktop GIS environment, where tabular data from chemical analyses, geometric data from 3D modelling and spectral data from photographs were used to organise and visualise the results (Fig 6). In addition, the high spatial resolution of the orthophotos and DSMs collected during the project will allow comparative studies beyond a single door to examine details of production processes and connections that indicate specific workshops.

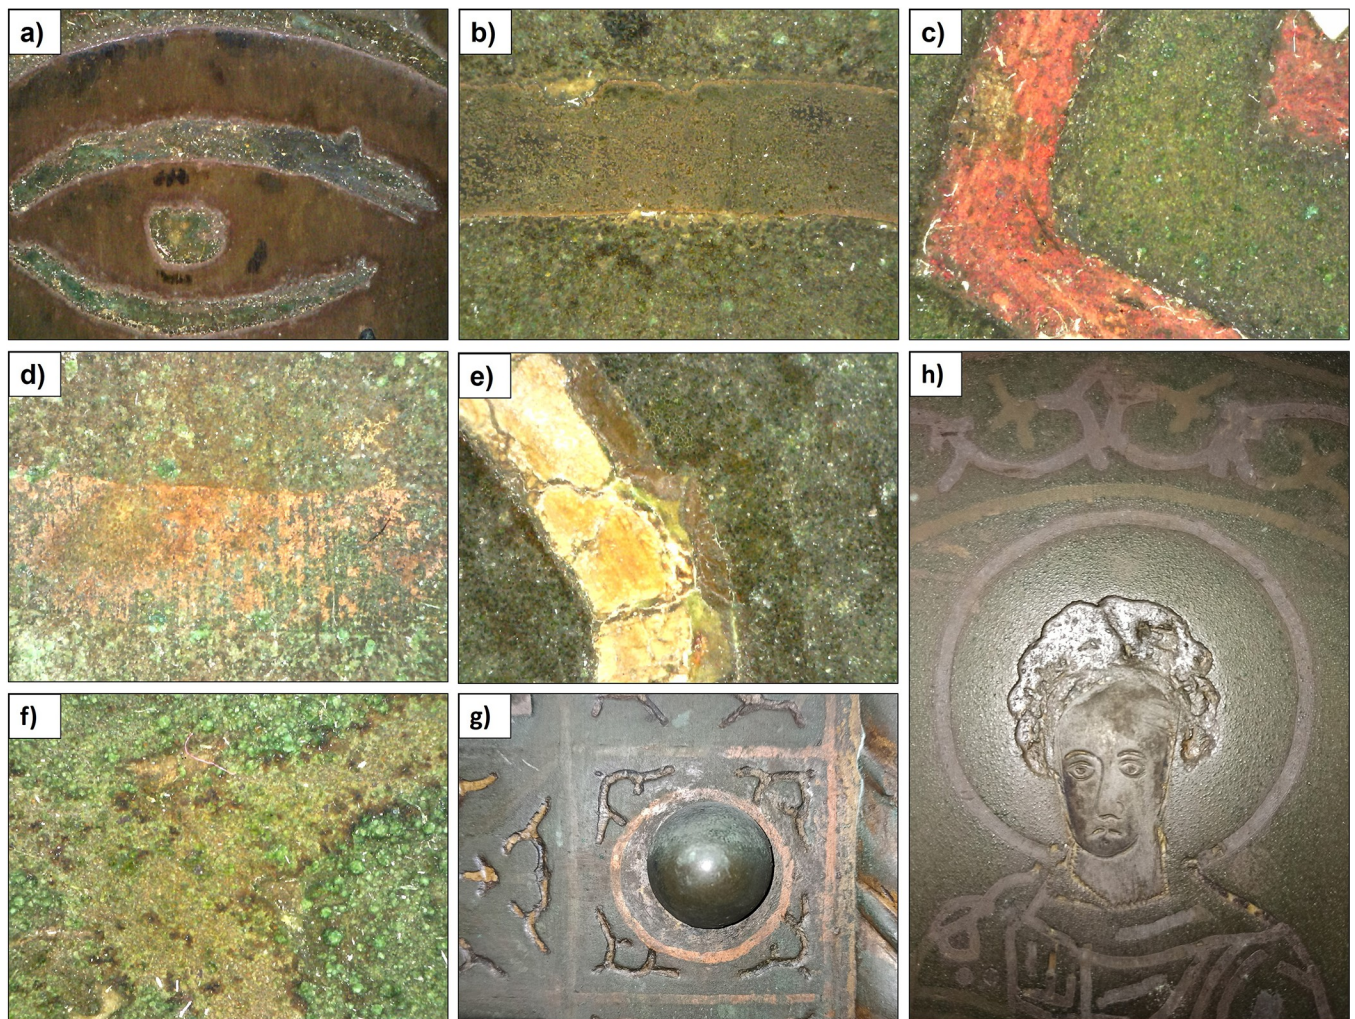
Fig 7. Details of some of the inlays documented. a) silver (MD; plate B3, eye of the saint). b) niello (MD; plate B3). c) red (cinnabar; MD, plate D3). d) copper (SC; frame between plates C7 and D7). e) yellow (SC; frame left of plate C5). f) surface treatment (?) as decorative element (SC; plate B4) g) copper and yellow (SC; frame between plates C7 and D7). h) San Filippo (SC, plate A3), showing silver plating (face), niello inlay and surface treatment (?) as decorative elements.

3.2.1 Inlays. Both bronze doors contain inlays of different colour and chemical composition. Quantitative results were not obtained with ED-XRF, firstly because S, a major compound of niello and cinnabar, cannot be detected with ED-XRF, and secondly because the inlay is too thin to be measured with ED-XRF alone; the chemical composition of the plate is always part of the result. Nevertheless, the following inlays have been identified (Fig 7):

1. Silver (Ag): the face, the hand and most of the feet of the person portrayed, as well as parts of their clothing;
2. Red (cinnabar; main elements detected: Cu, Hg): clothes, shoes, accessories (only on MD);
3. Reddish (Cu): decorative elements (only on SC);
4. Yellow (unknown): decorative elements on the plate and the main bronze structure of the side door (only on SC);
5. Gold (Au): on silver parts, associated with gilding.

On the main door, inlays were found only on the plates; the frame itself is undecorated. Silver has been found on the face, the hands and most of the feet of the person depicted, as well as on parts of his or her clothing. It was applied by plating, i.e. hammering thin sheets of silver into the cavities for the head, hands and feet in the plates. These cavities were chiselled out of the flattened and polished plate to ensure a firm hold for the silver plating. The silver plating sometimes contained up to 2% Au by weight, which may have been associated with earlier gilding. Niello (a black mixture of sulphur, copper, silver and lead) was used mainly for the depiction of clothing and the surrounding decoration of the saints. It was added as a paste or powder, heated until molten/softened, and then pressed into the engraved lines in the plate. As it is impossible to measure niello alone without the background, we have not been able to determine whether silver sulphide niello was used or not. Red colours (cinnabar or vermilion; HgS) were used for the saints' clothes, shoes and various accessories, such as books. Cinnabar was also used for some decorative elements. In addition to Hg, Re and sometimes Au were also found, up to 3.1 and 1.9 wt.% respectively. Traces of Se and Br were also found.

Like the main door, the side door of San Clemente also has inlaid work in a variety of colours. In addition to silver plating and inlays, niello inlays were also noted. Both the silvering and the inlays contained up to 3.5% Au by weight, consistent with the MD decoration. In contrast to the main door, no traces of red decoration (cinnabar) were found. The frames of the San Clemente door are also richly decorated. They contain inlays that are not present on the plates (except for plates A1 and C1) or on the main door. These inlays are made either of copper or of a yellowish compound that has not yet been identified. The copper inlays are mainly found as straight lines or circles around the buttons of the frame. The other type of inlay has a yellowish colour, is very brittle and has an as yet unidentified chemical composition. Finally, a special surface treatment allowed the appearance of more decorative elements (Fig 7F and 7H)—these are certainly not inlays.

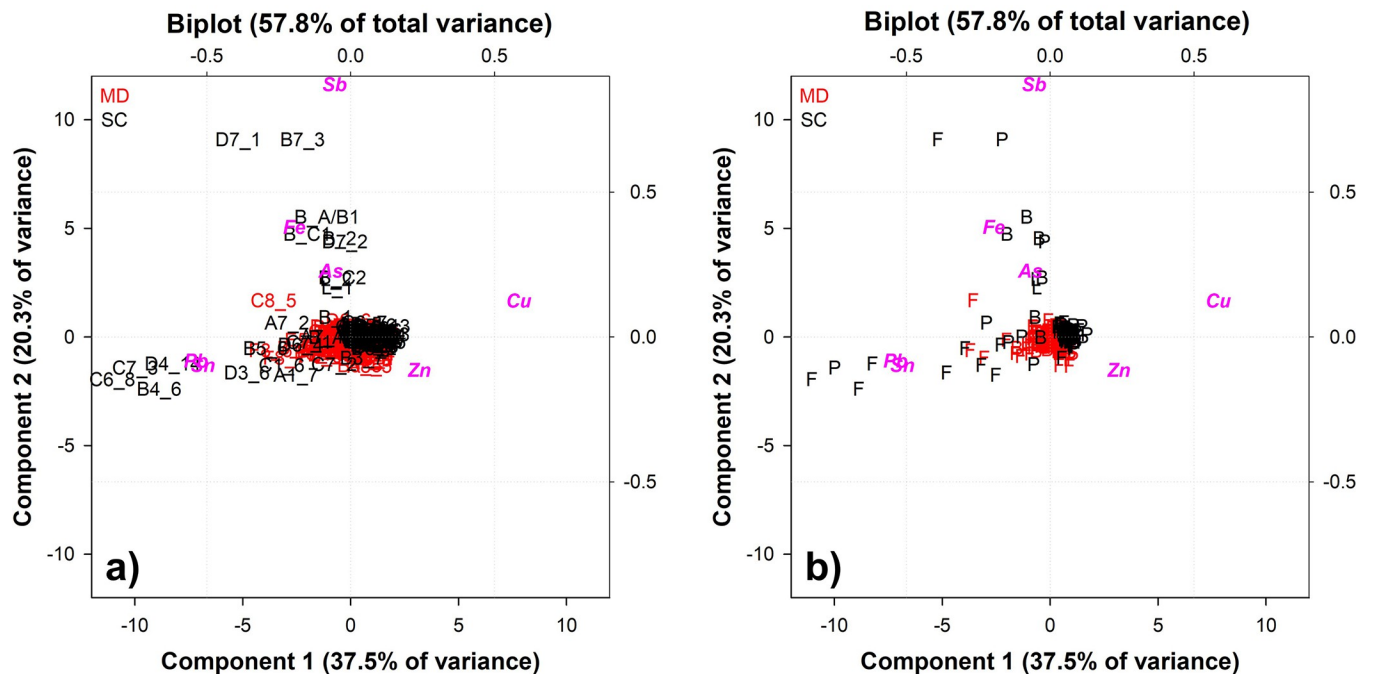
Fig 8. Biplot of the ED-XRF measurements of both Venice doors: MD = Main door in red; SC = San Clemente in black. **a)** ED-XRF number of measurements ([S2 Table](#)); **b)** coded samples: F = frames; P = plates; L = lionheads; B = spiral bars.

The plot appears as a 2D graph where the x and y axes represent the variance of each variable explained by PC1 (37.5% of the variance) and PC2 (20.3% of the variance). The alloying elements are distributed around a centre in the new orthogonal space and are located in

different quadrants. The inverse correlation between Cu, Zn and Sn and Pb indicates that samples with high amounts of Cu and Zn in the solid solution also have low amounts of Sn and Pb. Other elements, mainly As, Fe and Sb, are often present as traces (less than 0.3 wt.%) and do not correlate with Cu and Zn or Sn and Pb. This result suggests that their presence has little or no dependence on the concentration of alloying elements. They are generally associated with the copper ore; medieval ore processing is not comparable to modern techniques and many elements present in the copper ore still remain in the copper (albeit at lower levels).

The biplot (loadings and scores) shows the alloy differentiation even more clearly ([Fig 8](#)). Two compositional macro-clusters are highlighted, corresponding to the two doors (MD in red; SC in black). The alloy used to produce the SC door is generally richer in Zn, while the MD has higher percentages of Sn and Pb ([Fig 8A](#)). There are also some outliers in the score plot, particularly for some SC points that appear far from the 'cloud': these are mostly measurements taken from frames, lion heads and spiral bars, as can be seen from ([Fig 8B](#)). The points from the frames were considered as anomalies, possibly related to: i) the presence of the decorative inlays that influence the measurement (D7_1, B7_3, D7_2); ii) heterogeneities due to the corrosion products that do not give reliable results (B4_6, C6_8, C7_3, D4_14). According to [6], corrosion products were found on both doors: organic substances, oxides, sulphates, hydrochlorides, carbonates. These incrustations, heterogeneously distributed on the surface of the SC door, were detected by ED-XRF and must therefore be excluded. However, the analysis points obtained on the decorative elements (lion heads and spiral bars) do not fall into this category, as they appear to follow a specific pattern and require further study.

composition reflects that of a quaternary bronze, as shown in Fig 8B and S2 Table. This trend is also observed for the lion heads and spiral bars (S2 Fig). Their composition is also very similar or mostly overlapping with that of the decorative elements produced for the MD, possibly suggesting the use of the same alloy for their manufacture.

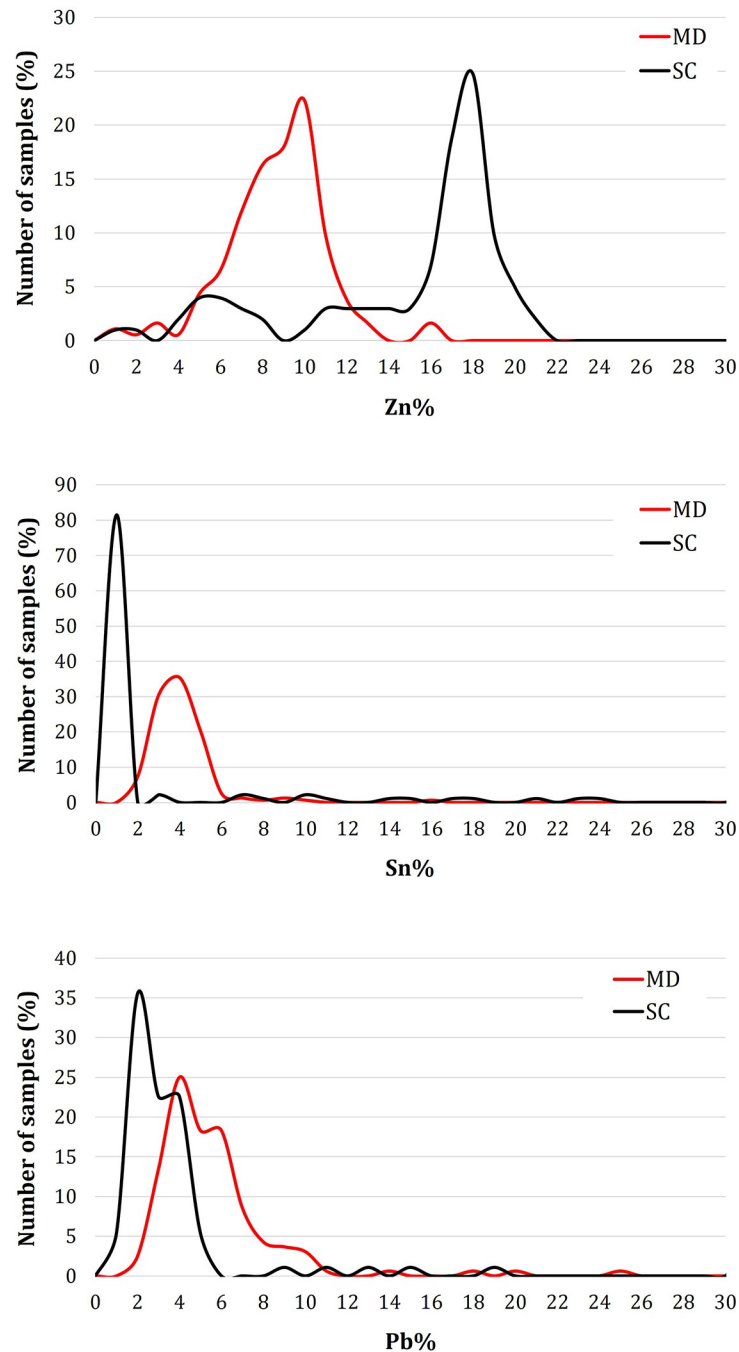
Fig 9. Frequency distribution of the main alloying elements detected in frames, plates and decorative elements in MD (red line) and SC (black line).

From the frequency distribution of the individual alloying elements (Zn, Sn and Pb; [Fig 9](#)) detected on MD (red line) and SC (black line), the major differences appear to be in the Zn and Sn contents rather than Pb.

Zn is much higher in SC, as confirmed by the PCA results, with an average of 18–19 wt.%, while MD shows lower averages, around 10 wt.%. As the Zn content increases, lower amounts

of Sn are registered, less pronounced in SC than in MD (around 1 wt.% and 4 wt.% on average, respectively). A small overlap in the frequency distribution of Pb is also observed, indicating that the amount of Pb was similar for both doors (3 wt.% on average for MD and 5 wt.% for SC) and sufficient to confer good castability properties (i.e. pouring temperature, fluidity, etc. . .). These results strongly support the use of two different alloys: the alloy produced for the MD is quaternary (CuZnSnPb), while the SC door is made of leaded brass (CuZnPb).

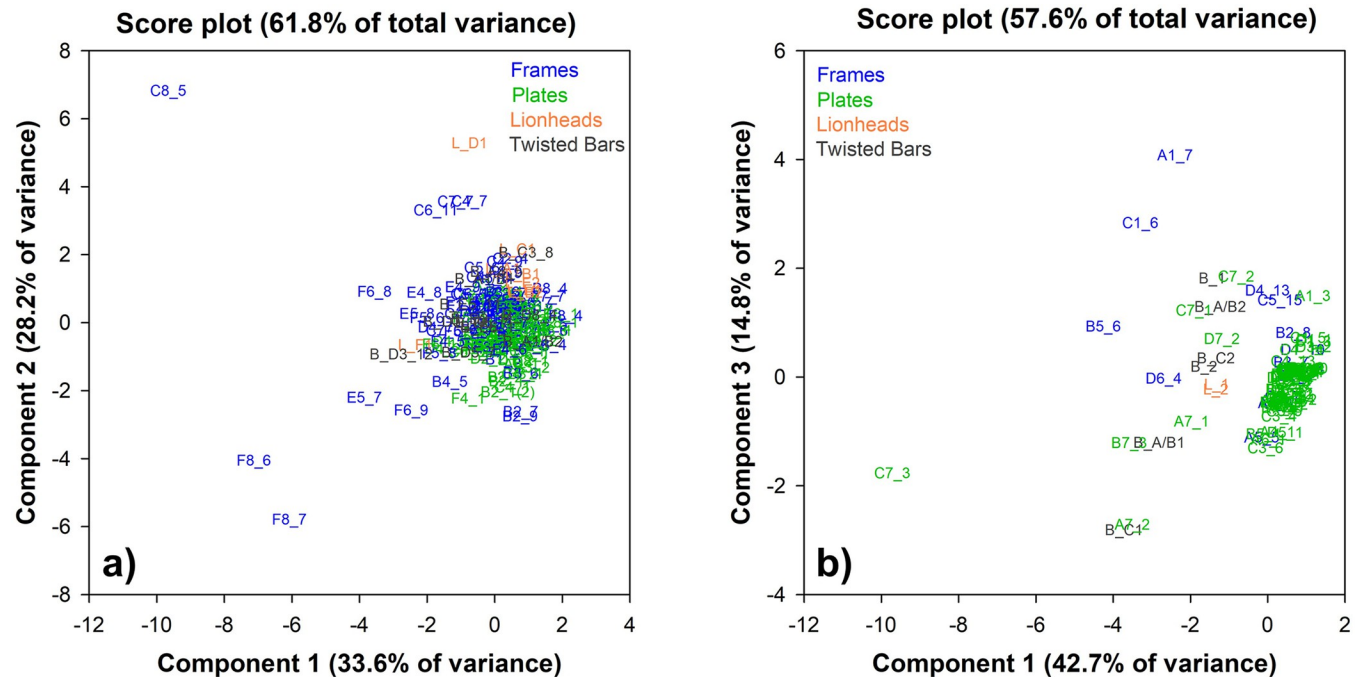
Fig 10. Score plot of the ED-XRF measurements on frames and plates of **a)** MD and **b)** SC. Coded samples (S2 Table) are distinguished by colour: frames = blue; plates = green; lionheads = orange; spiral bars = dark grey.

A PCA calculation was also carried out on the individual doors in order to distinguish possible clusters related to the area of measurement, namely frames, plates or decorative elements (lion heads and spiral rods). In this way, further information can be obtained to assess whether individual plates, frames or decorative elements have a significantly different chemical composition, indicating: i) a substitution of original plates; ii) and/or a different workshop/material. **Fig 10** shows the score plot of the two sets of MD and SC ED-XRF analyses.

Fig 10A, a score plot of Component 1 vs Component 2 (61.8% of total variance), shows that MD is made from a quaternary bronze alloy: Plates, decorative elements and most of the frames have a similar chemical composition, as shown by the 'cloud' of points concentrated between the I and II quadrants. Only the plates show a slight chemical differentiation: they are distributed in the upper part of the II quadrant, corresponding to a higher Zn content (**S1 Fig**). The variation in the alloying elements is not as pronounced, as can be seen from the frequency distribution plot (**Fig 11**), with only small average compositional changes in Zn (8 wt.% for the plates and 10 wt.% for the frames).

Lionheads and spiral bars fall within the compositional range of frames and plates, suggesting the use of the same alloy for the entire door, with some points showing a lower Zn content, possibly due to a thicker surface layer of corrosion products. Some measurements on the frames (C8_5, F8_6 and F8_7), far from the cloud (**S2 Fig**), suggest the use of an alloy richer in Sn (average 8.2 wt.%), Pb (average 17.2 wt.%) and Fe (average 1.7 wt.%). These points were collected on the base under the door and may be related to the replacement of the original lower part with a modern alloy. They are also well distinguished in the frequency plot as small peaks in the Sn and Pb wt.% graphs.

The SC score plot (Component 1 vs Component 3, 57.6% of total variance—**Fig 10B**) shows a heterogeneous distribution of samples with different chemical compositions. The plates are concentrated in the II quadrant where the cloud of points shows an alloy rich in Zn

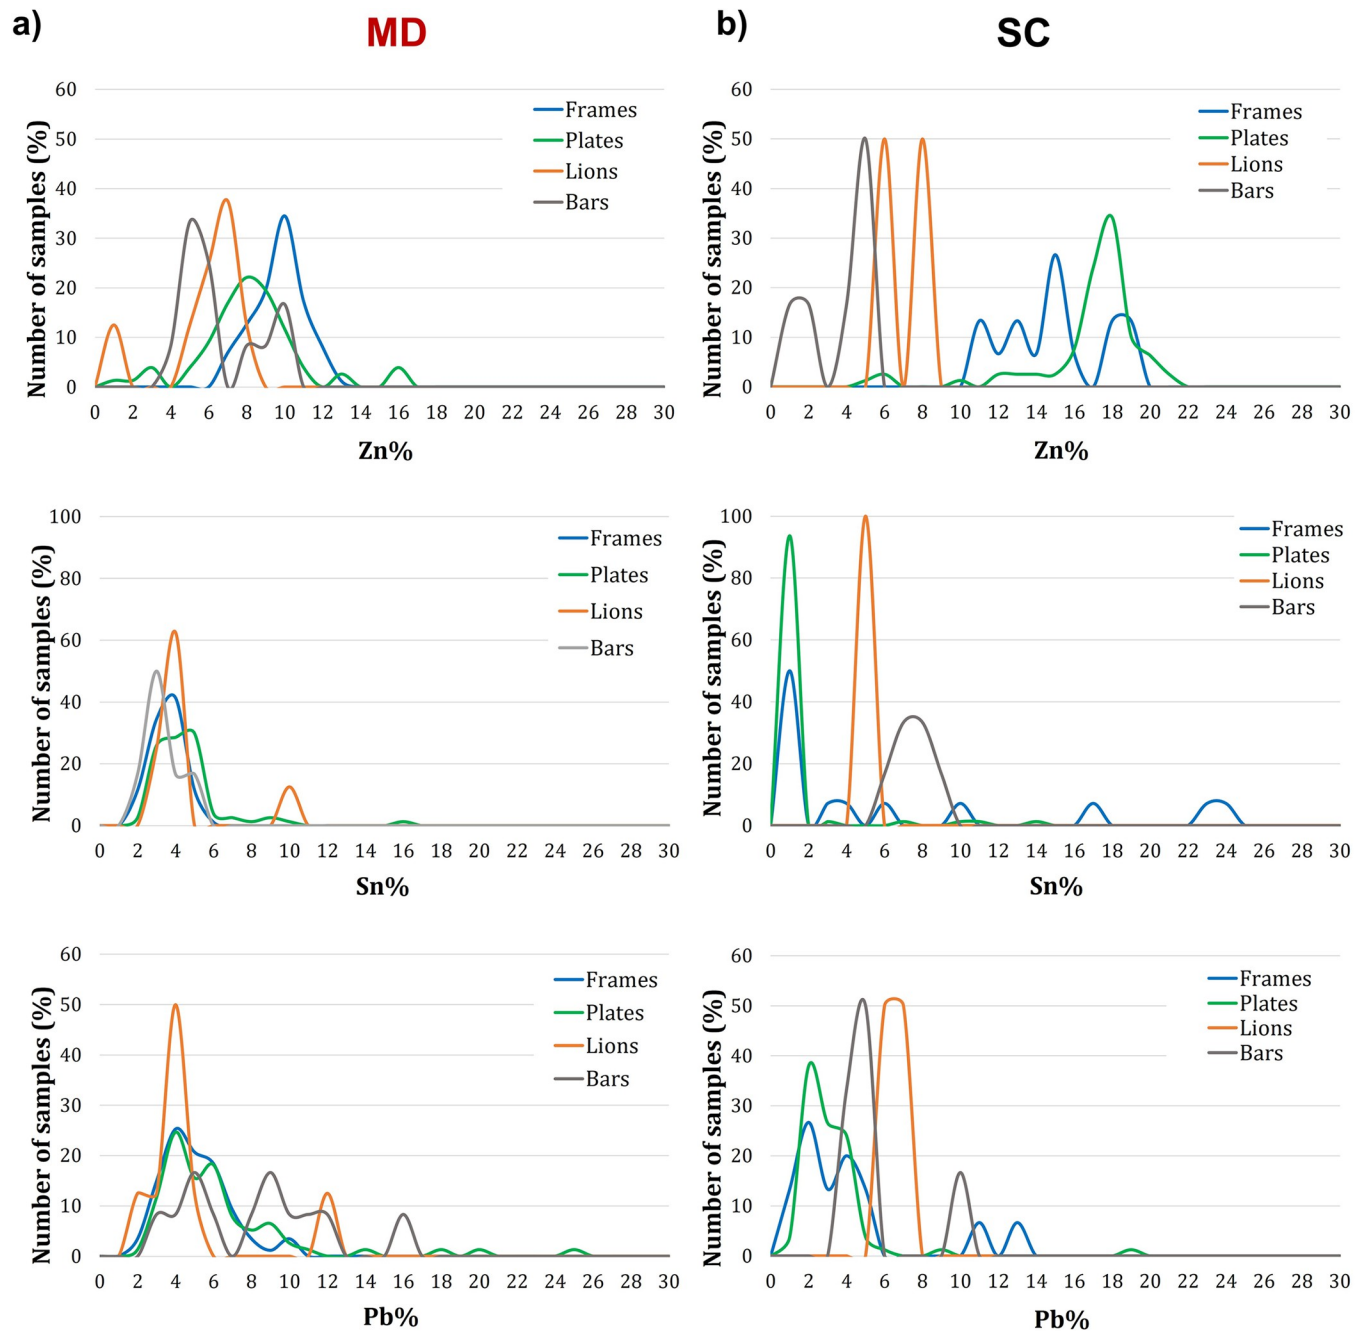
Fig 11. Frequency distribution of the main alloying elements detected in frames (blue), plates (green) lionheads (orange) and spiral bars (dark grey) of: a) MD; b) SC.

(18 wt.%) and poor in Sn and Pb, confirming the use of a leaded brass. Fig 11B indicates that frames and plates have almost the same composition, with frames made of an alloy poorer in Zn (between 10 and 16 wt.%) and balanced by Sn and Pb. Some points of the frames (A1_7, B5_6, C1_6, D6_4) are considered as outliers due to heterogeneities of the corroded layers and are therefore excluded. Some measurements on the plates, namely the lower row of the door (A7 to D7), appear far from the plate cluster and towards a higher Sn and Pb content. Their

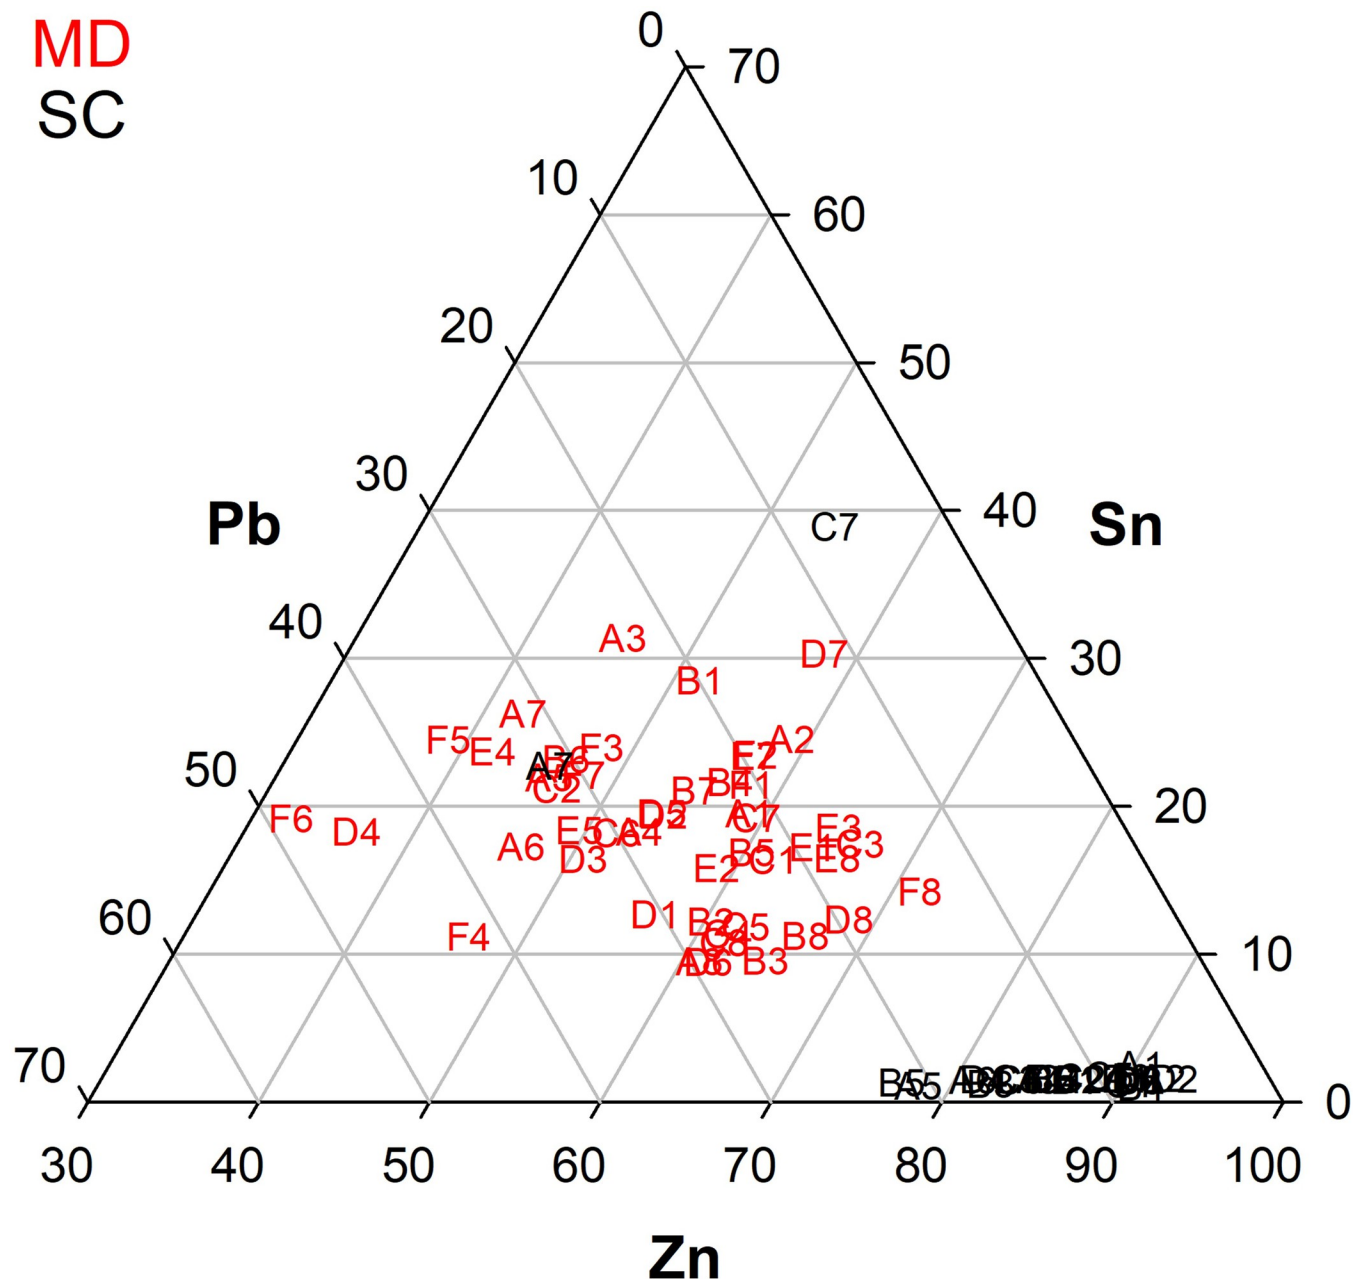
Fig 12. Ternary diagram of Zn-Sn-Pb of the plates average for MD (red) and SC (black).

In order to understand whether the plates of both doors had been replaced over the centuries, or whether some of them had been added later, further analysis was carried out. Plotting the average of the main alloying elements Zn, Sn and Pb on a reduced ternary diagram, two distinct clusters can be seen (Fig 12), confirming that two different types of alloy were used: quaternary for MD and leaded brass for SC.

This diagram also highlights the similarity of the composition of plates A7 and C7 of SC to the average composition of the MD alloy, suggesting a possible correlation between the plates. This result is consistent with the different decorative motifs that make up the lower part of the door (plates from A7 to D7).

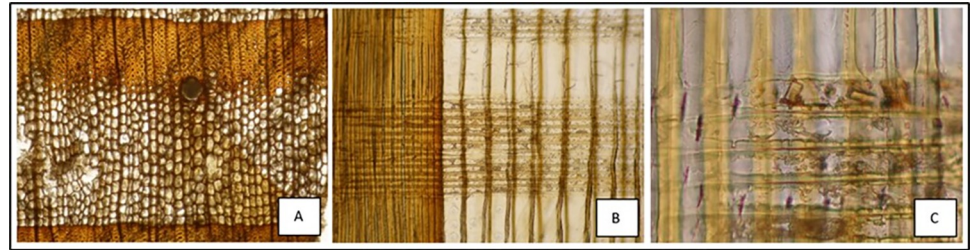
Fig 13. Microscopic features of the woods from San Clemente's door. A and B: cross and radial section of larch. C: radial section of silver fir.

Microscopic analysis showed that most of the structural wood in both doors is larch (*Larix decidua* Mill., Fig 13). Among our samples, only those from the inner layer next to the bronzes of the San Clemente door turned out to be made of another wood species, namely silver fir (*Abies alba* Mill.) (Table 1). In the case of the main door, there is no way of verifying the presence of a corresponding layer of wood, since all the sides of both leaves are completely covered with metal elements.

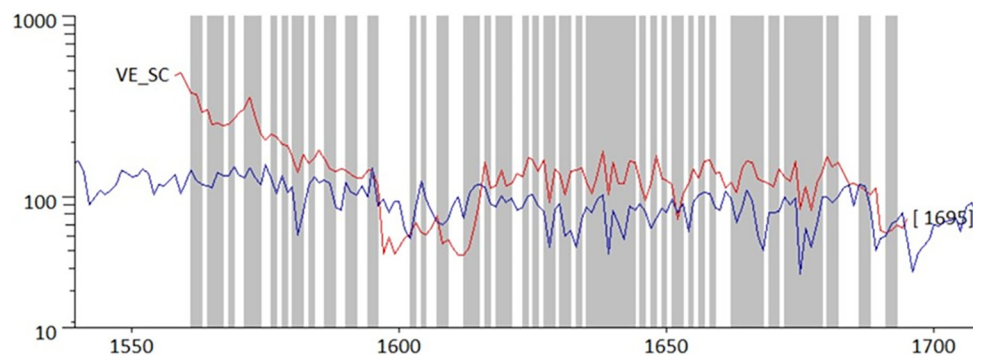
Fig 14. Visual cross-matching of the San Clemente's larch chronology (VE_SC, in red) and Bernabei-Bontadi's reference chronology (2018). The grey areas display the periods of common *Gleichlauf*, a measure of the year-to-year agreement.

The tree-ring sequences from the pictures taken on the vertical boards of the San Clemente Door cross-date very well with each other and have therefore been grouped into the mean chronology VE_SC, which spans 138 years (Fig 14; Table 2). Comparing the San Clemente door larch chronology with a number of reference chronologies, the best correlations were obtained with high-altitude chronologies from the Eastern Alps, i.e. our own Tonale larch chronology [23]. The last year of the larch wood of the San Clemente door is 1695 CE. Since they are planks, the dated wooden elements were trimmed during their production and therefore do not show any traces of the wane edge, i.e. the last ring, close to the bark, produced by the living tree before felling. In addition, the processing of the boards removed all sapwood, the outer part of the trunk recognizable in larch by its lighter colour, made up of a more easily degradable wood. In view of the above, the date of 1695 CE must be considered a *post quem* date, a threshold of time before which the wooden structure of the San Clemente door could not have existed. Mature larch trees usually have an average of 30–50 growth rings in the sapwood: this means that at least 30 years can be added to the date of 1695 CE to obtain an estimate of the most likely date of felling. Also taking into account the time needed for harvesting, transport and seasoning, it is reasonable to assume that the wooden structure of the San Clemente Gate was certainly built after 1730–1740 CE.
