Safety assessment of an existing bridge deck subject to different damage scenarios through the global safety format ECOV

# Safety assessment of an existing bridge deck subject to different damage scenarios through the global safety format ECOV

Gabriele Bertagnoli<sup>\*</sup>, Mario Ferrara, Elena Miceli, Paolo Castaldo, Luca Giordano

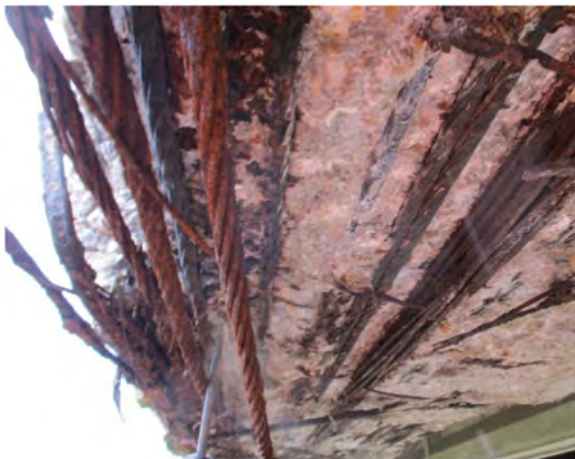
Fig. 10. Real damage on the side beam.

The side beam of the deck has been suffering from reinforcement corrosion as can be appreciated in Fig. 10: 19 out of 94 prestressing strands, 8 out of 32 wires of the prestressing tendon and 4 longitudinal ordinary reinforcement bars were broken and, therefore, ineffective in the midspan of the beam. The information about the damage is taken from the reports written by the highway authorities through visual and handy inspections. During the inspections, the entire deck is examined, but only the damage in the midspan of the structure was actually observed and described in the technical report. Other damages in different positions are not herein hypothesised since were not observed during the inspections as also confirmed by the symmetric values on
