Flexural and shear strengthening of RC beams reinforced with externally bonded CFRP laminates postfire exposure by experimental and analytical investigations

Flexural and shear strengthening of RC beams reinforced with externally bonded CFRP laminates postfire exposure by experimental and analytical investigations / Nestor, Mejía; Andrés, Sarango; Alejandro, Espinosa. - In: ENGINEERING STRUCTURES. - ISSN 1873-7323. - 308:(2024). [10.1016/j.engstruct.2024.117995]

Nestor Mejía^{a,*}, Andres Sarango^b, Alejandro Espinosa^b

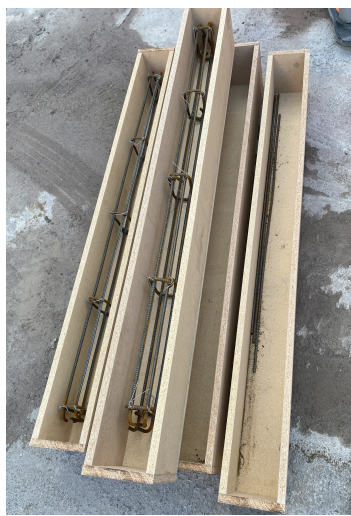
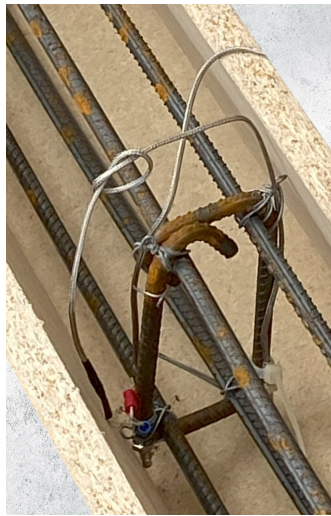
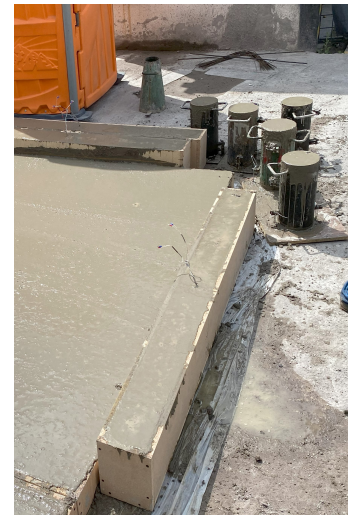
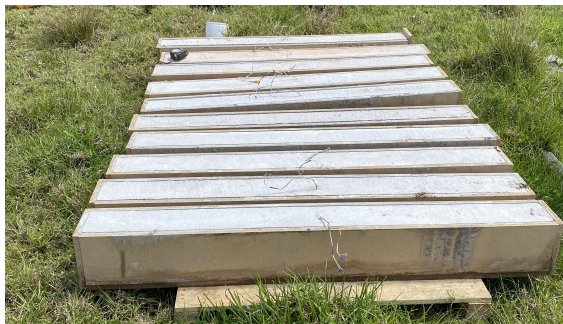
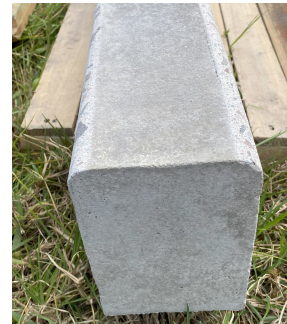
Fig. 1: Specimen fabrication process.

strength of 210 kg/cm^2 . It was obtained through the breaking of eight cylindrical concrete specimens. The thickness of the concrete cover was 30 mm. Furthermore, five K-type thermocouples are embedded and placed proportionally into the specimens to define the temperature distribution in the cross-section to study the cracking variations regarding temperature. In this sense, all beams were identically manufactured in materials, properties, and configurations.

(a) Steel Reinforcement

(b) Thermocouple sensor

(c) Cast concrete specimen

(d) Specimens

(e) Cross-section

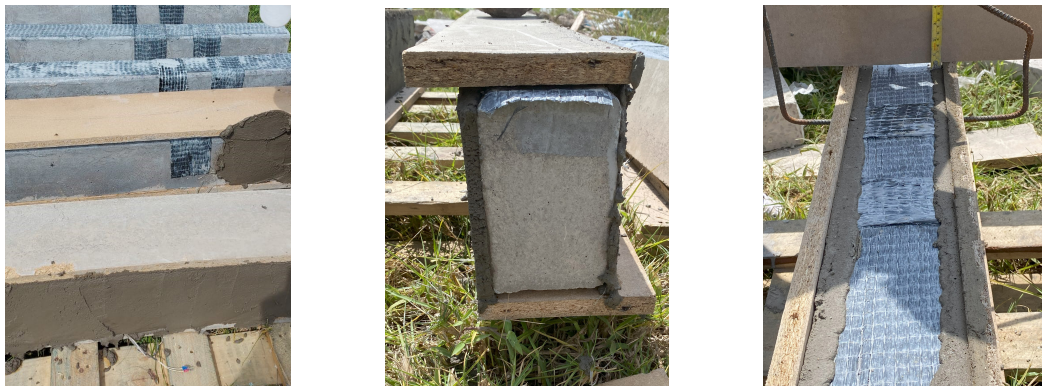
(a) Applying the mortar

(b) First layer application

The application of a U-shaped insulation jacket is specifically designed to serve exclusively as a thermal barrier, enhancing fire resistance. This thermal insulation method ensures that the resin, applied as an adhesive layer between the FRP reinforcement and the concrete matrix, remains below its glass transition temperature, preserving the integrity of

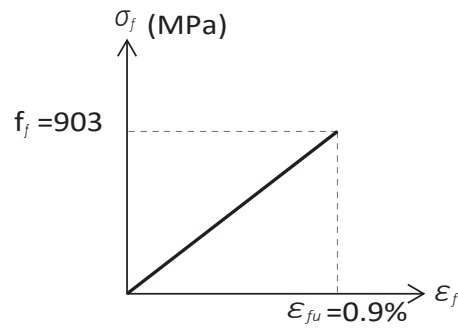
FRP materials typically exhibit a linear elastic behavior straight through to failure without a distinct yield point ([40]). In this context, the material does not undergo plastic deformation before breaking, resulting in a straight line (stress-strain) until rupture (Fig. 12). The relationship can be described by a modified form of Hooke's Law (Eq. 3), where σ_f , E_f , ε_f and ε_{fu} denote the tensile strength, elastic modulus, strain, and peak strain of the FRP sheet, respectively.

Fig. 12: Stres-strain diagram for FRP [35].
