Flexural and shear strengthening of RC beams reinforced with externally bonded CFRP laminates postfire exposure by experimental and analytical investigations

Nestor Mejía^{a,*}, Andres Sarango^b, Alejandro Espinosa^b

Abstract

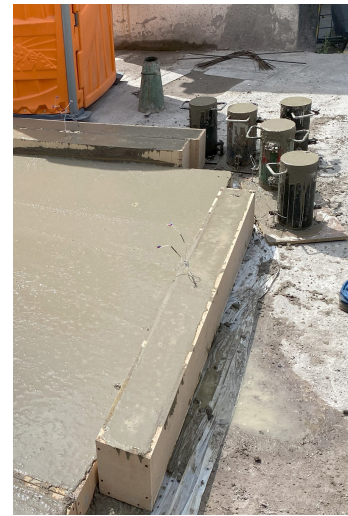
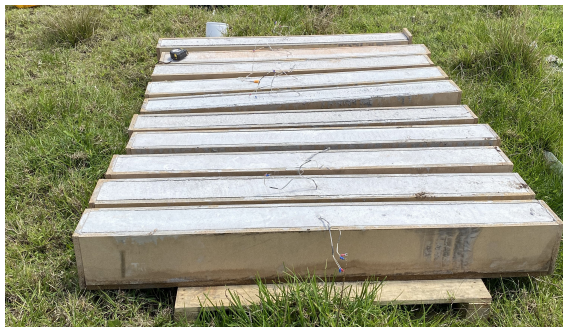
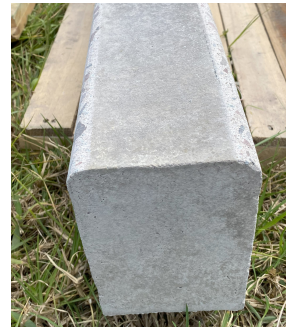
Fig. 1: Specimen fabrication process.

strength of 210 kg/cm^2 . It was obtained through the breaking of eight cylindrical concrete specimens. The thickness of the concrete cover was 30 mm. Furthermore, five K-type thermocouples are embedded and placed proportionally into the specimens to define the temperature distribution in the cross-section to study the cracking variations regarding temperature. In this sense, all beams were identically manufactured in materials, properties, and configurations.

(a) Steel Reinforcement

(b) Thermocouple sensor

(c) Cast concrete specimen

(d) Specimens

(e) Cross-section

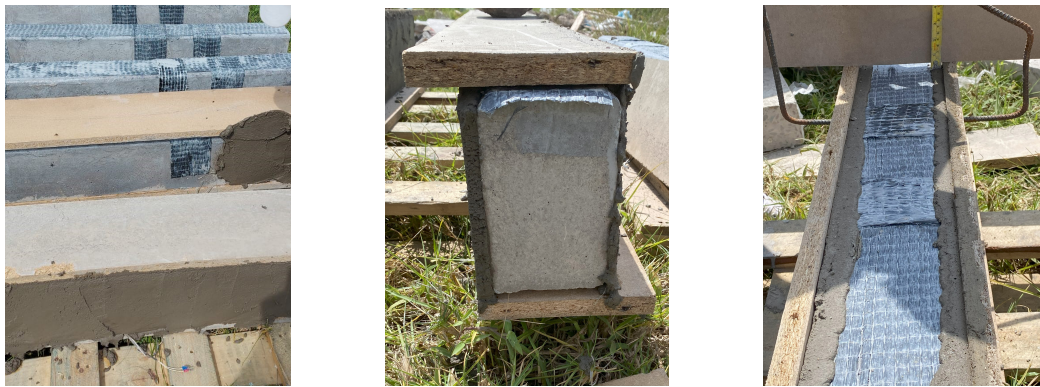
The application of a U-shaped insulation jacket is specifically designed to serve exclusively as a thermal barrier, enhancing fire resistance. This thermal insulation method ensures that the resin, applied as an adhesive layer between the FRP reinforcement and the concrete matrix, remains below its glass transition temperature, preserving the integrity of

(a) Applying the mortar

(b) First layer application
