Gravity-induced collapse of a soft rock cliff due to notch growth

Gravity-induced collapse of a soft rock cliff due to notch growth / Napoli, M.L., Barbero, M., Mascioli, F., Miccadei, E.. -  
In: ENVIRONMENTAL GEOTECHNICS. - ISSN 2051-803X. - ELETTRONICO. - 12:3(2025), pp. 183-193.  
[10.1680/jenge.24.00052]

**Manuscript title:** Gravity-induced collapse of a soft rock cliff due to notch growth

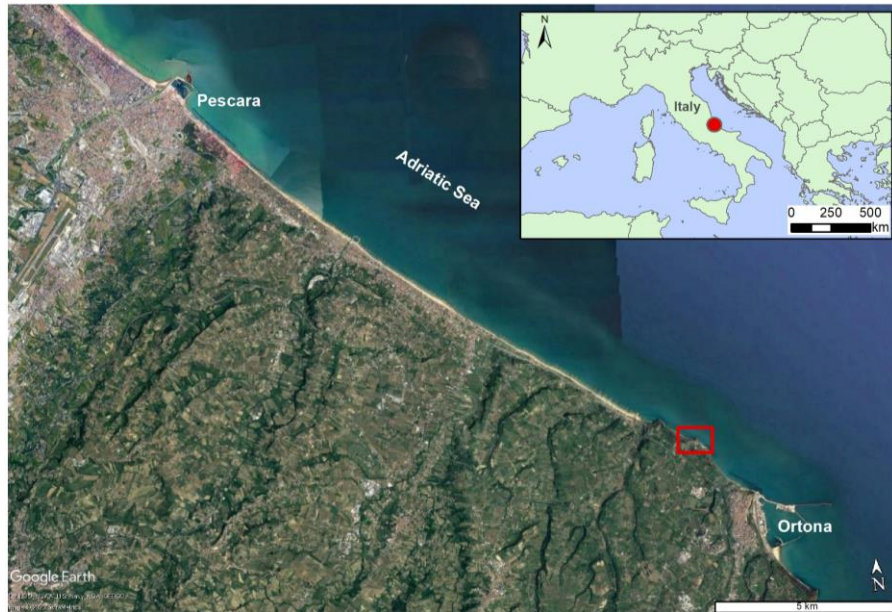
Fig. 1

First, 2D finite element (FE) analyses were carried out on homogeneous steep seacliffs with variable heights (from 7 m up to 25 m) and the same basal notch, to investigate if and how the slenderness of the rock overhangs affects their failure mechanism. The geometry and the mechanical properties of the cliff were based on the study of Calista *et al.* (2019) and Miccadei *et al.* (2019), related to the popular tourist site of Punta Ferruccio promontory, located in the Adriatic Sea (Abruzzo, Italy), which has been affected by several rockfalls in the last decades (Figure 1).

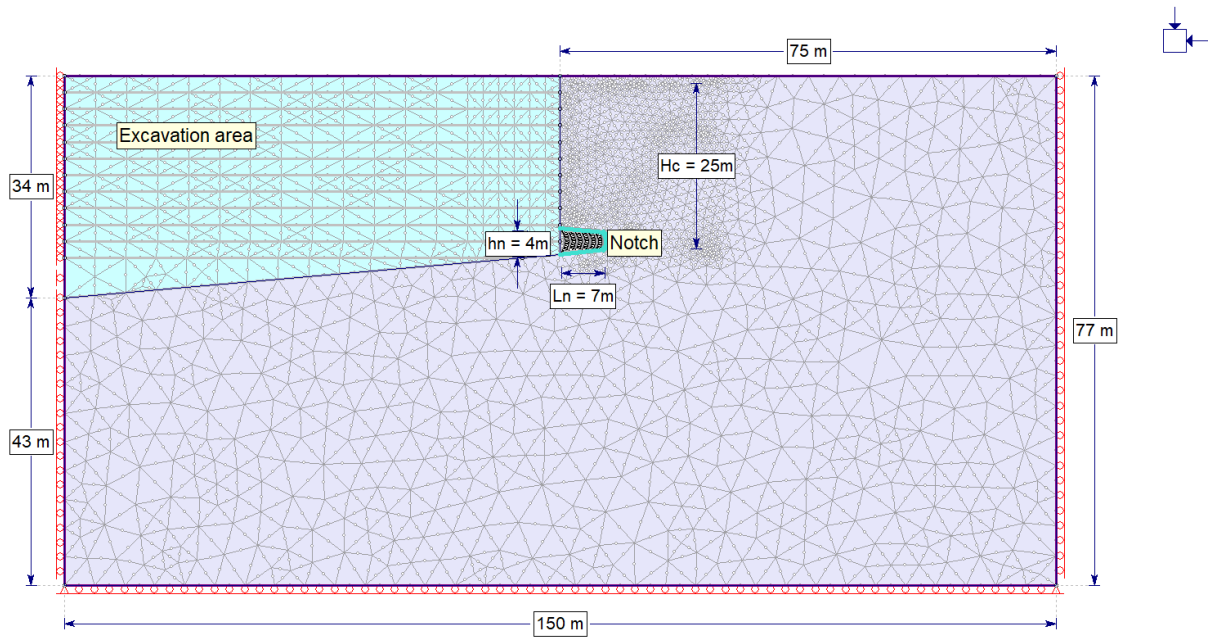
Fig. 2

node triangular elements were used to mesh the models, increasing the elements density close to the cliff face and the notch. In order to avoid stress modelling disturbance, two excavation processes (i.e. each one including several excavation stages) were simulated: the former in the left part of the model so as to reproduce the vertical cliff face, with a removal of 2.5 m layers of rock per stage; the second, in order to simulate the notch growth and its effect on the stability of the cliff, with a removal of 1 m of notch depth per stage (Figure 2).

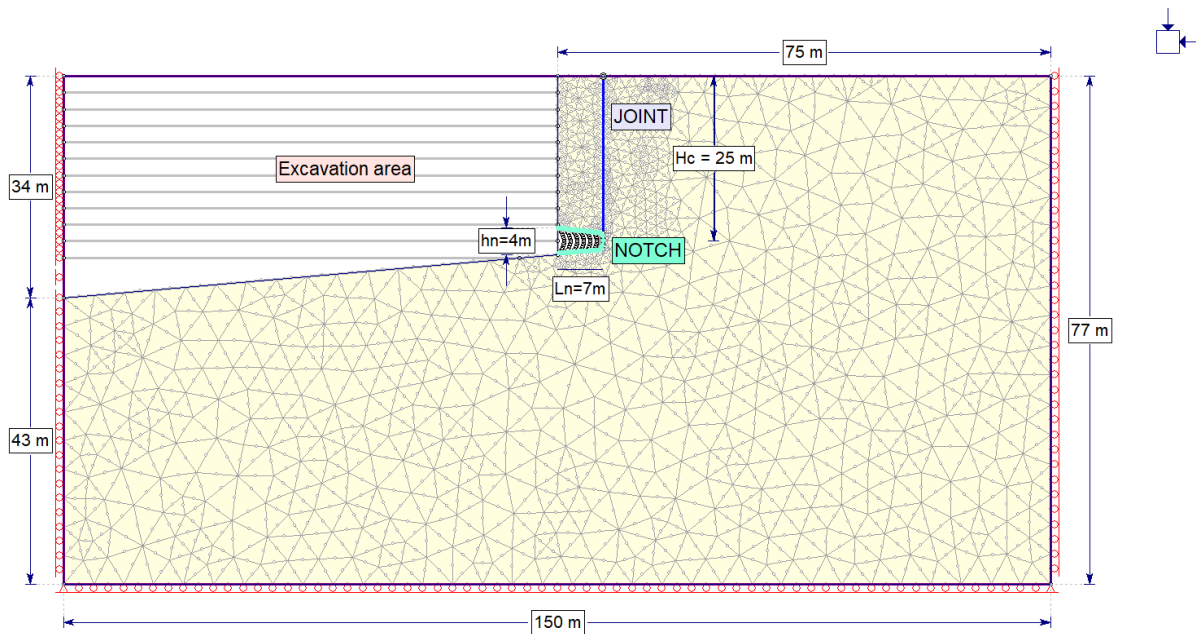
Fig. 7

1) to include a vertical deep joint, in the position observed on site. The joint is modelled with the RS2 code with the first end (on the cliff surface) open and the last end closed. As shown in Figure 7, the discontinuity was located 7 m far from the exposed cliff face.

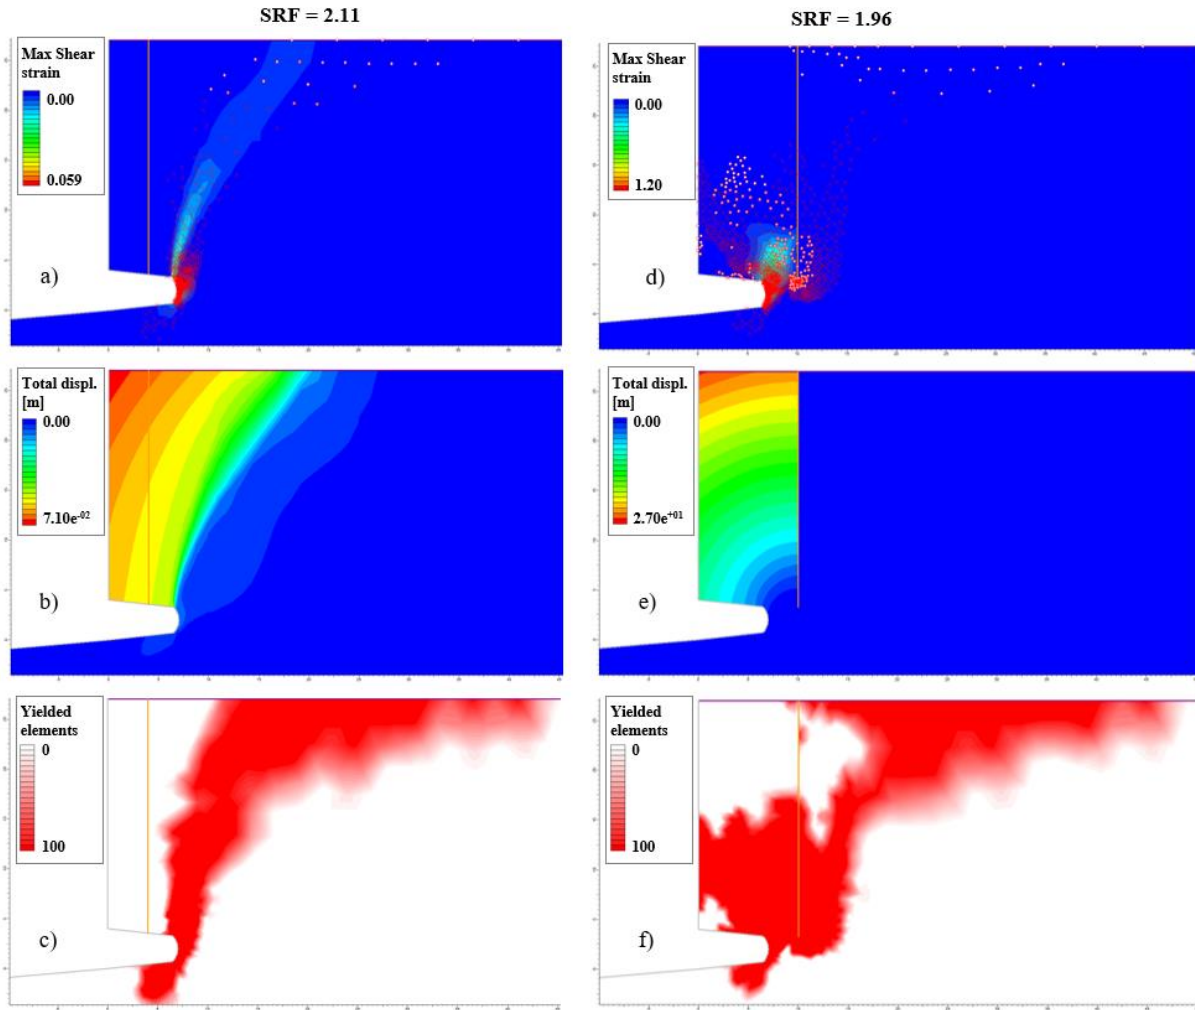
Fig. 9

As shown in Figure 9 and Figure 10, when the distance,  $d$ , between the joint and the cliff face is significantly lower than the notch depth (i.e.,  $d < L_n$ ), the joint has little influence on both the SRF and mechanical behaviour of the cliff. As illustrated in Figure 9a,b, and c, the failure mechanism of the cliff with the joint at 4 m from the cliff face is the same of that shown by the homogeneous model 1-h. On the contrary, as shown in Figure 8 and Figure 9d,e,f, if the joint is located at a distance from the cliff face almost equal or greater than the notch depth, its presence induces a significant perturbation that causes a reduction of the safety factor, more concentrated tensile failures at the top of the cliff (that may induce the development of tension cracks), shear strains localized in a smaller area close to the notch apex, larger displacements occurring only above the erosion area, and more diffuse yielded zones that affect also the exposed cliff face. When the structural joint (which can be considered as weakness plane in the rock cliff) is reached by the propagation of the notch and affected by the resulting stress concentration, it contributes to the collapse of the rock overhang, if its volume is sufficiently large. These findings are in good agreement with the results of Zhang et al. (2023), who analysed the failure process of a cliff with a tensile crack located directly above the notch apex.

Figure 9. Results of the cliff models with a deep vertical joint located at different distances,  $d$ , from the cliff face. a, b, c) maximum shear strains, total displacements and yielded elements, respectively, when  $d= 4\text{m}$ ; d, e, f) maximum shear strains, total displacements and yielded elements, respectively, when  $d= 10\text{ m}$

| Model | Joint distance from the cliff face, d [m] | SRF [-] | Ref. Figure |
|---|---|---|---|
| 5-PF_J10m | 10 | 1.96 | Fig. 9d,e,f |
