Tunnel convergence monitoring by radar interferometry

II Fabre Conference – Existing bridges, viaducts and tunnels: research, innovation and applications (FABRE24)

## Tunnel convergence monitoring by radar interferometry

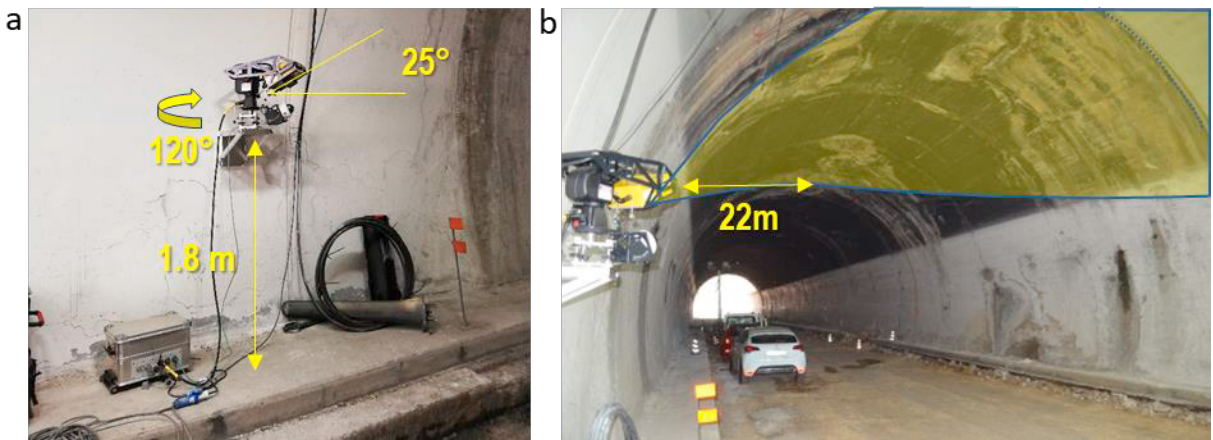
Fig. 2. (a) View of the Hydra-U installation point and (b) view of the monitored tunnel sector.

The equipment used for the experimental activities was a specifically designed ground-based radar called HYDRA-U optimized for use in underground applications. The instrument is composed of a radar head equipped with two antennas (one for signal transmission and one for receiving) mounted on a pan/tilt unit capable of rotating the radar unit thus realizing the synthetic aperture. The motion of the radar antenna over a circular trajectory provides finer angular resolution than conventional beam-scanning radars. The circular trajectory used for obtaining the synthetic aperture (often denoted as ArcSAR) permits a more compact design of the radar and a wider-angle coverage compared to the traditional linear SAR. An IR camera and a laser scanner are also coupled with the radar sensor. The instrument is completed by a power supply and control unit. The system was installed along one sidewall of the tunnel using a metallic shelf as shown in Fig. 2a. By tilting the radar head  $25^\circ$  from the horizontal and by using a synthetic aperture equal to  $120^\circ$  it was possible to monitor the tunnel crown and one sidewall up to a distance of about 22 m from the radar installation point (Fig. 2b). The accuracy of the displacement measurement along the LOS depends on the wavelength of the radar signal and is equal to  $\pm 0.1$  mm.
