SMAR 2024 – 7th International Conference on Smart Monitoring, Assessment and Rehabilitation of Civil Structures

## Effect of Textile Architecture on the Durability of Flax Textile-Reinforced Mortars

### Abstract

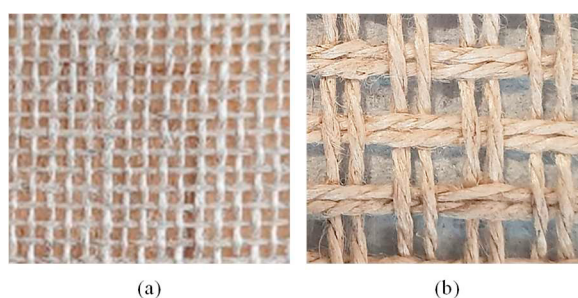
Fig. 1. Flax textile reinforcements adopted in the present study: (a) “K” and (b) “F” textiles.

Two types of flax textiles were used as structural reinforcement, including: 1) a flax textile comprising single twist yarns (denoted as “K”) arranged in a 1.5-mm mesh with linear density equal to 100 TEX; 2) a flax textile comprising two-ply twist yarns arranged in pairs across a 4-mm mesh (denoted as “F”) with linear density equal to 324 TEX (Fig. 1). Both textiles were woven (i.e. warp and weft yarns are interlaced at 90° to each other), balanced bi-directional, with a bulk density equal to 1.5 g/cm<sup>3</sup>. The yarn’s cross-sectional area was found equal to 0.07 mm<sup>2</sup> and 0.22 mm<sup>2</sup> for K and F textiles, respectively. It should be noted that the origin of the two types of flax fibres used in the textile production, and whether it was common to both textiles or not, is unknown.

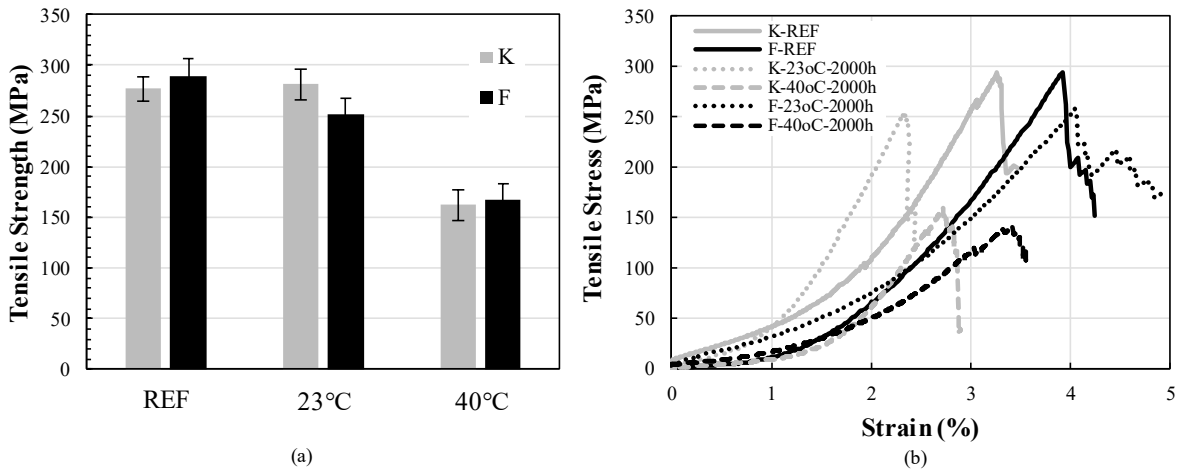
Fig. 2. (a) Tensile strength; (b) stress-strain curves of typical K and F bare textiles before and after exposure for 2000h.

Table 1 summarises the average mechanical properties of the bare “K” and “F” textiles before and after exposure to accelerated ageing. Fig. 2a illustrates the effect of the conditioning protocol on the tensile strength, while Fig. 2b presents the tensile stress–strain curves obtained from representative textiles from each conditioning protocol.

An initial inelastic behaviour followed by a linear elastic response up to the peak stress was consistently observed for both types of flax textiles. In all cases, failure occurred due to the progressive rupture of the individual yarns. Both types of unconditioned flax textiles attained similar values of strength (277 – 289 MPa) and ultimate strain (3.5-3.8%), in good agreement with those reported in previous studies (Ferrara et al., 2019).

Although exposure to 23°C for 2000h did not result in a significant change in the mechanical properties, given the observed variability, a decrease in tensile strength of up to 42% was recorded after exposure to 40°C, which accelerated the chemical reactions and the resulting degradation of the flax fibres.

Interestingly, the strength reduction was similar for both types of flax textiles. Typically, as higher linear density yarns contain more fibres, they also exhibit larger moisture absorption capacity (Alias et al., 2018). It can be surmised that the higher twist level and the presence of two-ply yarns in the “F” textile prevented the core yarns from being directly exposed to water molecules and hydration products, mitigating their overall degradation. Further work is needed to elucidate the moisture transport mechanism within the yarn cross-section as a function of its linear density.

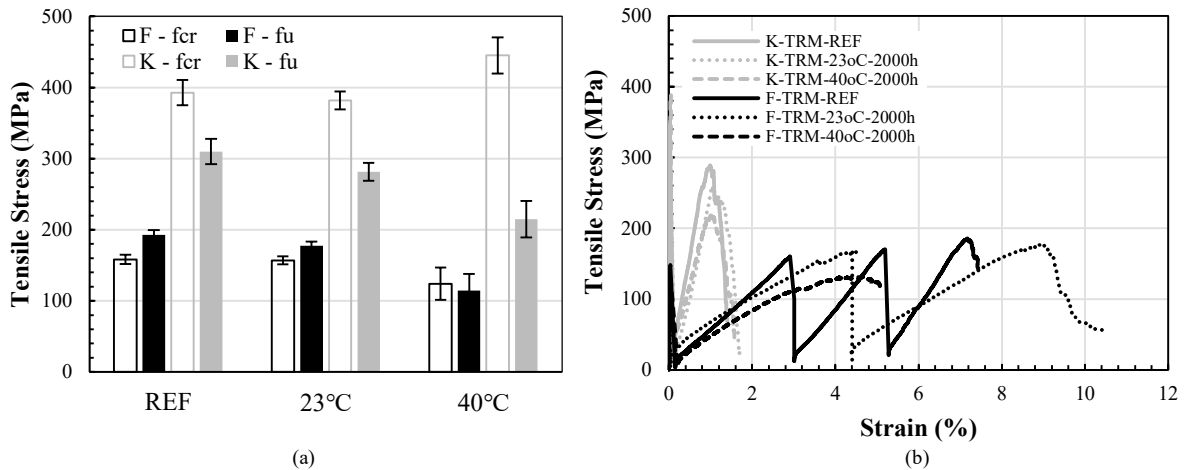
Fig. 3. (a) Cracking/ultimate strength; (b) stress-strain curves of typical K and F TRM composites textiles before and after exposure for 2000h.

Fig. 3a compares the average value of the tensile strength of TRM composites reinforced with two layers of “K” and “F” textiles, while Fig. 3b shows the tensile stress-strain response of representative TRM specimens from each system and ageing protocol. A summary of the average mechanical properties, their CoV, as well as the strength retention rate, calculated as the ratio of the ultimate strength of the TRM after exposure to that of the unconditioned TRM, are reported in Table 2.

The different ultimate strength attained by the two TRM systems can be explained upon the analysis of the associated stress-strain response (Fig. 3b). All “K”-TRM composites achieved a cracking load value higher than that of the maximum load attained during the cracked stage, with no strain hardening behaviour, exhibiting only one single crack during the test. This behaviour was observed in both unconditioned and aged composites, indicating that the reinforcement ratio in “K”-TRM composites (0,8%) was insufficient to enable stress redistribution. Failure occurred due to slippage of the yarns within the mortar in the proximity of the crack, followed by yarn rupture. For unconditioned coupons, the ultimate strength was similar to that attained by the corresponding bare “K” textiles. On the contrary, reference and conditioned “F”-TRM specimens at ambient temperature for 2000h presented the typical stages generally observed in TRM systems: i) stage I, where the stress increases linearly with the first crack formation, ii) stage II, crack development attributed to the degree of bond at the textile/mortar interface, iii) stage III, crack saturation and linear increase in stress until the peak load. The ultimate strength was immediately followed by the progressive failure of individual yarns, with unconditioned specimens showing typically more cracks than specimens conditioned at 20°C for 2000h. Stages II and III were not always distinguishable, with crack formation being accompanied by large energy release. This resulted in the limited contribution of the “F” reinforcement to the overall composite performance, and a lower exploitation of the textile strength (~67-70%) for both unconditioned and

conditioned “F”-TRM, indicating that the reinforcement ratio (1,7%) was still relatively low. This was also reported by Trochoutsou et al. (2021a) when examining flax-TRM composites of similar architecture and reinforcement ratios.

In general, and accounting for the observed variability in the cracking stress values in Table 2, accelerated ageing affected mainly the textile due the combination of moisture absorption as well as alkaline hydrolysis. Conditioning at ambient temperatures, as in the case of the bare textiles, did not affect significantly the ultimate strength ( $\leq 10\%$  after 2000h). However, a significant decrease was recorded after exposure to 40°C for 2000h, resulting in a strength retention rate similar for both TRM systems and ranging between 60-70% (Table 2). These exposure conditions also affected the crack development stage in “F”-TRM systems, and led to a composite performance with no strain hardening and absence of the crack development stage. This indicates that the significant degradation occurring in the textile resulted in a loss of stress transfer between the textile and the mortar and a further reduction of the actual reinforcement ratio, compromising the composite action. Overall, the reduction in the strength of the textile embedded in the composites as a function of the accelerated ageing was similar to that recorded for the associated bare textiles immersed in lime solution (approximately 10% for 23°C and 30-40% for 40°C), indicating the suitability of the alkaline solution to simulate the environment surrounding the textile within the composite.
