Procedia Structural Integrity 64 (2024) 1873-1879

SMAR 2024 – 7th International Conference on Smart Monitoring, Assessment and Rehabilitation of Civil Structures

## Effect of Textile Architecture on the Durability of Flax Textile-Reinforced Mortars

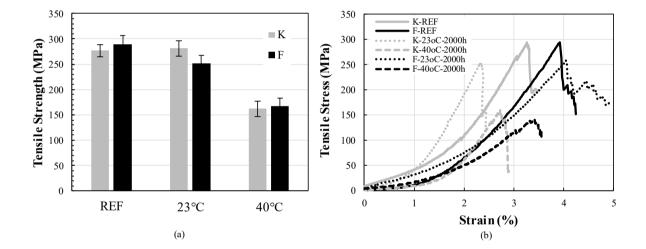
Table 1 summarises the average mechanical properties of the bare "K" and "F" textiles before and after exposure to accelerated ageing. Fig. 2a illustrates the effect of the conditioning protocol on the tensile strength, while Fig. 2b presents the tensile stress–strain curves obtained from representative textiles from each conditioning protocol.

Fig. 2. (a) Tensile strength; (b) stress-strain curves of typical K and F bare textiles before and after exposure for 2000h.

An initial inelastic behaviour followed by a linear elastic response up to the peak stress was consistently observed for both types of flax textiles. In all cases, failure occurred due to the progressive rupture of the individual yarns. Both types of unconditioned flax textiles attained similar values of strength (277 – 289 MPa) and ultimate strain (3.5-3.8%), in good agreement with those reported in previous studies (Ferrara et al., 2019).

Although exposure to 23°C for 2000h did not result in a significant change in the mechanical properties, given the observed variability, a decrease in tensile strength of up to 42% was recorded after exposure to 40°C, which accelerated the chemical reactions and the resulting degradation of the flax fibres.

Interestingly, the strength reduction was similar for both types of flax textiles. Typically, as higher linear density yarns contain more fibres, they also exhibit larger moisture absorption capacity (Alias et al., 2018). It can be surmised that the higher twist level and the presence of two-ply yarns in the "F" textile prevented the core yarns from being directly exposed to water molecules and hydration products, mitigating their overall degradation. Further work is needed to elucidate the moisture transport mechanism within the yarn cross-section as a function of its linear density.

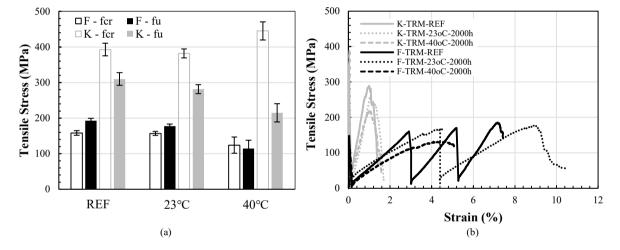
Fig. 3a compares the average value of the tensile strength of TRM composites reinforced with two layers of "K" and "F" textiles, while Fig. 3b shows the tensile stress-strain response of representative TRM specimens from each system and ageing protocol. A summary of the average mechanical properties, their CoV, as well as the strength retention rate, calculated as the ratio of the ultimate strength of the TRM after exposure to that of the unconditioned TRM, are reported in Table 2.

Fig. 3. (a) Cracking/ultimate strength; (b) stress-strain curves of typical K and F TRM composites textiles before and after exposure for 2000h.

Overall, unconditioned flax-TRM composites developed ultimate strength values ranging from 190-310 MPa, with those reinforced with "K" textiles exhibiting higher cracking stress and ultimate strength values than their "F"-TRM counterparts at the expense of deformability and ductility.

The different ultimate strength attained by the two TRM systems can be explained upon the analysis of the associated stress-strain response (Fig. 3b). All "K"-TRM composites achieved a cracking load value higher than that of the maximum load attained during the cracked stage, with no strain hardening behaviour, exhibiting only one single crack during the test. This behaviour was observed in both unconditioned and aged composites, indicating that the reinforcement ratio in "K"-TRM composites (0,8%) was insufficient to enable stress redistribution. Failure occurred due to slippage of the yarns within the mortar in the proximity of the crack, followed by yarn rupture. For unconditioned coupons, the ultimate strength was similar to that attained by the corresponding bare "K" textiles. On the contrary, reference and conditioned "F"-TRM specimens at ambient temperature for 2000h presented the typical stages generally observed in TRM systems: i) stage I, where the stress increases linearly with the first crack formation, ii) stage II, crack development attributed to the degree of bond at the textile/mortar interface, iii) stage III, crack saturation and linear increase in stress until the peak load. The ultimate strength was immediately followed by the progressive failure of individual yarns, with unconditioned specimens showing typically more cracks than specimens conditioned at 20°C for 2000h. Stages II and III were not always distinguishable, with crack formation being accompanied by large energy release. This resulted in the limited contribution of the "F" reinforcement to the overall composite performance, and a lower exploitation of the textile strength (~67-70%) for both unconditioned and

conditioned "F"-TRM, indicating that the reinforcement ratio (1,7%) was still relatively low. This was also reported by Trochoutsou et al. (2021a) when examining flax-TRM composites of similar architecture and reinforcement ratios.

In general, and accounting for the observed variability in the cracking stress values in Table 2, accelerated ageing affected mainly the textile due the combination of moisture absorption as well as alkaline hydrolysis. Conditioning at ambient temperatures, as in the case of the bare textiles, did not affect significantly the ultimate strength ( $\leq 10\%$  after 2000h). However, a significant decrease was recorded after exposure to 40°C for 2000h, resulting in a strength retention rate similar for both TRM systems and ranging between 60-70% (Table 2). These exposure conditions also affected the crack development stage in "F"-TRM systems, and led to a composite performance with no strain hardening and absence of the crack development stage. This indicates that the significant degradation occurring in the textile resulted in a loss of stress transfer between the textile and the mortar and a further reduction of the actual reinforcement ratio, compromising the composite action. Overall, the reduction in the strength of the textile embedded in the composites as a function of the accelerated ageing was similar to that recorded for the associated bare textiles immersed in lime solution (approximately 10% for 23°C and 30-40% for 40°C), indicating the suitability of the alkaline solution to simulate the environment surrounding the textile within the composite.
