Durability of flax textile-reinforced mortar systems

DURABILITY OF FLAX TEXTILE-REINFORCED MORTAR SYSTEMS

This paper presents the preliminary results of an experimental programme on the tensile performance of flax-TRM systems subjected to accelerated ageing. Composites consisting of two layers of flax textiles embedded in a lime-based mortar were conditioned in water for 1000 h and 2000 h at controlled temperatures of 23°C and 40°C. Bare textiles were also conditioned in a lime solution for the same duration and temperature conditions to assess and decouple the deterioration mechanisms at the textile and composite scale. The mechanical behaviour of both unconditioned and aged textiles and composites was characterised through uniaxial tensile tests. Based on the preliminary results of this study, the key degradation mechanisms seem to mainly involve the textile reinforcement. The tested FTRM systems exhibited a strength retention of approximately 86% after an exposure time of 1000 h. However, when exposure time increased to 2000 h, a retention rate of only 60% was achieved.

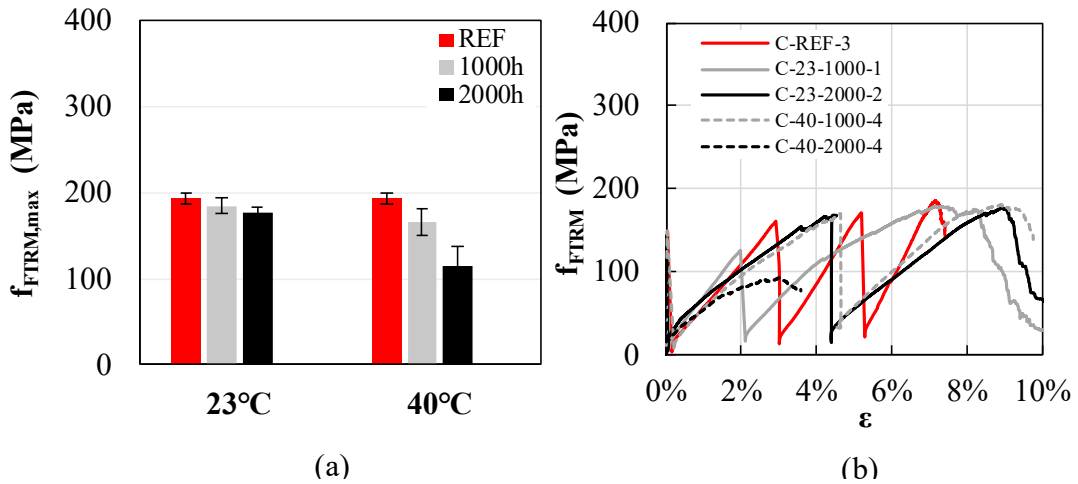
Figure 3. (a) Tensile strength of FTRM composites versus temperature and exposure duration; (b) typical tensile stress-strain of representative specimens from each conditioning protocol

The results of the tensile tests on the FTRM coupons are summarised in Table 3 in terms of average maximum strength at cracking, f_{cr} , and at failure, $f_{FTRM,max}$, corresponding strains, ϵ_{cr} and $\epsilon_{FTRM,max}$, exploitation ratio of the textile, $\eta = f_{FTRM,max}/f_{t,max}$, and strength retention ($f_{FTRM,max}/f_{FTRM,max(REF)}$). The stress was calculated by dividing the load by the cross-sectional area of the textile (accounting for two layers of reinforcement), while the exploitation ratio was calculated as the ratio of the maximum strength developed by the FTRM composite to that developed by the bare textile exposed to the same environment. Figure 3a compares the average values of $f_{FTRM,max}$, while Figure 3b shows the tensile stress-strain response of representative composites subjected to the examined conditioning protocols.

In general, accelerated ageing resulted in a loss of tensile strength, which was minimal after exposure to 23°C ($\leq -10\%$ after 2000 h) and more significant after exposure to 40°C, (-40% after 2000 h). Regardless of the conditioning protocol, all specimens failed due to fibre rupture after distinct large cracks were formed in the composites. However, the different exposure conditions affected the crack development stage, with conditioned specimens being characterised by the development of two major cracks, typically close to the gripping tabs, which widened significantly during the test. Exposure to harsher environments (40°C, 2000 h) led to a composite performance with no strain hardening and absence of the crack development stage, indicating that the significant degradation occurring in the fibres, also evidenced by the reduction in the ultimate tensile strength of the composite, resulted in a further reduction of the actual reinforcement ratio.
