Durability of flax textile-reinforced mortar systems

Durability of flax textile-reinforced mortar systems / Trochoutsou, N.; Baldassari, M.; Monaco, A.; Cornetti, P.; Guadagnini, M. - ELETTRONICO. - (2024). ( Sixth International Conference on Sustainable Construction Materials and Technologies (SCMT6) Lyon (France) 9-14 June 2024) [10.18552/2024/SCMT/327].

## **DURABILITY OF FLAX TEXTILE-REINFORCED MORTAR SYSTEMS**

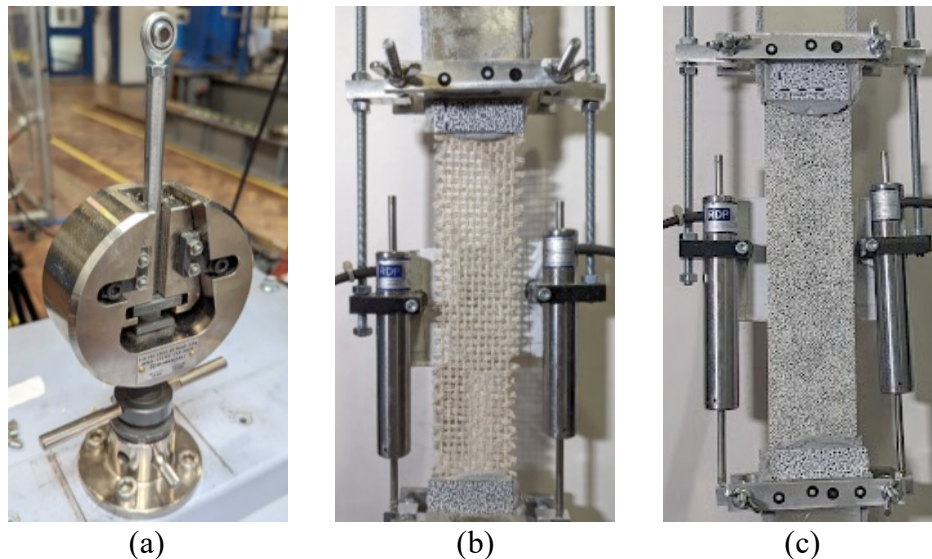
An overview of the experimental setup is presented in Figure 1. Displacements were recorded by both contact and non-contact instrumentation. Two LVDTs were placed on opposite sides of the specimens and recorded uniaxial deformation. In addition, a bespoke 2D Digital Image Correlation (2D-DIC) setup was employed to obtain full-field displacement measurements of both textiles and FTRM composites. Detailed results from DIC analyses will be presented in future publications.

Figure 1. (a) Spherical joint of the clevis grips; (b) setup for textiles; (c) setup for FTRM composites.

Direct tensile tests were performed on bare textiles and FTRM composites following the EAD 340275-00-0104 (EOTA, 2020). The tests were carried out in displacement control in a universal testing machine of 10 kN capacity, at a displacement rate of 0.5 mm/min for the bare textile and 0.2 mm/min for the composites. The load was transferred through clevis-type grips, allowing for in- and out-of-plane rotation of the specimens while being loaded (Figure 1a).

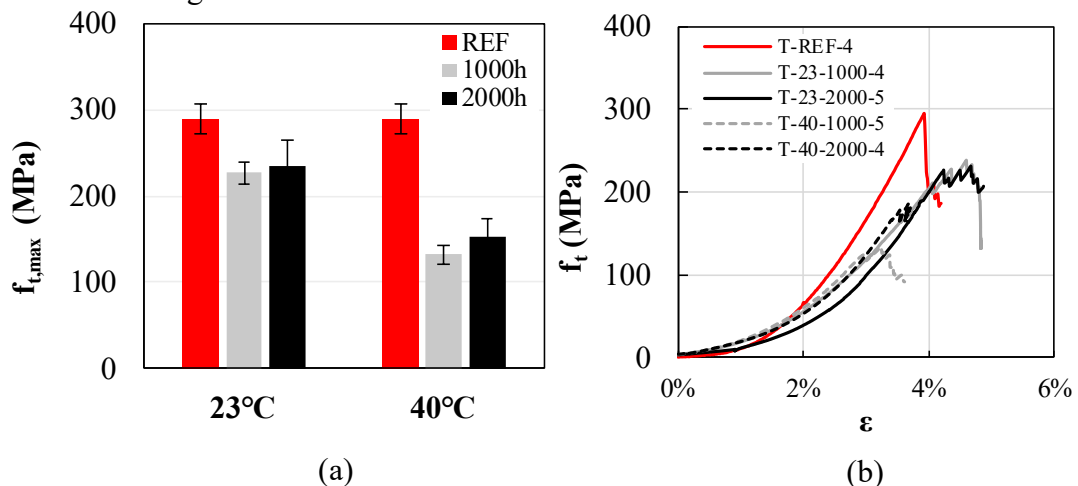
modulus was calculated as the secant modulus of the linear part in the stress–strain response curve to allow the characterisation of the largest stiffness that can be developed. The tensile strengths developed in the textiles after each conditioning protocol, along with the associated standard deviation values, are compared in Figure 2a, while the tensile stress-strain response of representative textiles from each conditioning protocol is shown in Figure 2b.

Figure 2. (a) Textile strength versus temperature and exposure duration; (b) typical tensile stress-strain of representative specimens from each conditioning protocol.

The response of the textiles was characterised by an initial inelastic branch followed by linear behaviour up to the peak stress and a softening stage resulting from the progressive failure of individual yarns. The unconditioned textiles developed strength values in good agreement with those reported in previous studies on similar flax textiles (Ferrara *et al.* 2019).

However, when subjected to 23°C and 40°C for 1000 h, flax textiles suffered a reduction in tensile strength and stiffness of about 22-24% and 50-54%, respectively. This is probably due to the combined effect of anisotropic swelling of the flax fibre multi-stack structure during immersion (Le Duigou *et al.* 2015), and the progressive alkaline hydrolysis of the chemical components of the fibre cell-walls (Wei and Meyer, 2015), which was accelerated under higher temperatures. Longer exposure durations did not seem to result in any further deterioration in the mechanical properties, taking into account the reported variability in Table 2 and illustrated in Figure 2a.

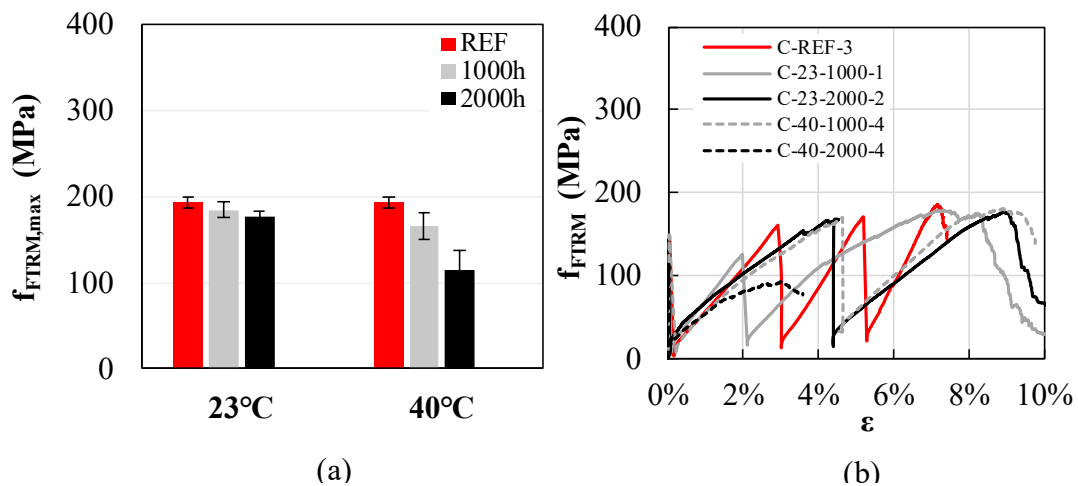
The results of the tensile tests on the FTRM coupons are summarised in Table 3 in terms of average maximum strength at cracking,  $f_{cr}$ , and at failure,  $f_{FTRM,max}$ , corresponding strains,  $\epsilon_{cr}$  and  $\epsilon_{FTRM,max}$ , exploitation ratio of the textile,  $\eta = f_{FTRM,max}/f_{t,max}$ , and strength retention ( $f_{FTRM,max}/f_{FTRM,max(REF)}$ ). The stress was calculated by dividing the load by the cross-sectional area of the textile (accounting for two layers of reinforcement), while the exploitation ratio was calculated as the ratio of the maximum strength developed by the FTRM composite to that developed by the bare textile exposed to the same environment. Figure 3a compares the average values of  $f_{FTRM,max}$ , while Figure 3b shows the tensile stress-strain response of representative composites subjected to the examined conditioning protocols.

Figure 3. (a) Tensile strength of FTRM composites versus temperature and exposure duration; (b) typical tensile stress-strain of representative specimens from each conditioning protocol

The three stages characterising the typical tensile response of TRM systems (Arboleda *et al.* 2016) were identified in all tested unconditioned FTRM composites, with failure following the formation of the last crack and occurring due to progressive yarn rupture, which triggered the initiation of a softening stage, as also observed in the tests on the textile specimens. Hence, the cracked stiffness could not be evaluated. The formation of large discrete cracks (typically three to four) was accompanied by a high energy release, and the absence of a clear stabilised cracking stage indicated that the provided reinforcement ratio (1.73%), although higher than the critical (Trochoutsou *et al.* 2021a), was still relatively low.

In general, accelerated ageing resulted in a loss of tensile strength, which was minimal after exposure to 23°C ( $\leq -10\%$  after 2000 h) and more significant after exposure to 40°C, ( $-40\%$  after 2000 h). Regardless of the conditioning protocol, all specimens failed due to fibre rupture after distinct large cracks were formed in the composites. However, the different exposure conditions affected the crack development stage, with conditioned specimens being characterised by the development of two major cracks, typically close to the gripping tabs, which widened significantly during the test. Exposure to harsher environments (40°C, 2000 h) led to a composite performance with no strain hardening and absence of the crack development stage, indicating that the significant degradation occurring in the fibres, also evidenced by the reduction in the ultimate tensile strength of the composite, resulted in a further reduction of the actual reinforcement ratio.
