Durability of flax textile-reinforced mortar systems

Durability of flax textile-reinforced mortar systems / Trochoutsou, N.; Baldassari, M.; Monaco, A.; Cornetti, P.; Guadagnini, M. - ELETTRONICO. - (2024). (Sixth International Conference on Sustainable Construction Materials and Technologies (SCMT6) Lyon (France) 9-14 June 2024) [10.18552/2024/SCMT/327].

DURABILITY OF FLAX TEXTILE-REINFORCED MORTAR SYSTEMS

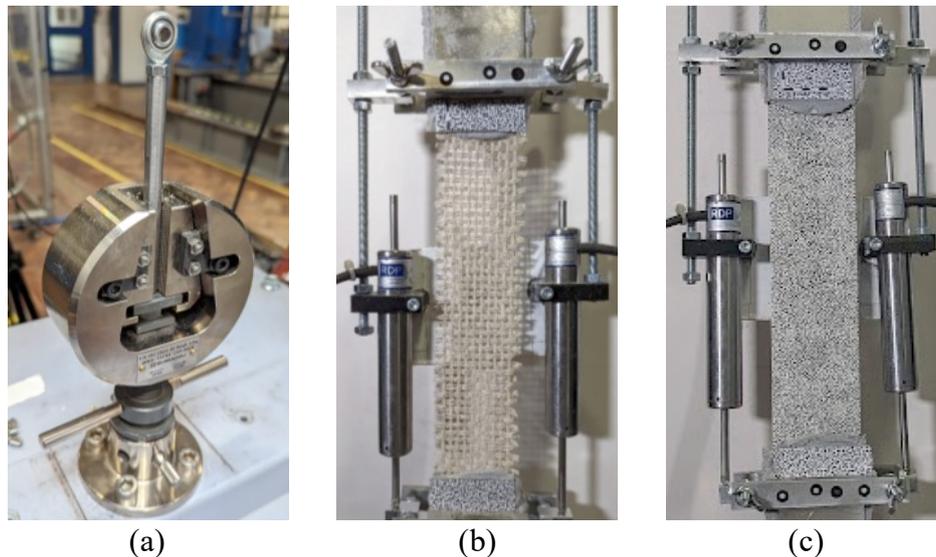
An overview of the experimental setup is presented in Figure 1. Displacements were recorded by both contact and non-contact instrumentation. Two LVDTs were placed on opposite sides of the specimens and recorded uniaxial deformation. In addition, a bespoke 2D Digital Image Correlation (2D-DIC) setup was employed to obtain full-field displacement measurements of both textiles and FTRM composites. Detailed results from DIC analyses will be presented in future publications.

Figure 1. (a) Spherical joint of the clevis grips; (b) setup for textiles; (c) setup for FTRM composites.

Direct tensile tests were performed on bare textiles and FTRM composites following the EAD 340275-00-0104 (EOTA, 2020). The tests were carried out in displacement control in a universal testing machine of 10 kN capacity, at a displacement rate of 0.5 mm/min for the bare textile and 0.2 mm/min for the composites. The load was transferred through clevis-type grips, allowing for in- and out-of-plane rotation of the specimens while being loaded (Figure 1a).

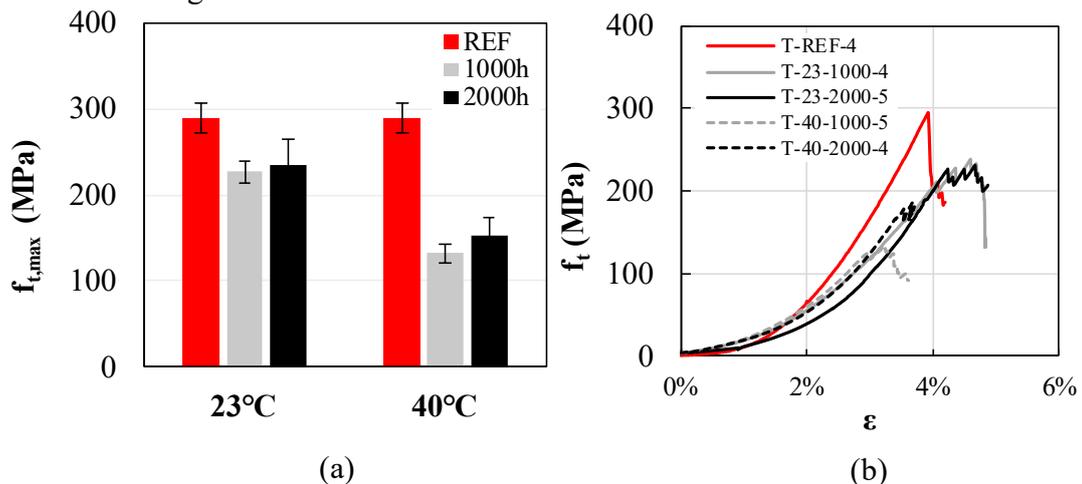
The response of the textiles was characterised by an initial inelastic branch followed by linear behaviour up to the peak stress and a softening stage resulting from the progressive failure of individual yarns. The unconditioned textiles developed strength values in good agreement with those reported in previous studies on similar flax textiles (Ferrara *et al.* 2019).

However, when subjected to 23°C and 40°C for 1000 h, flax textiles suffered a reduction in tensile strength and stiffness of about 22-24% and 50-54%, respectively. This is probably due to the combined effect of anisotropic swelling of the flax fibre multi-stack structure during immersion (Le Duigou *et al.* 2015), and the progressive alkaline hydrolysis of the chemical components of the fibre cell-walls (Wei and Meyer, 2015), which was accelerated under higher temperatures. Longer exposure durations did not seem to result in any further deterioration in the mechanical properties, taking into account the reported variability in Table 2 and illustrated in Figure 2a.

Figure 2. (a) Textile strength versus temperature and exposure duration; (b) typical tensile stress-strain of representative specimens from each conditioning protocol.

modulus was calculated as the secant modulus of the linear part in the stress–strain response curve to allow the characterisation of the largest stiffness that can be developed. The tensile strengths developed in the textiles after each conditioning protocol, along with the associated standard deviation values, are compared in Figure 2a, while the tensile stress-strain response of representative textiles from each conditioning protocol is shown in Figure 2b.

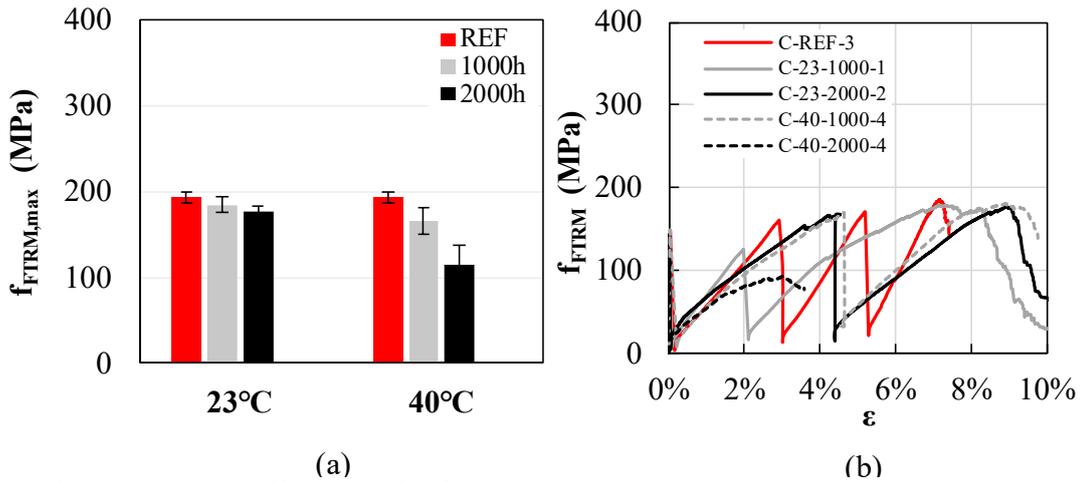
The three stages characterising the typical tensile response of TRM systems (Arboleda *et al.* 2016) were identified in all tested unconditioned FTRM composites, with failure following the formation of the last crack and occurring due to progressive yarn rupture, which triggered the initiation of a softening stage, as also observed in the tests on the textile specimens. Hence, the cracked stiffness could not be evaluated. The formation of large discrete cracks (typically three to four) was accompanied by a high energy release, and the absence of a clear stabilised cracking stage indicated that the provided reinforcement ratio (1.73%), although higher than the critical (Trochoutsou *et al.* 2021a), was still relatively low.

Figure 3. (a) Tensile strength of FTRM composites versus temperature and exposure duration; (b) typical tensile stress-strain of representative specimens from each conditioning protocol

In general, accelerated ageing resulted in a loss of tensile strength, which was minimal after exposure to 23°C ($\leq -10\%$ after 2000 h) and more significant after exposure to 40°C, (-40% after 2000 h). Regardless of the conditioning protocol, all specimens failed due to fibre rupture after distinct large cracks were formed in the composites. However, the different exposure conditions affected the crack development stage, with conditioned specimens being characterised by the development of two major cracks, typically close to the gripping tabs, which widened significantly during the test. Exposure to harsher environments (40°C, 2000 h) led to a composite performance with no strain hardening and absence of the crack development stage, indicating that the significant degradation occurring in the fibres, also evidenced by the reduction in the ultimate tensile strength of the composite, resulted in a further reduction of the actual reinforcement ratio.

The results of the tensile tests on the FTRM coupons are summarised in Table 3 in terms of average maximum strength at cracking, f_{cr} , and at failure, $f_{FTRM,max}$, corresponding strains, ϵ_{cr} and $\epsilon_{FTRM,max}$, exploitation ratio of the textile, $\eta = f_{FTRM,max}/f_{t,max}$, and strength retention ($f_{FTRM,max}/f_{FTRM,max(REF)}$). The stress was calculated by dividing the load by the cross-sectional area of the textile (accounting for two layers of reinforcement), while the exploitation ratio was calculated as the ratio of the maximum strength developed by the FTRM composite to that developed by the bare textile exposed to the same environment. Figure 3a compares the average values of $f_{FTRM,max}$, while Figure 3b shows the tensile stress-strain response of representative composites subjected to the examined conditioning protocols.
