Tensile behavior of flax textile reinforced lime-mortar: Influence of reinforcement amount and textile impregnation

Tensile behavior of flax textile reinforced lime-mortar: Influence of reinforcement amount and textile impregnation / Ferrara, Giuseppe; Pepe, Marco; Martinelli, Enzo; Tolêdo Filho, Romildo Dias. - In: CEMENT & CONCRETE COMPOSITES. - ISSN 0958-9465. - 119:(2021). [10.1016/j.cemconcomp.2021.103984]

6 *In this context, this paper investigates the mechanical properties of a Textile-Reinforced Mortar (TRM)*
7 *system produced with Flax textile embedded within a hydraulic lime-based mortar. The research aims at*
8 *revealing the influence of either the reinforcement amount and the applied pre-treatment of the textile on the*
9 *resulting tensile response and the cracking patterns exhibited by these TRM systems. The analysis of the results*
10 *presented herein allows to have a comprehensive overview of the feasibility of using flax textiles for*
11 *strengthening a retrofitting of existing structures.*

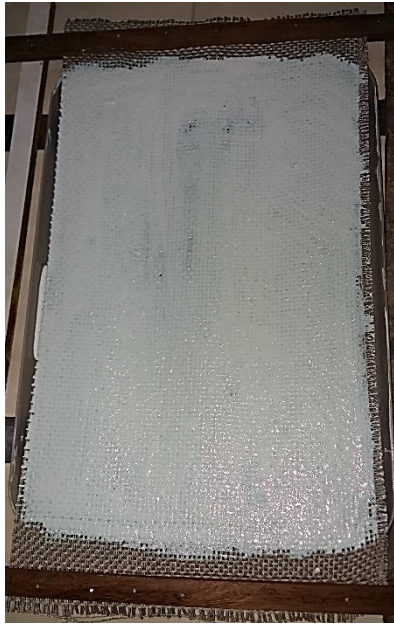
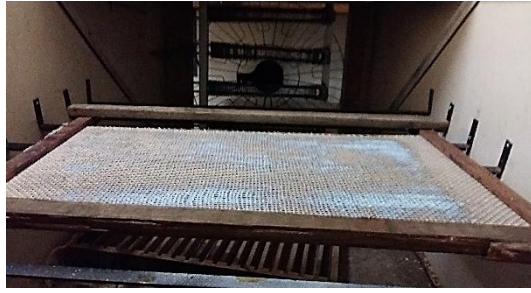
1 **Figure 2.** *Textile impregnation treatment: (a) polymer coating application, (b) drying of the textile*
2 *and (c) impregnated flax strip.*

18 In the present research, the impregnation treatment was based on applying a polymer coating
19 on the flax textile. Specifically, the coating substance (XSBR Latex, commercial name “NTL-218”
20 produced by Nitriflex [42]) consisted in an aqueous solution with a *styrene-butadiene* polymer
21 characterized by a solid content of 49 ± 1 % of weight, a pH of 9 ± 0.5 and a viscosity of 50-350
22 mPas. The *styrene butadiene* polymer was adopted since beneficial effects were observed, both in
23 terms of tensile strength and bond adherence with the matrix, when applied on plant fibers filaments
24 [39]. The treatment was carried out by brushing the substance on flax fabric portions of 350 x 600
25 mm² (**Figure 2a**). During the treatment, the textile was arranged in wood frames to guarantee a correct

1 tensioning of the yarns. The flax textile portions were treated at ambient temperature conditions
2 (**Figure 2b**) then released of the excess liquid and dried in a ventilated chamber for 24h at a controlled
3 temperature of 38 ± 2 °C and with a wind velocity of 0.5 m/s. Finally, impregnated flax strips (60
4 mm large) were cut from the treated textile (**Figure 2c**).

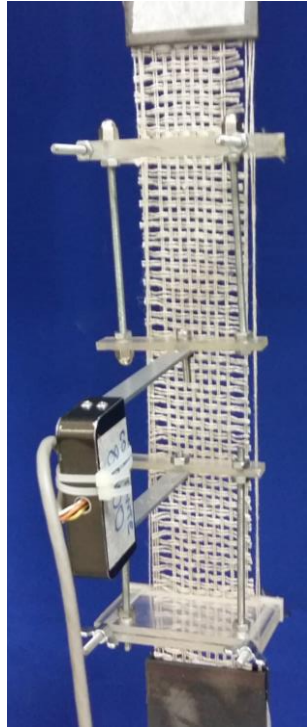
Figure 3. *Tensile test set-up for Flax Textile.*

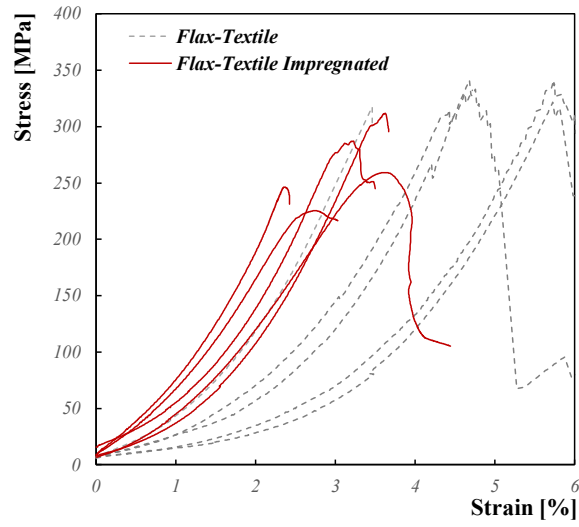
Figure 6. Stress-strain response of *Flax-Textile* and *Impregnated Flax-Textile strips*.

9 The curves shown in **Figure 6** highlight that the tensile response of both *Flax-Textile* and
10 *Impregnated Flax-Textile* strips can be divided into two different stages: a first branch in which high
11 deformation is registered and a subsequent more rigid and quasi-linear branch up to failure.

12 The untreated *Flax Textile* strips show a first branch with a significantly low stiffness increasing
13 up to a quasi-linear response before failure (grey curves in **Figure 6**). The high deformability of the
14 strips at low strain level can be attributed to the peculiar geometric arrangement of the fabric. In fact,
15 the textile is made of yarns comprising several flax filaments that are randomly distributed within the
16 section, with some of them not oriented in the direction of tensile stresses: they need an initial
17 displacement to be stretched and start contributing to the axial stiffness. Moreover, the textile strip
18 includes 24 yarns that are, unavoidably, not uniformly subjected to the same stress level, with a
19 consequent heterogeneous distribution of the tensile stresses among the bundle. The failure mode is
20 characterized by a progressive rupture of the flax yarns, occurring for each one in a random section

22 Similarly, the *Impregnated Flax-Textile* strips also show a first stage in which the stiffness is
23 lower than the quasi-linear branch up to failure of the textile. However, the initial stiffness is slightly
24 higher than the one observed for untreated textiles. This is certainly due to the beneficial effect of the
25 coating treatment: on the one hand, the stretching of the textile during the impregnation

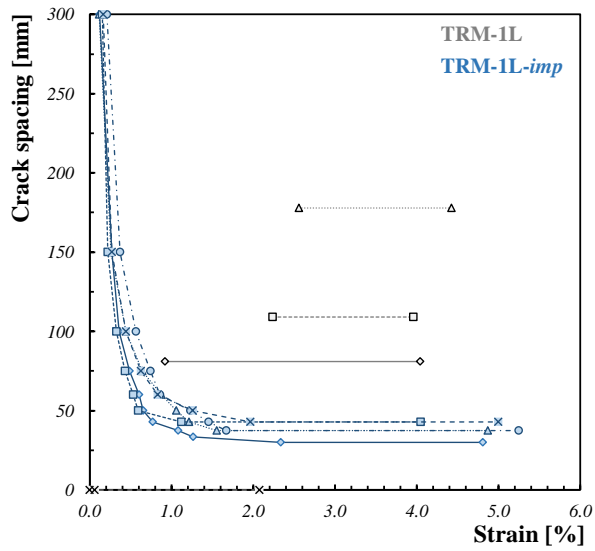
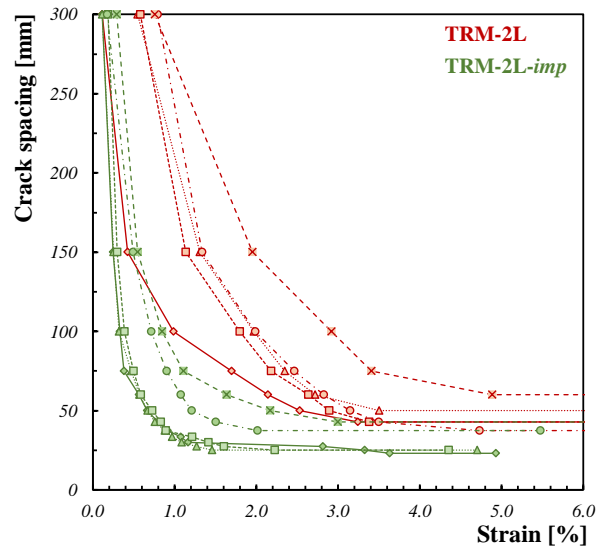
1 **Figure 12.** Crack spacing vs strain curves for (a) Flax TRM-1L & Flax TRM-1L-imp and (b) Flax
 2 TRM-2L & Flax TRM-2L series.
 3

22 Significant differences are observed in terms of crack developments between the two series of
23 TRM with 1 textile layer (**Figure 12a**). *TRM-1L* specimens are characterized by the formation of
24 either one or two cracks, while *TRM-1L-imp* specimens are characterized by a well-defined *Stage II*
25 in which several cracks develop. Moreover, the load drop corresponding to the occurrence of a crack

1 is far less significant in the *TRM-1L-imp* specimens than those of the reference series. **Figure 12a**
2 clearly shows this different behavior. Due to the development of several cracks developed at lower
3 strain values, the average crack spacing of *TRM-1L-imp* specimens steeply decreases when compared
4 to that of the *TRM-1L* specimens. This aspect, together with a less significant drop in load
5 corresponding to each crack occurrence, makes the *TRM-1L-imp* specimens behaving more
6 efficiently as a composite system when compared to the *TRM-1L* specimens in which the tensile
7 response seems to be alternatively exhibited by either the textile or the matrix, rather than by the
8 entire composite system.

9 The analysis of the crack pattern presented in **Figure 12b** also emphasizes the lower
10 deformability of the *TRM-2L-imp* composites. The group of curves representing the crack spacing as
11 a function of the axial strain, concerning the *TRM-2L-imp* series are characterized by a steeper trend
12 with a closer crack spacing, indicating the higher number of cracks developed. Also, the use of the
13 impregnated textile leads to developing a denser crack pattern (**Figure 10**), which occurs at lower
14 strain values, anticipating the beginning of the *Stage III*, in which the composite is supposed to
15 contribute to the strength of the reinforced structural element.

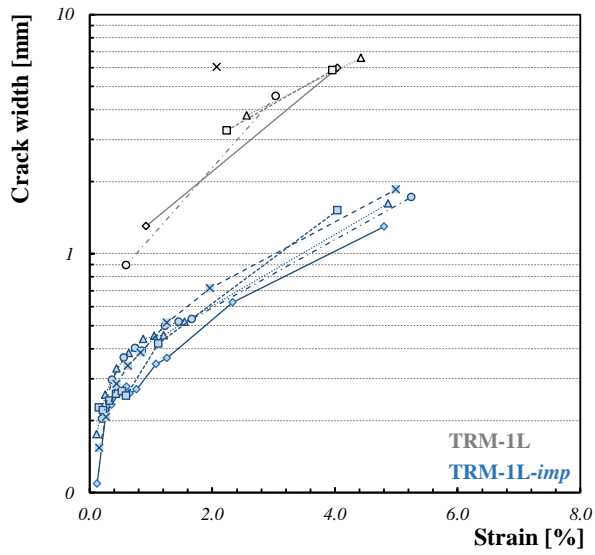
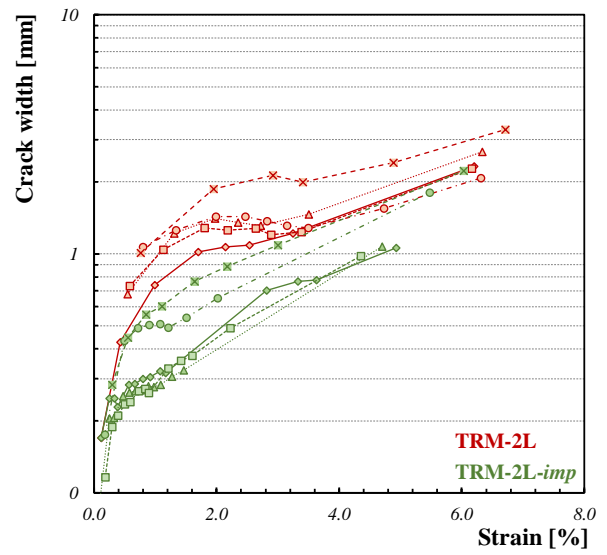
1 **Figure 14.** Crack width vs strain curves for (a) Flax TRM-1L & Flax TRM-1L-imp and (b) Flax
 2 TRM-2L & Flax TRM-2L series.
 3

9 **Figure 14** reports the curves obtained by eq. (1) for each specimen as a function of the
 10 corresponding axial strain. The crack width of the *TRM-1L-imp* specimens is much lower than that
 11 exhibited by the *TRM-1L* specimens (**Figure 14a**). This is due to the lower deformability of the
 12 impregnated textile, and to the development of a higher number of cracks. The curves plotted in
 13 **Figure 14b** for the *TRM-2L* and *TRM-2L-imp*, yet emphasizing a variability in the results concerning
 14 the two series, show that the group of specimens in which the impregnated textile was adopted are
 15 characterized by crack openings lower than those exhibited by the *TRM-2L* specimens. It is worth to
 16 mention that although the two series of specimens failed in *mode A*, a significantly beneficial effect
 17 was provided in terms of crack opening by adopting the impregnated textile.
