Bridges monitoring and assessment using an integrated bim methodology

D. Rodriguez Polania¹ · F. Tondolo¹ · A. Osello¹ · M. Piras² · V. Di Pietra² · N. Grasso²

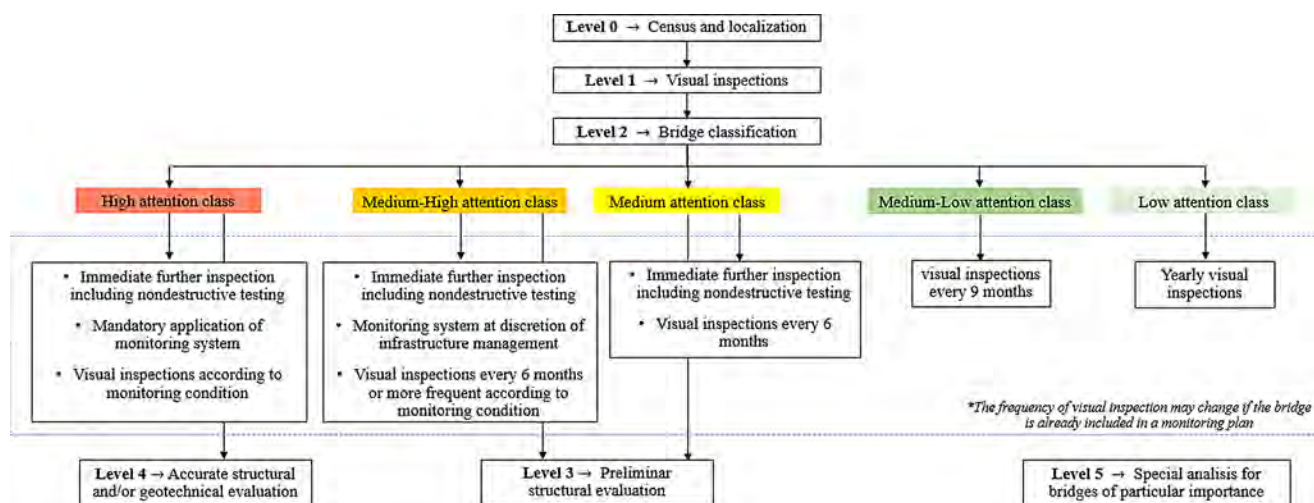
**Fig. 1** Decision-making procedure for bridge assessment described in the Italian guidelines in 2020 for bridge risk evaluation, classification, and monitoring

explanation of the level of analysis can be seen in Table 1 while the decision-making process proposed by the guidelines can be seen in Fig. 1. All bridges in the Italian network are subject to levels 0, 1, and 2; however, the complexity of further analyses depends on the bridge classification—termed “Attention Class”—assigned at level 2. Notably, as demonstrated in Fig. 1, the sequence of analyses after classification at level 2 is not necessarily linear. For example, a bridge may advance directly from level 2 to level 4 without undergoing the intermediate levels of analysis.

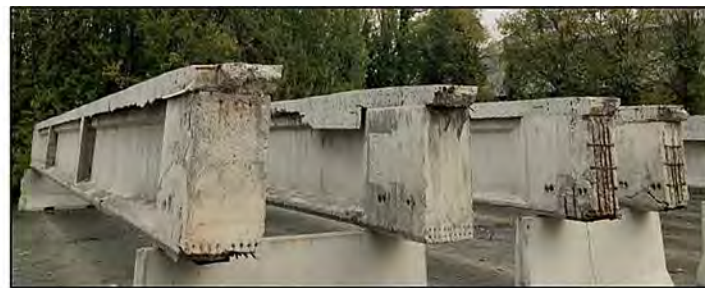
Fig. 4 (a) Dismantled beams collected in the inspection site. (b) Example of inspection sheet produced after the inspection procedure in an I-shaped beam element

An initial inspection phase was conducted for all elements, resulting in a unique damage sheet for each beam. This damage sheet includes photographs and a CAD drawing of each planar face of the beam, with the respective damage accurately marked. The defects surveyed during this inspection for the selected I-shaped beam are detailed in Table 2, while an example of the damage sheets produced during the inspection phase is shown in Fig. 4b.

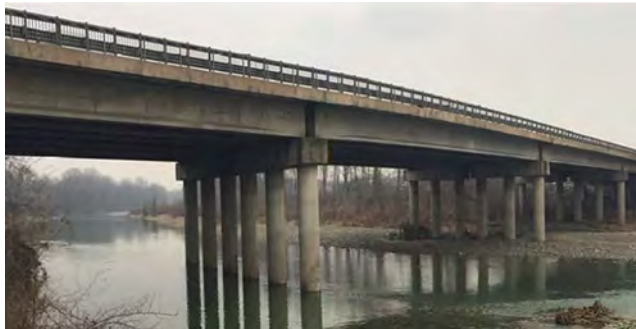
Fig. 5 Photograph of the first 3 spans of the Stura river bridge (Turin-Caselle direction)

0.175 m concrete deck. The longitudinal beams rest on rubber supports above prestressed pier caps located atop three piers of variable height. The superstructure of each bridge features a cross-section accommodating a double lane for a single direction of travel, equipped with a barrier system at the ends corresponding to a steel parapet (Fig. 5).

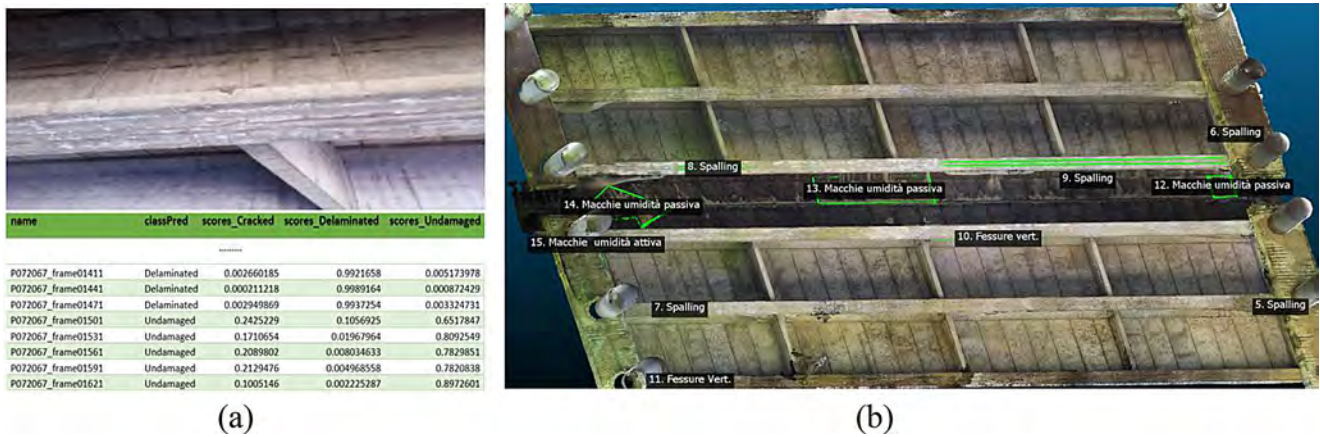
Fig. 9 (a) Example of an input image used for CNN analysis, along with the defect classification scores generated by the network. (b) Mesh model during the visual inspection process, showing isolated defects and areas of defect marked for defects of greater extent

To avoid the interoperability issues of having a no-colored block in the BIM platform it was decided to avoid the mesh passage to BIM software and produce a double model for the bridge database: One for visualization purposes (the mesh-model) and one for data collection (BIM model). This decision implies that the damage inspection is performed directly in *CloudCompare* software, and it is later transferred into a BIM model (a simple parametric model of the bridge created on a previous work). *CloudCompare* allows the insertion of points and polylines that can only be assigned ID information; therefore, the characterization of the defect in terms of extension, intensity and criticality is not possible. Consequently, this type of information needs to be added in the BIM platform during the communication phase between software. The intrados of the bridge was visually inspected supported by the application of a convolutional neural network (CNN) for automatic classification of damage developed by Savino and Tondolo [50] (Fig. 9).

where a pretrained GoogLeNet network was used to classify the model images into three classes: “undamaged”, “cracked”, and “delaminated”. As an output, the network generates a score for each image, indicating the probability the image belongs to a particular class. Details concerning the network training parameters (learning rate, batch size, number of epochs, accuracy) are found in the original publication [50].

The network analyzed the drone and 360 laser scanner images used to create the mesh model, validating defect recognition and minimizing potential human errors. For other defect types not addressed by the CNN, a visual inspection of the model was performed. Markers were added to the model using *point picking* tool for single isolated defects, while the *polyline* tool was used to delineate defects spanning larger areas. A summary of the identified defects is shown in Table 4. Additionally, a text file including the defect name as well as its coordinates (area coordinates for the defects of large extent) was also obtained as an output.
