Development of a Large Database of Italian Bridge Bearings: Preliminary Analysis of Collected Data and Typical Defects

Abstract: This paper presents the development and analysis of a bridge bearing database consistent with the 2020 Italian Guidelines (LG2020), currently enforced by the Italian law for risk classification and management of existing bridges. The database was developed by putting together the contribution of 24 research teams from 18 Italian universities in the framework of a research project foreseen by the agreement between the High Council of Public Works (CSLP, part of the Italian Ministry of Transportation) and the research consortium ReLUIIS (Network of Italian Earthquake and Structural Engineering University Laboratories). This research project aimed to apply LG2020 to a set of about 600 bridges distributed across the Italian country, in order to find possible issues and propose modifications and integrations. The database includes almost 12,000 bearing defect forms related to a portfolio of 255 existing bridges located across the entire country. This paper reports a preliminary analysis of the dataset to provide an overview of the bearings installed in a sign

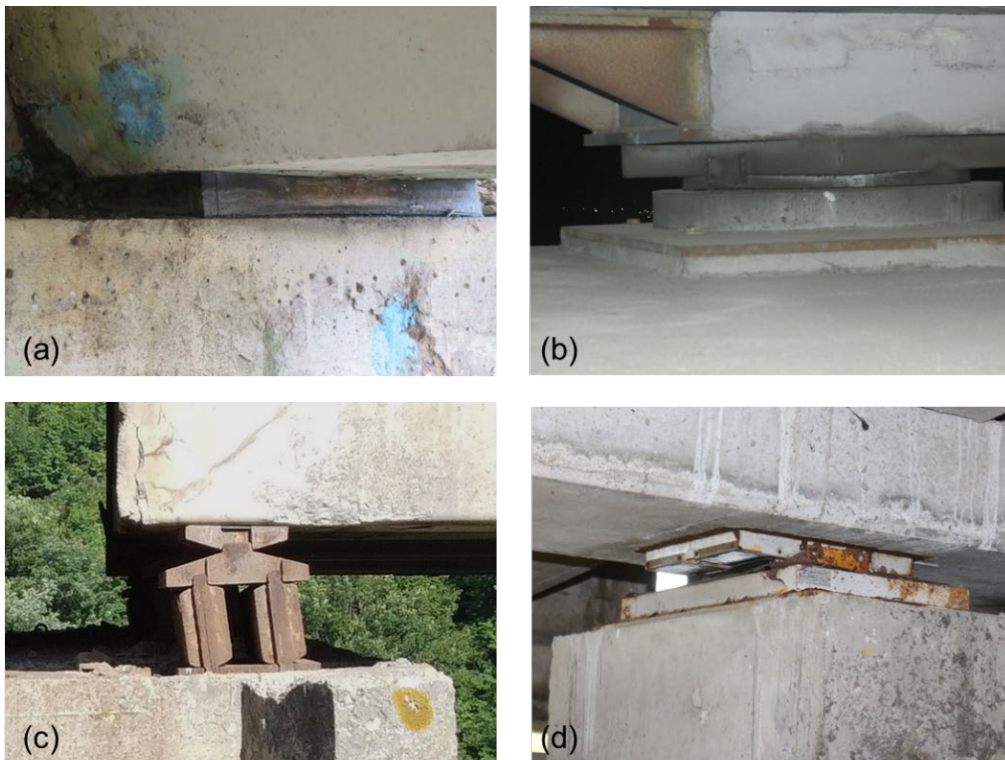
Figure 2. (a) Elastomeric, (b) pot, (c) steel, and (d) steel–Teflon bearings in inspected bridges.

Figure 2 shows some samples of bearings photographed during the inspections on the bridge subjects of this project. Figure 2a is related to a laminated elastomeric bearing

with light degradation signs on a vertical surface; Figure 2b represents a pot bearing with no visible degradation; and Figure 2c shows a heavily corroded steel roller installed in a half-joint belonging to a Gerber bridge. Lastly, Figure 2d depicts a recently installed bearing with planar multidirectional steel–Teflon surfaces.

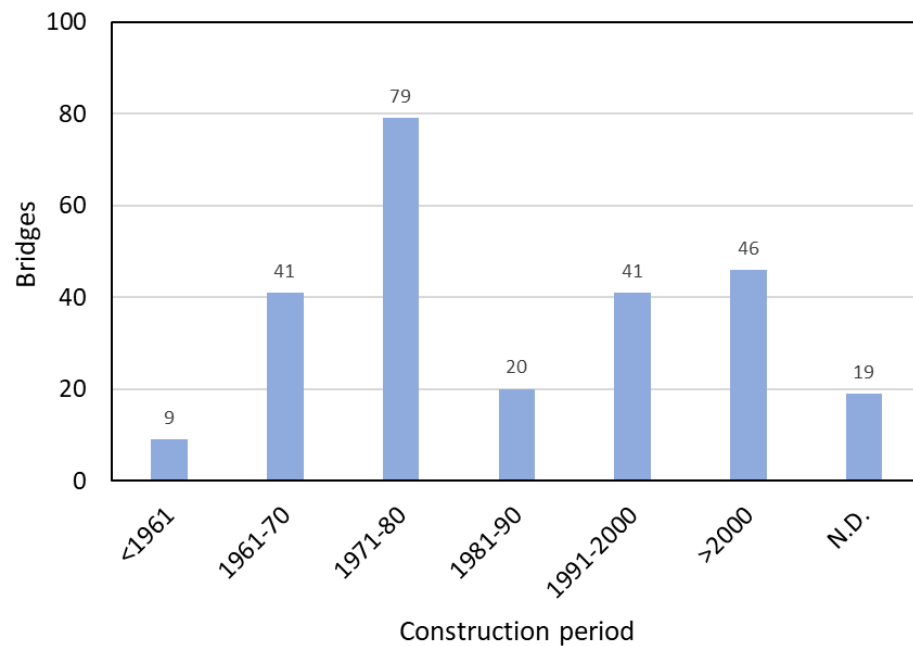
Figure 6. Distribution of bridges by construction period.

Regarding the construction periods, Figure 6 shows the distribution across the periods from pre-1961 to post-2000. Most bridges were constructed in the period 1971–80 (79 structures) while 1961–70, and from 1991 onwards, present almost the same number of bridges, around 40. The least covered periods are <1961 and 1981–90. There is also a share of bridges lacking this information (19 structures identified as N.D.). This means that for some bridges, due to the poor availability of design documents, even a basic piece of information like the construction period is missing. This aspect can impair the bridge knowledge necessary for detailed assessment activities and intervention planning necessary for effective bridge management. However, it is assumed that the age of the bearings is the same as that of the bridge they belong to, since some of the bridges may have undergone bearing replacement interventions, which are beyond our current knowledge.

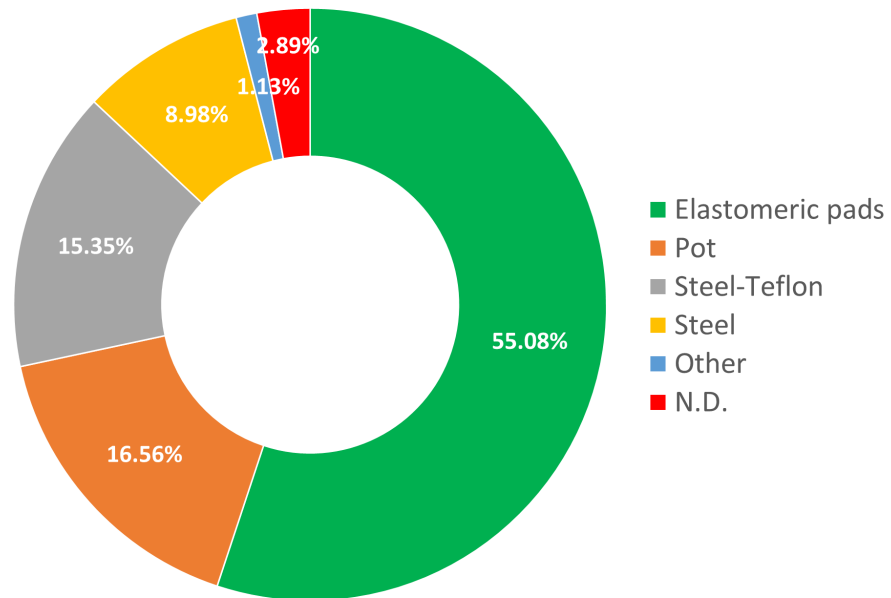
Figure 7. Typological distribution of bearings in database.

Figure 7 shows the percentage presence of each type of bearings within the available database. Out of the 11,984 bearings, 55.0% are elastomeric pads (plain or reinforced), 15.35% feature steel–Teflon surfaces, 16.56% are pot bearings (confined elastomeric disks), and 8.98% are entirely steel. In a few cases, seismic isolators or other types of bearing are installed (e.g., reinforced concrete pendulums). These latter are classified as “other” and represent 1.13% of the total. Moreover, 2.89% are bearings for which the typology is not identified (N.D. in Figure 7).

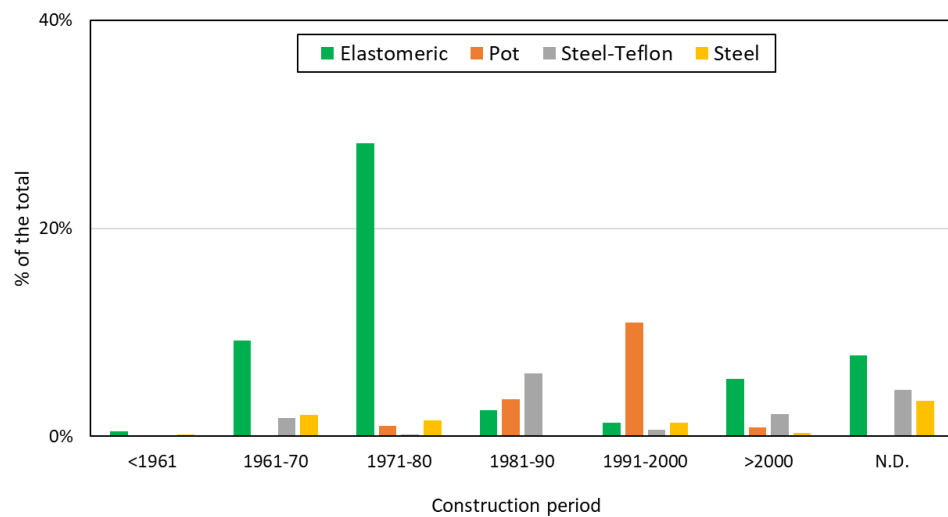
Figure 8. Percentages of bearing types by bridge construction period.

As shown in Figure 8, the ease of installation of elastomeric pads made them the preferred ones for bridges built before 1980, although they were used also after that period. The use of pot bearings started in the 1970s but had a wider diffusion after 1980. It is well-known that steel bearings were the first used in bridge applications, and based on this database analysis, were mostly used before 1980, even though they are also present in bridges built after 1990. However, they have a significant share with the unknown construction period that could be likely attributed to earlier periods (e.g., <1970). Steel-Teflon bearings, although present before 1970, were widely used after 1980.

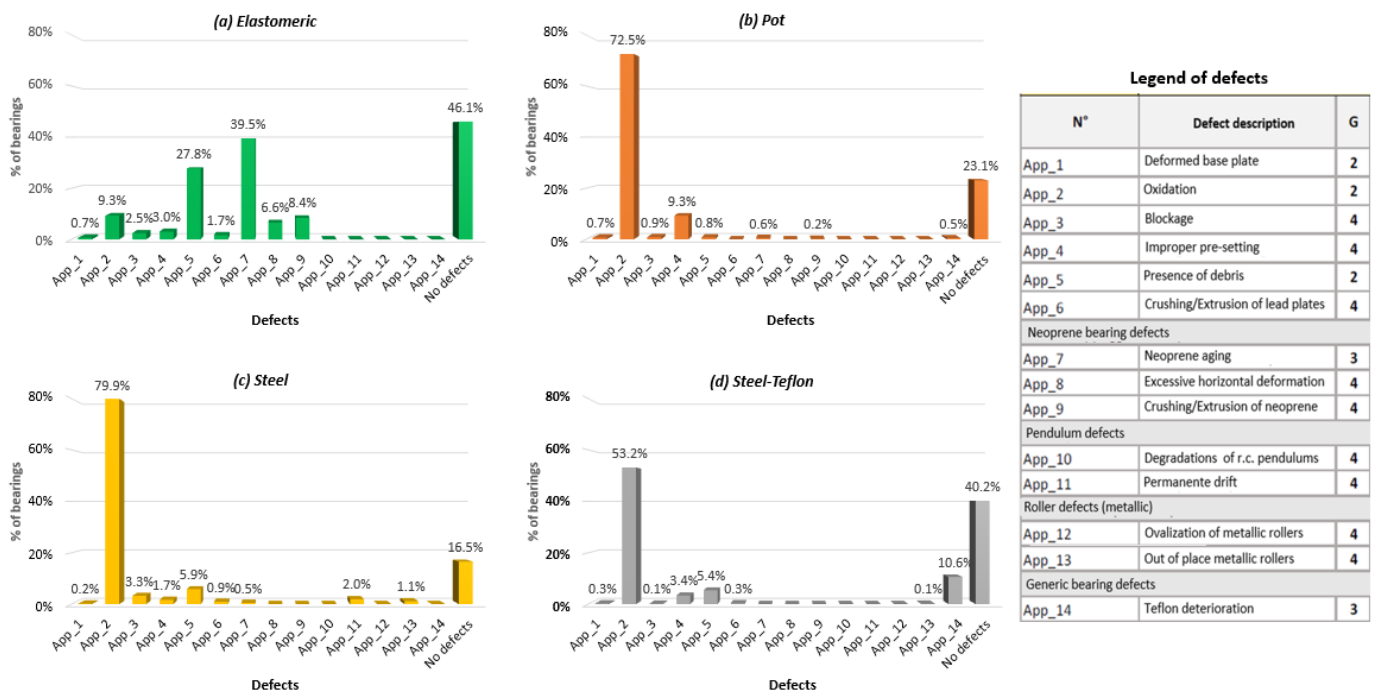
Figure 10. Defect incidence by bearing type.

For elastomeric bearings (Figure 10a), the most frequent defect is App_7 (neoprene aging, related to surface microcracking or delamination), followed by App_5 (presence of debris), then App_2 (oxidation), and App_9 and App_8 (neoprene crushing/extrusion and

For pot bearings (Figure 10b), App_2 (oxidation) is by far the most prevalent, observed in over 72% of cases, with App_4 (improper pre-setting) occurring around 9.3%, while other defects are either absent or negligible. For steel bearings (Figure 10c), some considerations made for elastomeric bearings apply. In fact, almost 80% feature oxidation, and about 6% are affected by App_5 (presence of debris), which, among minor defects, appears most frequently. The presence of App_7 is clearly attributable to form entry errors since steel bearings do not have neoprene parts.

Finally, for bearings with steel-Teflon surfaces [22] shown in Figure 10d, the most common defect is App_2 (Oxidation), affecting more than 53% of devices, with a significant presence of App_14 (Teflon degradation) with 10.7%, App_5 (presence of debris) with 5.4%, and App_4 (improper pre-setting) with 3.4%. Additionally, for these bearing types, the notes often report defects like "Loose bolts", with known issues of anchoring pins

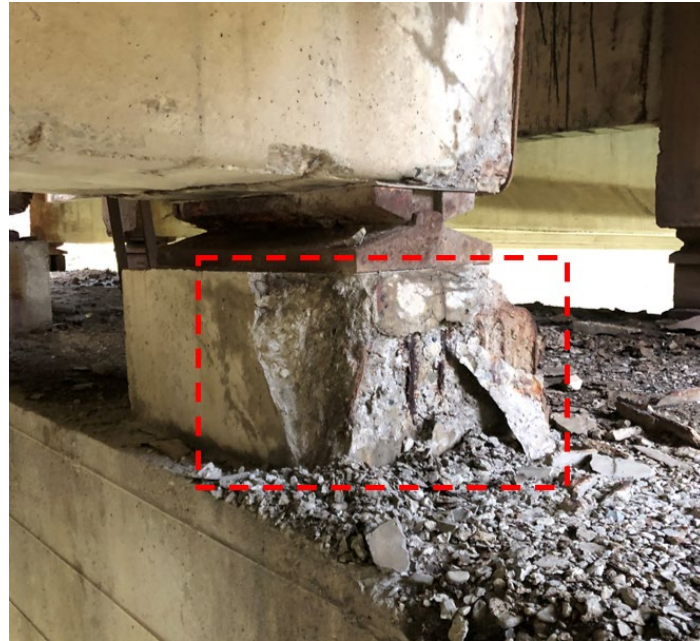
Figure 11. Example of damaged/degraded (spalling and reinforcement corrosion) reinforced concrete support (from Authors' inspection).

excessive horizontal deformation) are present. Inspectors occasionally report defects not covered in the bearings form, such as damaged/degraded bearing supports (Figure 11). Although this defect is not directly related to the bearing device, it can affect its correct operation and, therefore, should be considered among the defects of bearings, highlighting those that need restoration interventions. A similar issue can be detected for the members supporting or directly related to bearing devices in Gerber bridges (also referred to as cantilever bridges) (e.g., [21]) as, for example, the half-joints.
