A modal-based shape optimization methodology for conventionally shaped patches in composite plate repair

A modal-based shape optimization methodology for conventionally shaped patches in composite plate repair / Echer, Leonel; Ochoa, Ozden O.; De Souza, Carlos Eduardo; Marczak, Rogério J.. - In: COMPOSITES. PART B, ENGINEERING. - ISSN 1359-8368. - ELETTRONICO. - 309:(2026), pp. 1-18. [10.1016/j.compositesb.2025.113084]

# A modal-based shape optimization methodology for conventionally shaped patches in composite plate repair<sup>☆</sup>

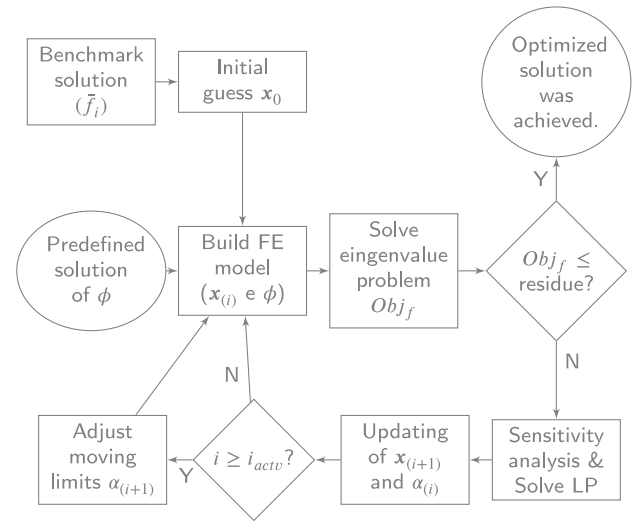
Fig. 5. Optimization flowchart.

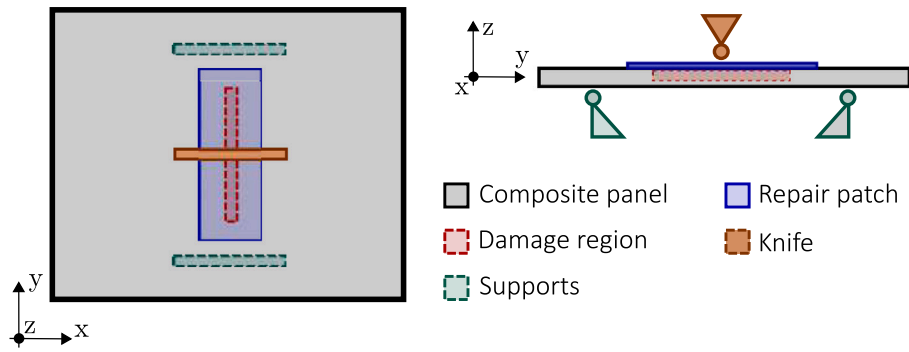
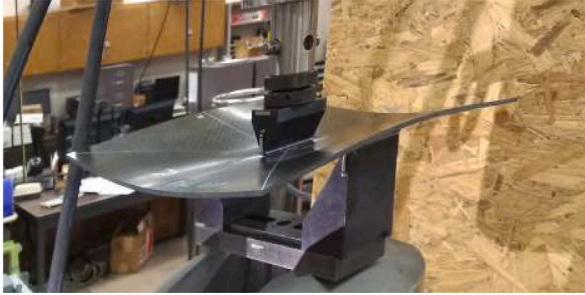
(a) 3-points bending setup for the repair patch under nominal compression.

(b) Panels top surface.

(c) Panels bottom surface.

Fig. 9. Mechanical testing until failure.

The mechanical tests until failure were conducted using a three-point bending fixture (ASTM D790 [44]) mounted on a servo-hydraulic universal testing machine (MTS 810) with a maximum load capacity of 244.0 kN. Due to the panel dimensions, strict adherence to standard testing guidelines was not feasible. Instead, the best possible arrangement was sought to ensure proper positioning relative to the supports (Fig. 9(c)) and the loading knife (Fig. 9(b)). The knife edge was placed at the center of gravity of the panels, aligned transversely to the bonded patches, while the supports were positioned past the patch edges. Fig. 9(a) illustrates the adopted setup, ensuring that the repair region was subjected to direct loading without overlapping the supports or the patch edges. The total span between supports was 203.2 mm, and both the knife edge and supports had a depth of 50.8 mm. Details of the test setup are provided in Fig. 9.

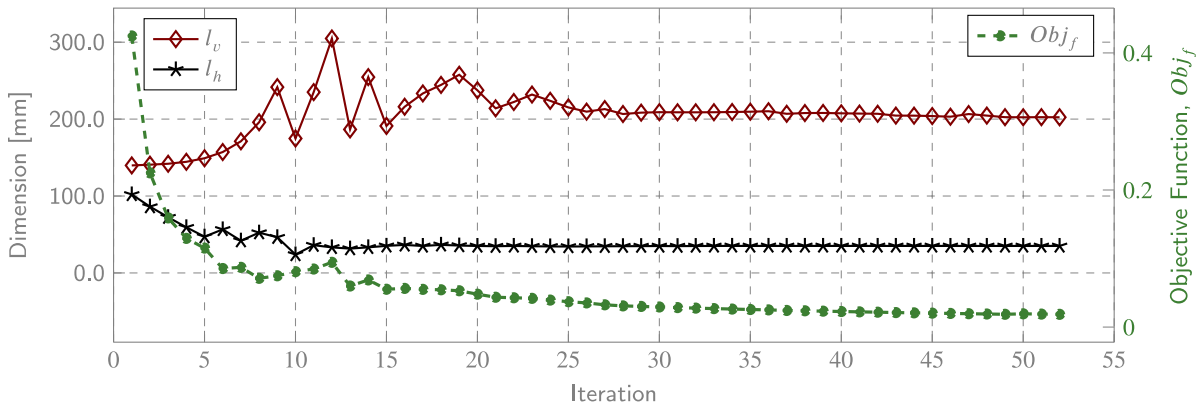
Fig. 10. Convergence of design variables ( $l_v$ ,  $l_h$ ) and the objective function ( $Obj_f$ ) during the optimization process.

of the pristine panels PNL-00, PNL-01, and PNL-02, as detailed in Section 2.3. Furthermore, assuming a rectangular repair patch reduces the design vector to two variables: the dimensions comprising the side lengths  $l_v$  and  $l_h$ . This consideration facilitated the formulation of the optimization problem, integrating these design dimensions into Eq. (2). Fig. 10 illustrates the solution associated with this optimization problem. The objective function  $Obj_f$  evolution across iterations is shown on the right vertical axis, while the convergence of the design variables  $l_v$  and  $l_h$  is depicted on the left vertical axis.

The convergence criterion was met after 52 iterations. The total computational time amounted to 509.6 s, with only 206.5 s spent on the actual optimization; the residual time was devoted to the iterative analysis of the resulting FE models during each iteration  $i$ . The optimal configuration corresponded to a rectangular patch with dimensions  $l_v = 202.4$  mm by  $l_h = 35.1$  mm, yielding a total area of 7101.5 mm<sup>2</sup>. Comparatively, the single-layer repair patch's total area constituted 7.6% of the panel's total surface area, and was 5.4 times larger than the damaged region's surface area.

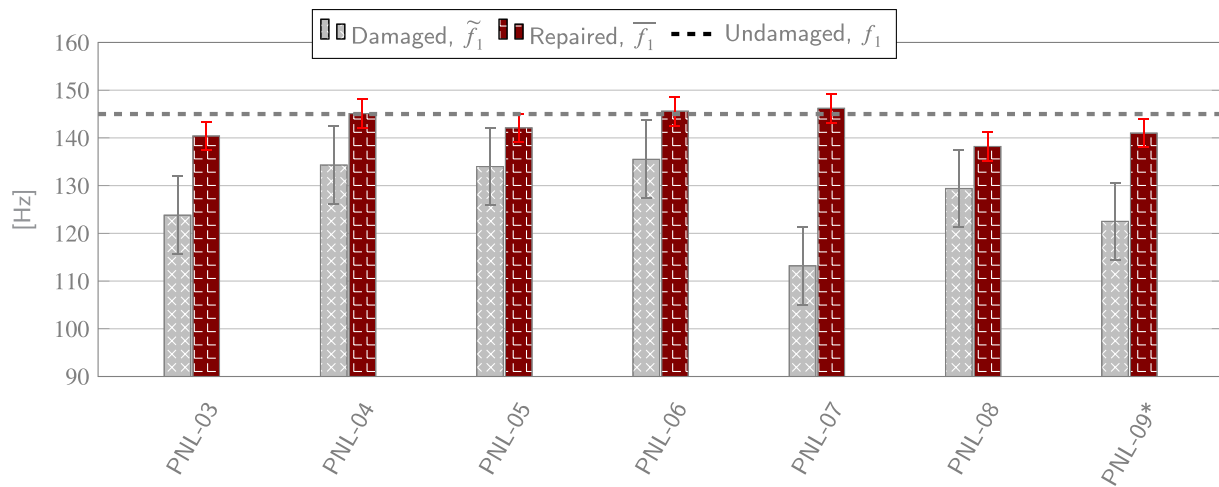
Fig. 12. Panels modal response: damaged and repaired.

restoration process. Fig. 12 also highlights an interesting observation regarding PNL-09. Although it underwent the most severe damage – a through-thickness material removal – its restoration efficiency remained comparable to that of the other specimens. This suggests that, despite the patches being optimized for a different configuration, the repair methodology was effective in recovering stiffness. However, as will be discussed in the following section, such efficiency is less evident when evaluating mechanical resistance through three-point bending tests.

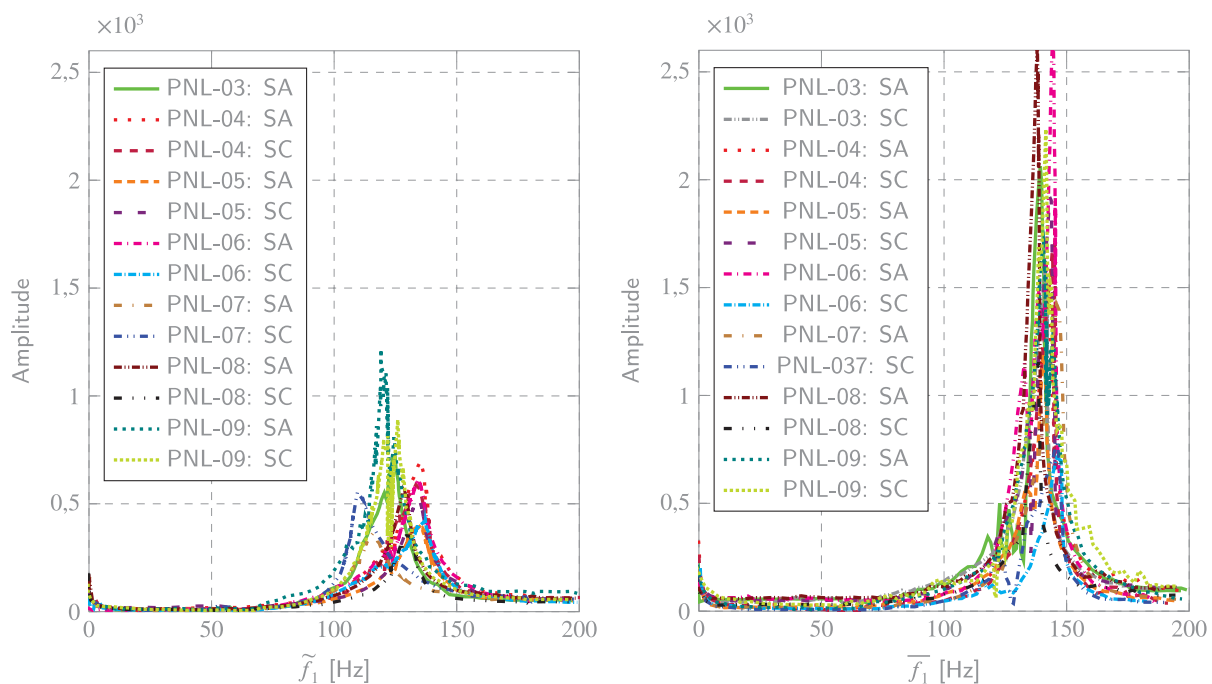
(a) Modal response curves: damaged specimen.

(b) Modal response: repaired specimen.

Fig. 13. Modal response for all panels, damaged and repaired, at two distinct sensor positions: SA and SC.

Fig. 13 illustrates the modal response curves for each panel before and after repair, overlaid for direct comparison. Significant variations in signal amplitude among specimens are anticipated due to the nature of the test. The introduction of damage inherently induces greater dispersion of the signal curves about the average  $\bar{f}_1$ , Fig. 13(a). Nevertheless, the repair procedure effectively consolidates the curves, thereby reducing the dispersion around the average response as noted in  $\bar{f}_1$ , Fig. 13(b).

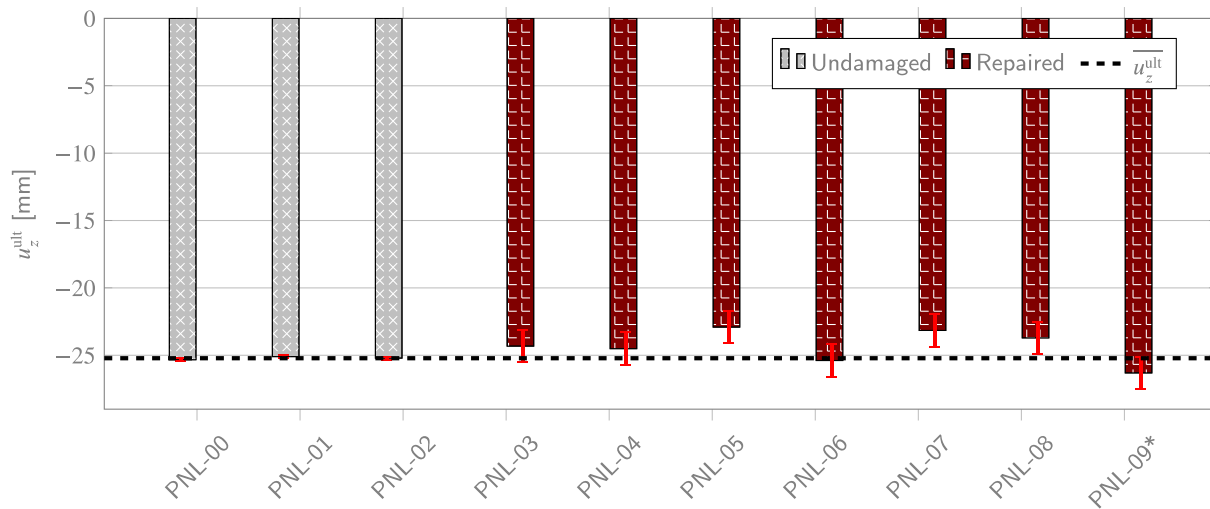
Fig. 17. Three-point bending: ultimate displacement ( $u_z^{ult}$ ).

The ultimate displacement of the undamaged and repaired panels are presented in Fig. 17. The undamaged panels exhibited an average ultimate displacement ( $u_z^{ult}$ ) of  $-25.2\text{mm}$ , with a sample standard deviation of  $0.1\text{mm}$ . In comparison, the repaired panels showed a slightly lower average of  $-24.3\text{mm}$  and a substantially higher standard deviation of  $1.2\text{mm}$ , approximately 11 times greater. However, this contrast stems from the exceptionally low dispersion among the undamaged specimens, indicating strong population representation. When evaluated in relative terms, this difference becomes even more evident, as shown in Table 6.

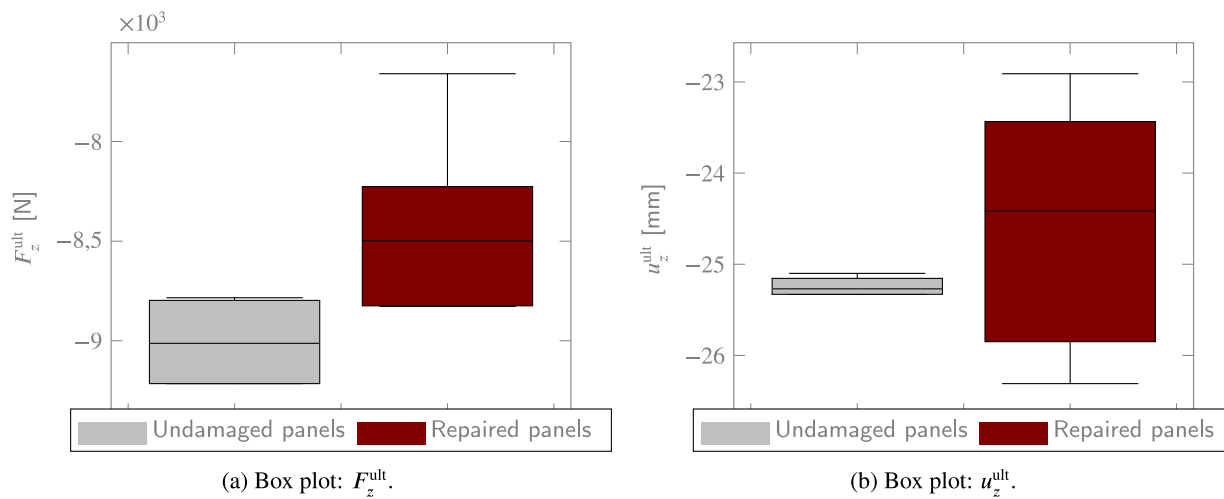
Fig. 18. Results dispersion for the undamaged and repaired configurations.

As shown in Fig. 18(a), the peak load sustained by the repaired panels was consistently lower than that of the undamaged ones. Conversely, Fig. 18(b) shows that the ultimate displacement of the repaired panels fluctuated around the undamaged mean, suggesting that, on average, the original flexibility was nearly restored—an outcome aligned with the observed recovery in modal response ( $f_1$ ). Meanwhile, the monotonic trend in  $F_z^{ult}$  confirms that although the optimized patches enhanced structural strength, full recovery to the original performance level was not achieved. Notably, a significant portion of the variability within the repaired group can be attributed to panel PNL-09, which exhibited a through-thickness defect—a more critical condition not addressed in the patch design—resulting in a more compliant repaired configuration.
