Chapter 8

The Sanctuary of Vicoforte

Rosario Ceravolo, Mario Alberto Chiorino, Stefania Coccimiglio,
and Gaetano Miraglia

Abstract Renowned for its massive masonry oval dome, the largest worldwide, the Sanctuary of Vicoforte has faced significant structural issues, including settlement and cracking. Since the 1980s, a sophisticated monitoring system has evolved, incorporating static and dynamic measurements, supported by geotechnical surveys. Recent advancements include the integration of satellite data. The collection and the analysis of these different kind of data aimed at developing a robust Digital Twin for real-time diagnostics and predictive analysis, paving the way for resilient management of architectural heritage. Temperature-induced behaviors, such as changes in vibration frequencies and crack dynamics, reveal complex interactions between environmental conditions and structural responses. Future upgrades will focus on further integrating remote sensing capabilities to enhance this innovative approach.

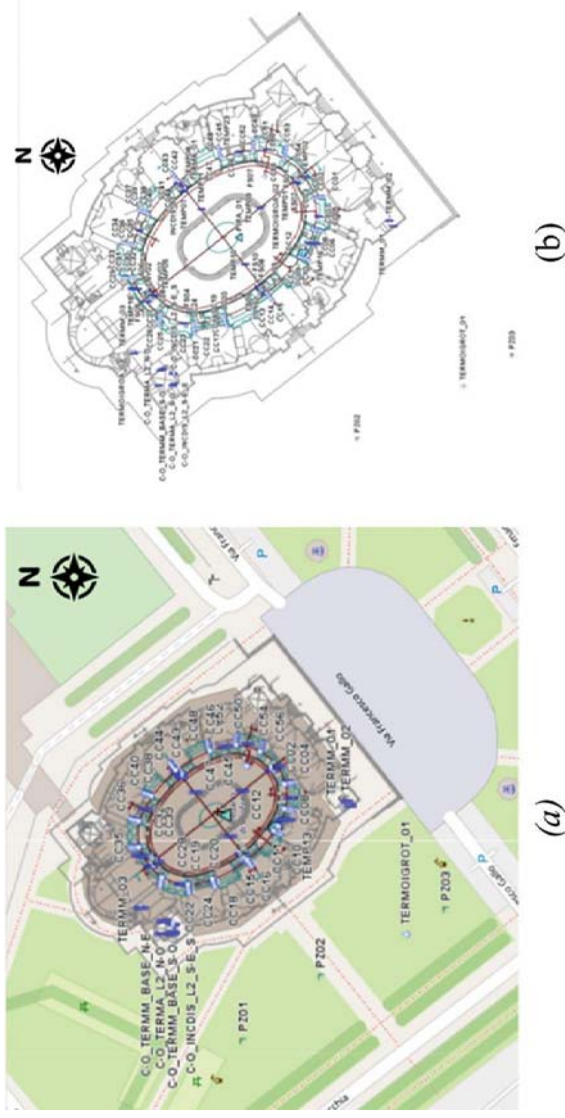
Fig. 8.2 Layout of the low-rate system of the Sanctuary and the mixed monitoring system of the West bell tower

In the early 1980s, a hooping system was installed to prevent the widening of cracks, primarily concentrated in the dome-drum system. The system consists of four high-strength steel bars arranged in each of the 14 tangential directions. Steel frames connect the ends of the bars in two adjacent stretches. The tie bars, slightly prestressed to 50 kN using jacks, were retensioned in 1997 to compensate for physiological load losses (Chiorino et al., 2008). Geological and geophysical investigations, conducted between 1976 and 2008, confirmed that the subsoil of the Sanctuary is composed of different materials (Scandella et al., 2011). A marl layer slopes downwards from the northeast to the southwest, while a clay layer exists beneath the rest of the building, causing serious cracking patterns. Monitoring of the Vicoforte Sanctuary began in 1983 with the installation of instruments to investigate crack pattern evolution. Since then, the static monitoring system has undergone several updates, culminating in 2004 with an automated data acquisition system; this system was comprised of 133 instruments specifically placed on the dome-drum structure (Ceravolo et al., 2017). The system continuously operated from 2004 to 2015, after which it was restored and reactivated in November 2023. Today, the static monitoring of the Vicoforte Sanctuary consists of 56 load cells, 2 laser distance meters, 2 distance meters, 12 crack meters, 28 thermometers, 1 barometer, 1 pyranometer, 3 thermo-hygrometers, and 3 piezometers (Fig. 8.2). In 2015, a dynamic monitoring system was added, consisting of 12 accelerometers (Ceravolo et al., 2016) (Fig. 8.3) distributed at different heights to monitor the overall structural behaviour, which also underwent adjustments and updates in 2023. The dynamic acquisition system at the Sanctuary of Vicoforte records data based on two criteria: time and threshold. The time criterion involves recording for 20 min every hour to limit data storage, while the threshold criterion records data when ground horizontal acceleration exceeds 0.042 g, in line with Italian seismic hazard

Finally, in 2023, a mixed monitoring system was installed in the West bell tower, including 2 MEMS triaxial accelerometers, 2 inclinometers combined with biaxial laser distance meters, 6 thermometers, and 4 strain gauges.

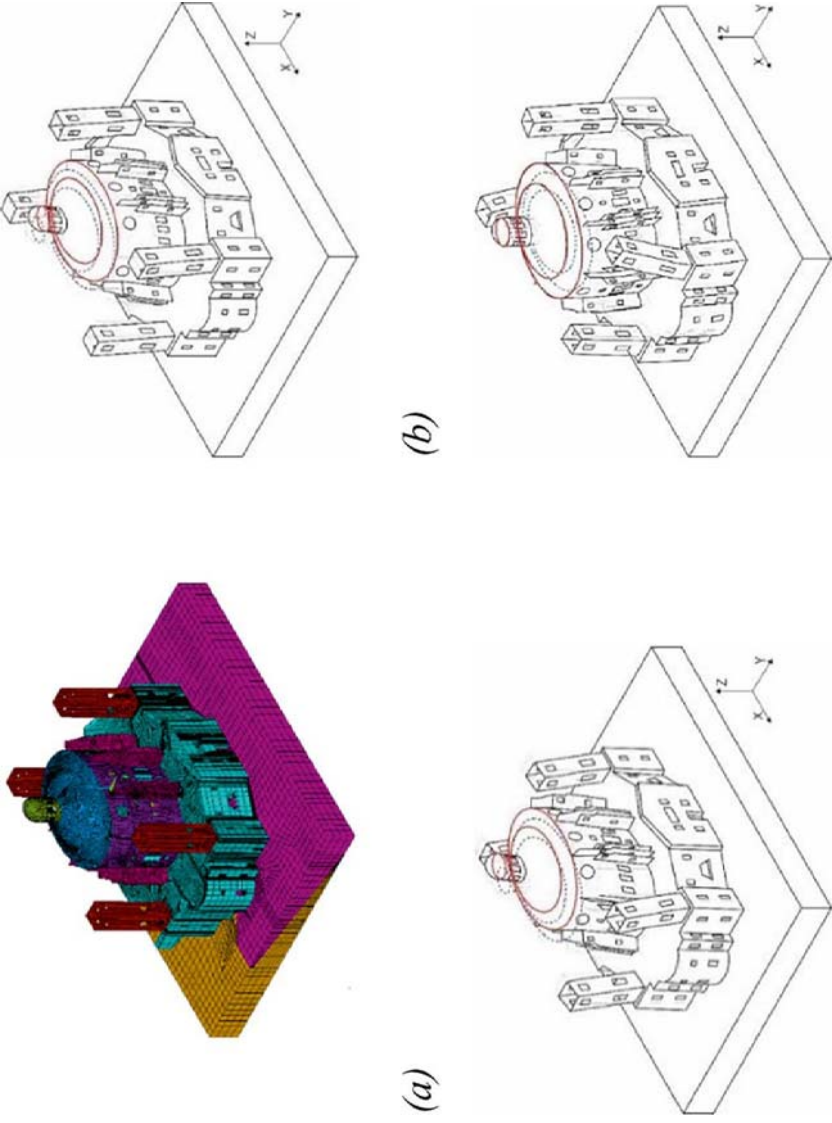
Fig. 8.5 (a) FEM of the Sanctuary of Vicoforte, (b) first modal shape (longitudinal along Y direction), (c) second modal shape (longitudinal along X direction), and (d) third modal shape (torsional)

Then, the data acquired from the monitoring system can be used for the updating of the Finite Element Model (FEM) of the Sanctuary. The first model updating of the Sanctuary was based on the results of a dynamic test campaign conducted in 2008 (Chiorino et al., 2011). Successively, in order to consider the structural, typological and historical peculiarities of each component of the structure, a more accurate FEM model was built that consisted of 9 homogeneous macro-elements: 7 for the building (lantern, dome, drum, basement, but-tresses, belltowers and iron ties) and 2 for the soil (marl and clay). Then a thermo-elastic updating was performed using multiphysics data, including the thermal analysis to obtain the temperature distribution of the drum-dome system as related to the forces acting in the tie-bars (Ceravolo et al., 2020). This distribution was determined by applying local temperature measurements to the thermal FE model.

The update of the FEM model (Fig. 8.5) through experimental data allows the model to be as close as possible to reality, enabling it to accurately reflect the actual behaviour of the structure while always considering the uncertainties inherent in its nature. The more types of data are used to enrich the model and study the behaviour of the structure (Figs. 8.4 and 8.6), the greater the fidelity of the model to its real-world counterpart. Thus, it was decided to equip the Sanctuary of Vicoforte with instruments capable of characterizing its behaviour from multiple perspectives. In addition, when dealing with SHM, it is essential to consider the influence that the environment and the soil can have on the structure response. For this reasons, the Sanctuary of Vicoforte presents a complex monitoring system (Table 8.1) that
