Casual or causal? The lightning-triggered NaTech accident at the supertanker base of Matanzas, Cuba

# Casual or Causal? The Lightning-Triggered NaTech Accident at the Supertanker Base of Matanzas, Cuba

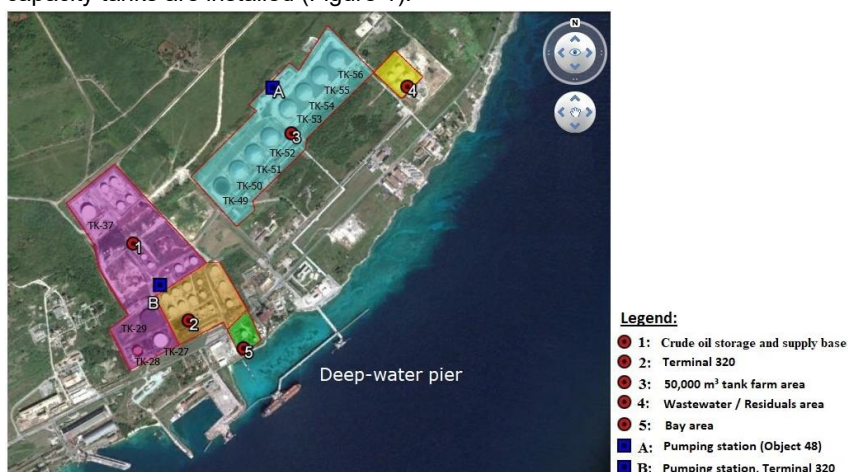
The Matanzas Supertanker Terminal, located in the Port of Matanzas (Cuba) and operated by the national Fuel Commercializing Company (*Empresa Comercializadora de Combustibles in Spanish*), was commissioned in the late 1980s. The terminal comprises five deep-water berths designed to receive tankers of up to 180,000 deadweight tonnage, with a maximum draft of approximately 20 m. With an overall storage capacity close to 800,000 m<sup>3</sup>, the site represents one of the largest national hubs for the handling and storage of multiple petroleum products and is therefore considered a critical component of Cuba energetic infrastructure. In 2012, major rehabilitation works were conducted to restore large-volume crude oil storage units and expand operational capacity. Several tanks were retrofitted with geodesic dome roofs, consisting of lightweight aluminium structural systems to mitigate hydrocarbon evaporation losses. The storage system included ten atmospheric tanks of 50,000 m<sup>3</sup> each, eight of which are arranged in the northern tank farm with an inter-tank spacing of approximately 50 m. Additional process and storage units, including the crude supply base and a terminal dedicated to refined products, are located in the western sector of the industrial complex, where smaller-capacity tanks are installed (Figure 1).

Figure 1: Matanzas Supertanker Base. Source: Modified from Cabrera-Estupiñán et al. (2016).

The initiating incident occurred on August 5 of 2022, approximately at 19:00, when lightning struck the geodesic dome roof of one of eight hydrocarbon tanks in the farm area igniting a fire (TK-52 in Figure 1). This tank contained approximately 26,000 m<sup>3</sup> of fuel oil (approximately 50% of its capacity). By 5:00 a.m. on August 6, despite ongoing firefighting and cooling efforts, Tank 51 exploded, further escalating the incident. Several explosions occurred, including the boilover phenomenon—defined as the violent ejection of liquid hydrocarbons

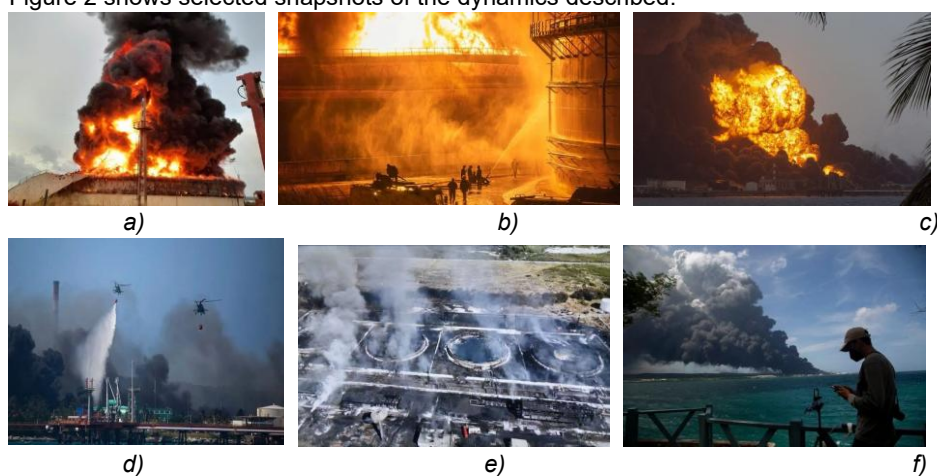
*Figure 2: Major fire at the Matanzas Supertanker Base: a) Fire in tank 52. Source: Portal Cubadebate. b) Firefighters cooling tank 51. Source: Gramma Newspaper. c) Third day of fire. Source: Portal Cubadebate. d) Aircraft fighting the fire. Source: Portal Cubadebate. e) Accident zone after five days. Source: The presidency of Cuba. f) Black smoke cloud above the Matanzas Supertanker Base. Source: Portal Cubadebate.*

caused by the vaporization of water layers beneath the fuel during prolonged storage tank fires. These events led to tank rupture and structural failure. By August 8, a change in wind direction from the Northeast caused the fire to spread to tank 50 containing fuel oil. The flames subsequently reached tank 49 of crude oil, thereby substantially increasing the magnitude and consequences of the accident. The three additional affected tanks after the initiating event were all full, with a capacity of 50,000 m<sup>3</sup>. The resulting thermal radiation reached extreme intensities, severely impacting surrounding industrial areas. Thermal radiation intensities peaked at around 70 kW/m<sup>2</sup> within a radius of 500 meters after the initial fireball, considerably amplifying the severity of the incident. The firefighters, assisted by Mexican and Venezuelan reinforcements, also cooled tanks 53, 54, 55, and 56 and put out the fire after five days. The four tanks involved in the fire were destroyed and the inventory was totally lost. Consequently, a large amount of toxic black smoke persisted for approximately five days, substantially deteriorating regional air quality. Although the accident caused substantial operational and environmental impacts, its most severe effects were on the human and social dimension, which reached level 5 on the European industrial accident scale (where 6 represents the maximum severity). This led to 16 fatalities among firefighting personnel, 132 injuries, and the temporary evacuation of 4744 residents (BARPI, 2024). Figure 2 shows selected snapshots of the dynamics described.

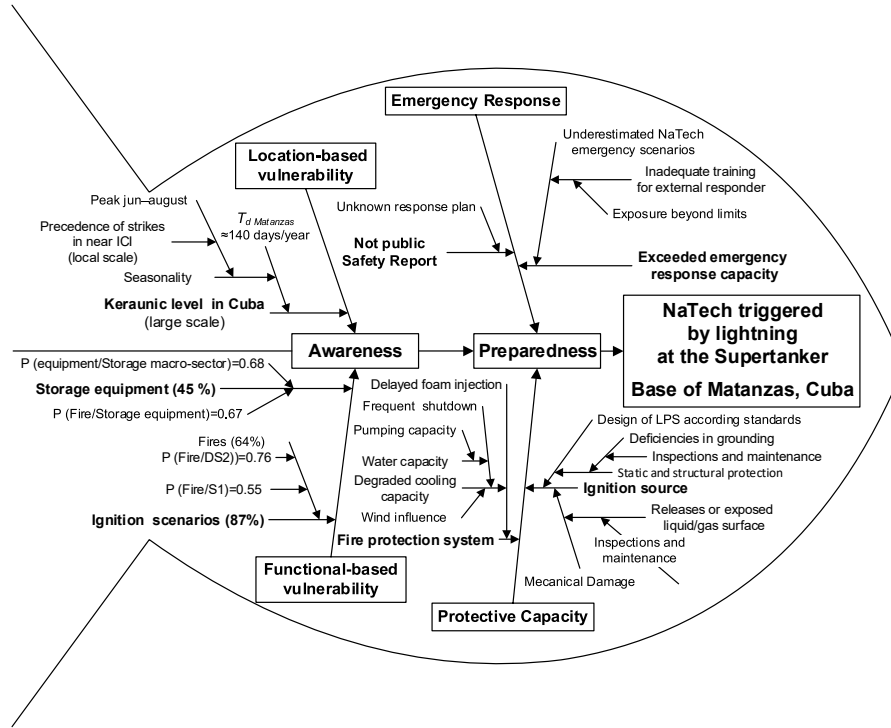
This section analyses the fishbone diagram in Figure 3 for the NaTech accident described in subsection 2.1, following the structured framework in 2.2. Subsection 3.1 addresses location-based vulnerabilities, 3.2 examines technological vulnerabilities, 3.3 evaluates protective capacity, and 3.4 discusses emergency response.

Figure 3: Fishbone Diagram of lightning-triggered NaTech accident at the Matanzas Supertanker Base.

From a causal perspective, several technical failure mechanisms can be considered: i) degradation or discontinuity of the grounding system; ii) insufficient equipotential bonding; iii) compromised dome sealing due to maintenance activities leading to vapor exposition; and iv) indirect lightning current propagation through instrumentation or sensor cabling. Overall, in the absence of evidence of a single-point failure, the event is better understood as the outcome of interacting factors. This systemic perspective coherently aligns with the causal pathways identified in the ignition-source branch of the fishbone diagram.
