# Microplastics contamination in Isinuka springs and CO<sub>2</sub>-seeping freshwater systems in South Africa: a baseline study

Microplastic (MP) pollution is increasingly being reported in freshwater ecosystems, yet culturally significant and geochemically unique systems remain poorly studied. This study provides baseline evidence of MP contamination in South Africa's sacred freshwater systems, specifically Isinuka springs and CO<sub>2</sub>-seeping freshwater systems along the Bongwana Fault. Surface water samples were collected from nine sites, including Isinuka springs (four sites;  $n = 4$ ) and CO<sub>2</sub>-seeping freshwater systems (five sites;  $n = 5$ ). Microplastics were found at all sites, with abundances ranging from 5 to 48 particles l<sup>-1</sup> (average  $\approx 20.4$  particles l<sup>-1</sup>). Transparent MP particles were the most common colour (38.6%), fibres/filaments were the dominant shape (69.6%), particles  $\geq 20$   $\mu\text{m}$  accounted for the highest proportion by size (51.1%), and polypropylene (PP) was the most frequently identified polymer (38%). A variety of MP patterns were observed, with the highest number of MP particles found at the

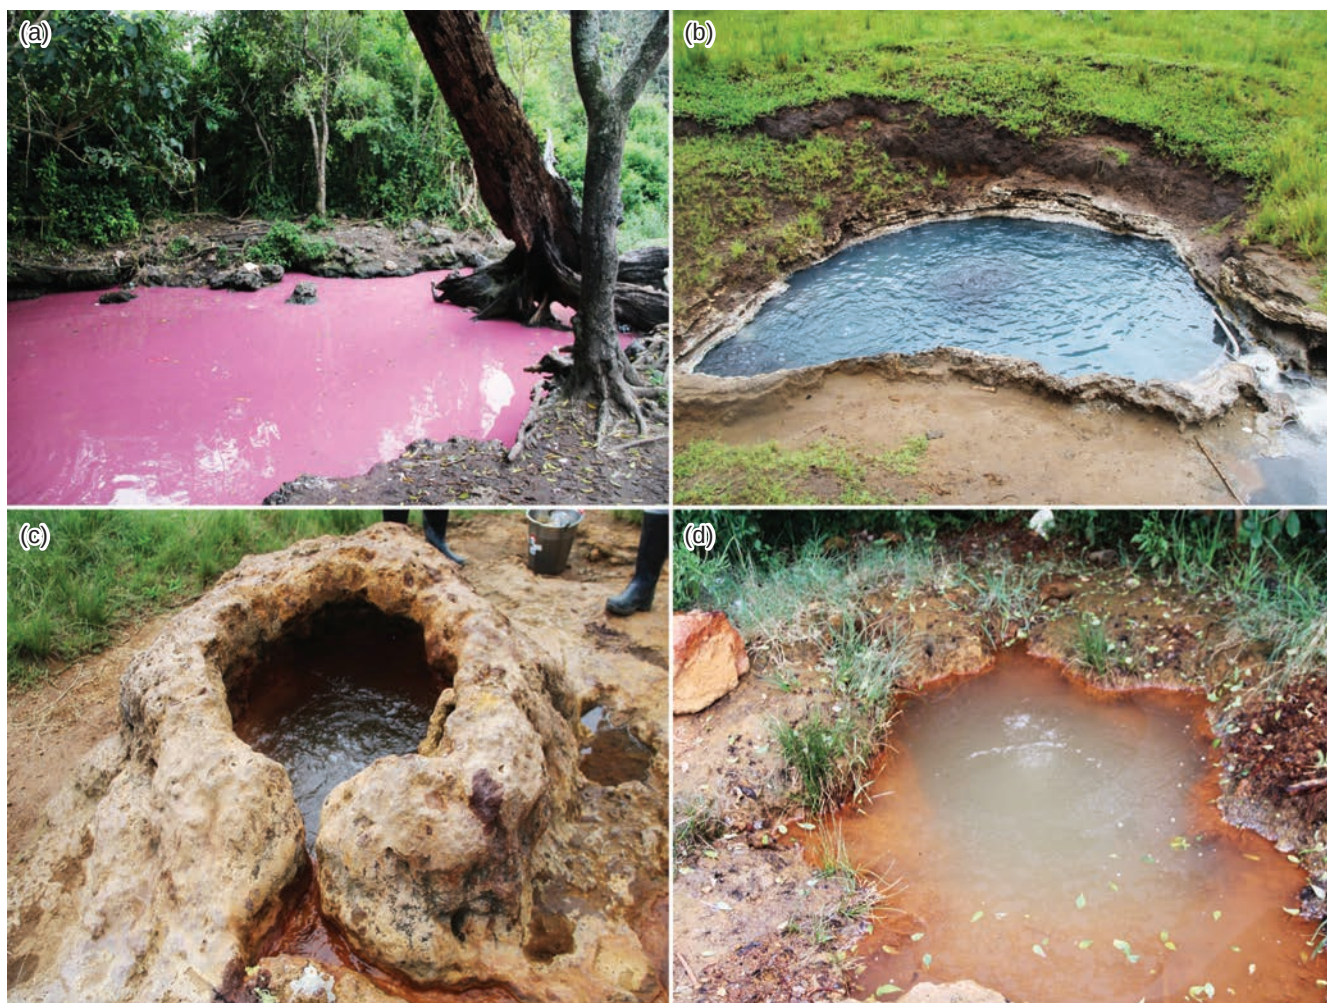
**Figure 1:** Images of selected sampled sacred freshwater systems: (a) Isinuka Spring (also known as Isinuka Healing Spa/the naturally pink spring; Site 1); (b) Sulphur-rich spring located ~10 km from Isinuka Spring (Site 4); (c) and (d) CO<sub>2</sub>-seeping systems at Nomkololwana village in Mbizana. Photographs by Thendo Mutshekwa

Water sampling was conducted in March 2025 across nine sacred freshwater systems (Figure 1; Table S1). Three sites (Sites 1–3) were located in the Isinuka springs (also known as Isinuka Mud Caves and Sulphur Pools) in the Isinuka Village, and one (Site 4) located 10 km from Isinuka village near Mzimvubu River (see Ncube et al. 2020 and Ogola et al. 2025 for detailed site descriptions). Five sites on CO<sub>2</sub>-seeping freshwater systems were located along the Bongwana gas fault in the Bongwana village ( $n = 3$ ; Site 5–7), and a further two sites were located at Mbizana/Nomkololwana village near Mtamvuna River in the border of Eastern Cape and KwaZulu-Natal ( $n = 2$ ; Sites 8–9) (see Harris et al. 1997; De Decker 1981 for detailed site descriptions). The Isinuka springs are regarded as sacred due to their long-standing use for ritual bathing, spiritual cleansing, healing, and domestic water collection by local communities (Ncube et al. 2020). Similarly, several CO<sub>2</sub>-rich seeping systems along the Bongwana gas fault hold cultural significance linked to ancestral beliefs and traditional practices (Bond et al. 2017).

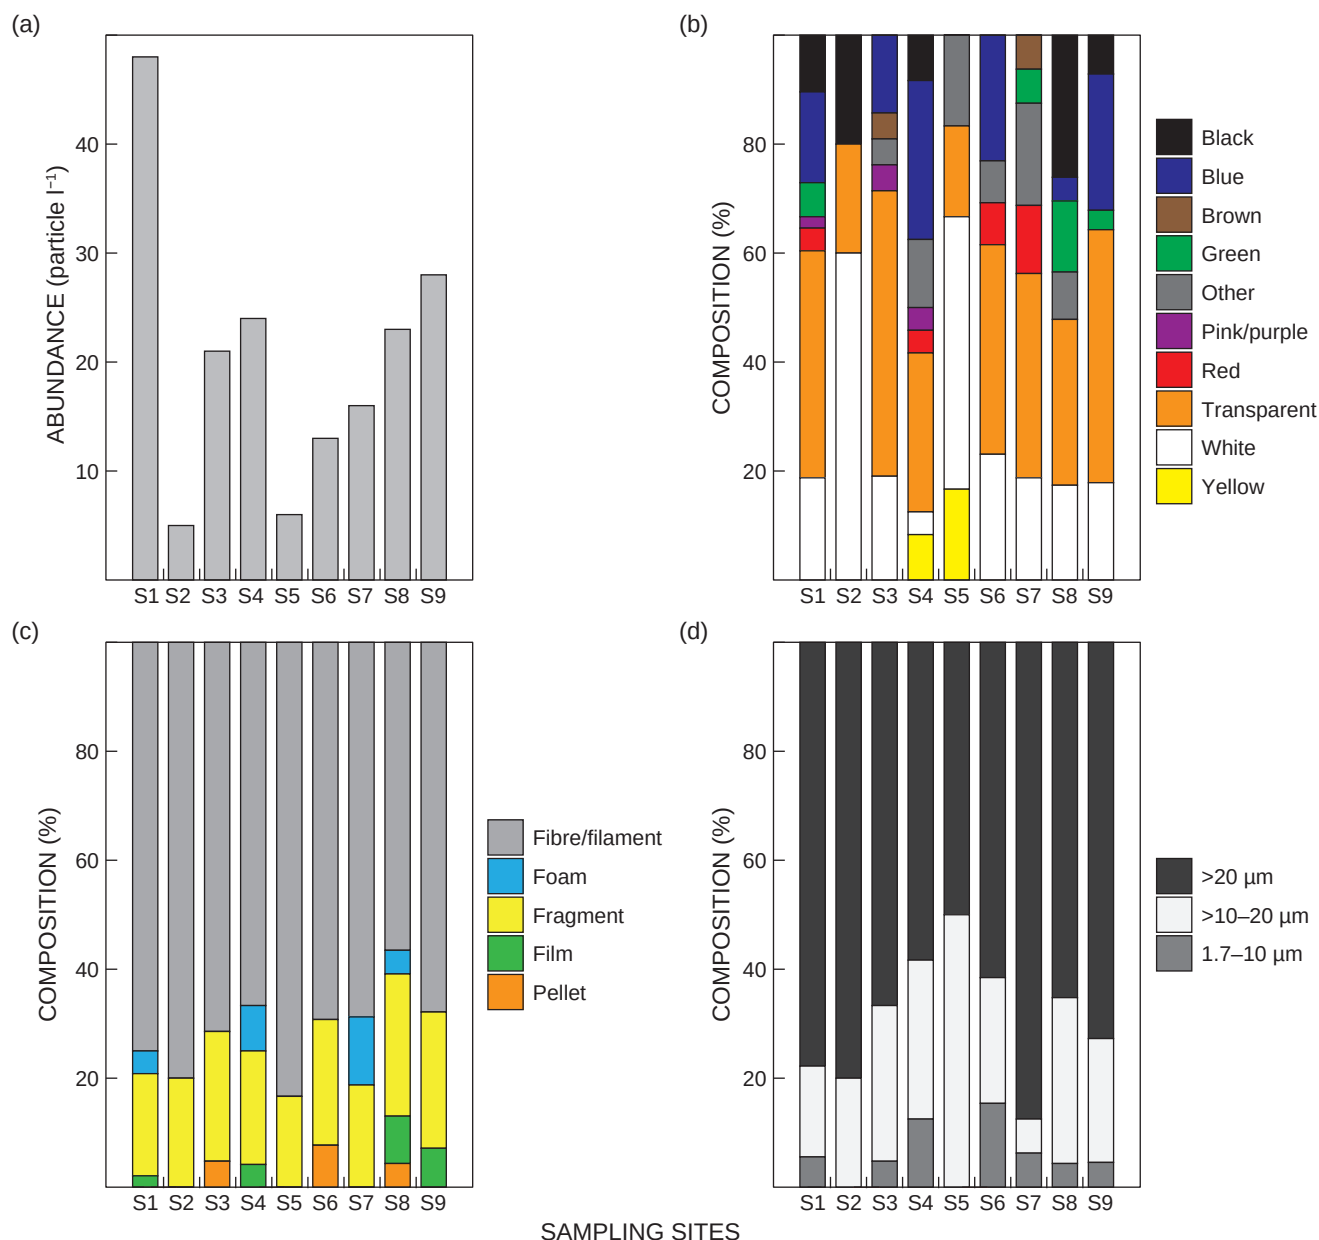
**Figure 2:** Microplastic characteristics in sacred freshwater systems: (a) abundance, (b) colour, (c) shape, and (d) size in Isinuka springs (sites 1–4) and CO<sub>2</sub>-seeping faults (sites 5–9) in the Eastern Cape and KwaZulu-Natal provinces, South Africa. S1–S9 denote sites 1 to 9

Contamination was not found in controls (i.e. controls in the laminar flow and bench top). As procedural blanks showed no MP contamination, a conservative observational reporting threshold of 5 particles l<sup>-1</sup> was adopted, corresponding to the lowest non-zero concentration detected among samples. A total of 184 MPs were found across all 9 sampled sites, ranging from 5 to 48 particles l<sup>-1</sup> and an average of 20.4 ( $\pm$  4.3 SD) particles l<sup>-1</sup>. The highest abundance of MP particles, 48 particles l<sup>-1</sup>, was found in Site 1 (Isinuka spring), and the lowest abundance was found in site 5 (CO<sub>2</sub>-seeping) (Figure 2a). The most common MP colours found were transparent (38.6%), white (19.0%), and blue (15.8%) (Figure 2b), while fibres/filaments (69.6%) and fragments (21.7%) dominated in shape, with foam (3.8%), film (3.3%), and pellets (1.6%) being less frequent (Figure 2c). Microplastic particles were also found across different sizes, with particles >20  $\mu$ m contributing to the largest proportion of MP particles (51.1%) followed by 1.7  $\mu$ m (29.9%), and 10  $\mu$ m (19.0%) (Figure 2d).

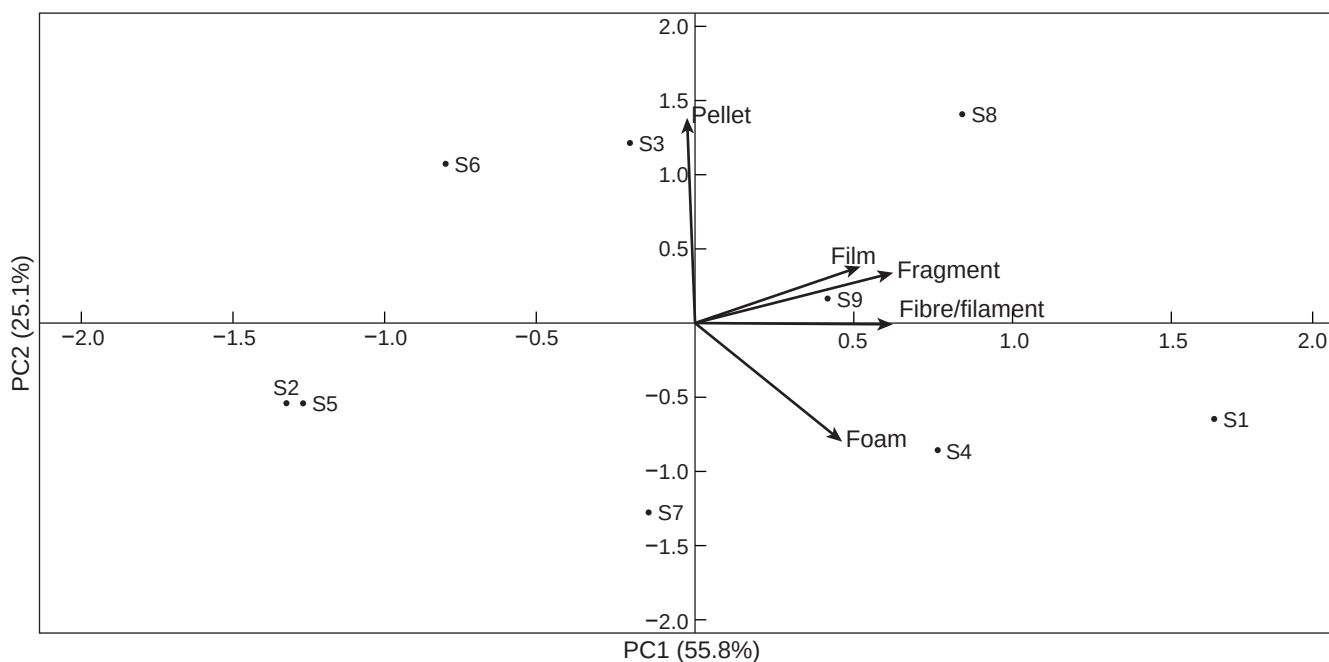
**Figure 3:** Principal Component Analysis (PCA) of MP shapes between sampled sites in the Eastern Cape and KwaZulu Natal, South Africa. S1–S9 denote sites 1 to 9

Principal Component Analysis (PCA) revealed distinct site-level differences in MP shape and colour composition (Figures 3 and 4). The first principal component (PC1) represented MP abundance, with Sites 1, 8, and 9 characterised by higher counts of fibres/filaments, fragments (Figure 3), and transparent particles (Figure 4). The second principal component (PC2) also reflected differences in MP shape and colour.

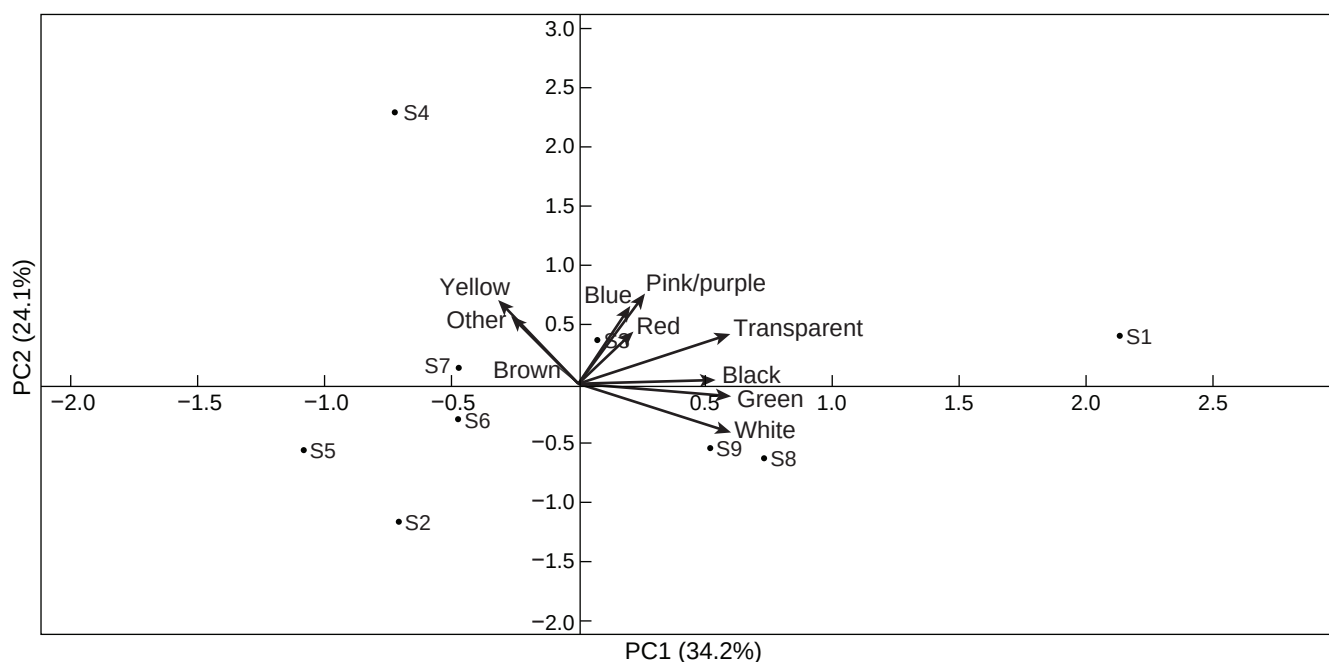
**Figure 4:** Principal Component Analysis (PCA) of MP colours between sampled sites in the Eastern Cape and KwaZulu Natal, South Africa. S1–S9 denote sites 1 to 9
